All Atlanta Inspection Services Inspection Report

2203 Clanton Ter, Decatur, GA 30034
Inspection prepared for: Joey Gumataotao
Date of Inspection: 2/17/2025 Time: 10am
Age of Home: 62 years Size: 2024sq
Weather: 33 degrees

Inspector: Rico Hardrick

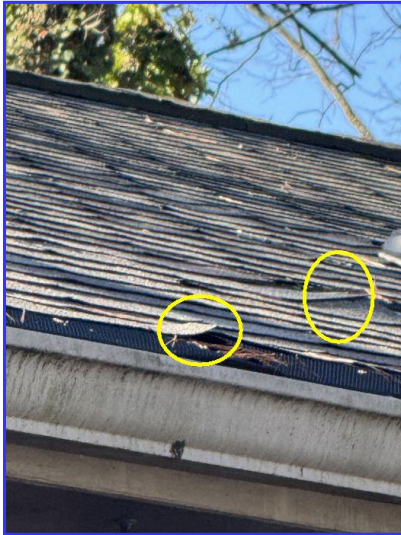
1.3. Minor curling is noted at the edges of the shingles. This is a result of the roofs age. No significant repairs are needed. Suggested to monitor area and repair if needed.

Curling noted on shingles on roof

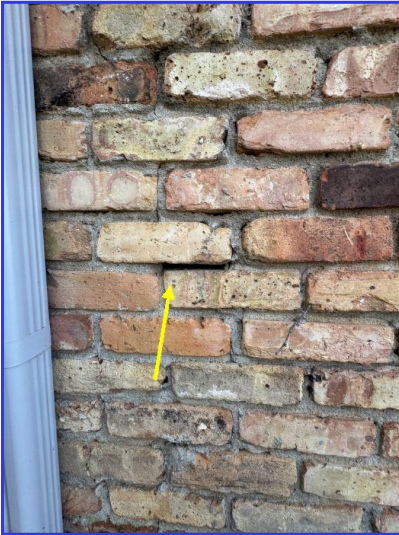
2.3. Cracks are noted in the brick siding at several areas around the home. Cracks in the brick should be professionally sealed to prevent possible water entry and monitored for any future movement. The bricks are siding and are not a structural element of the home.

Damaged brick and mortar at home

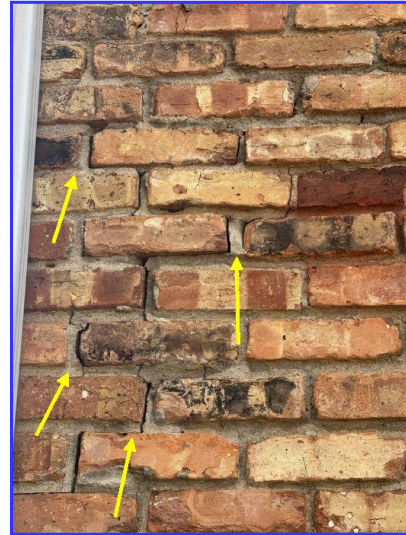
Cracked brick siding at rear

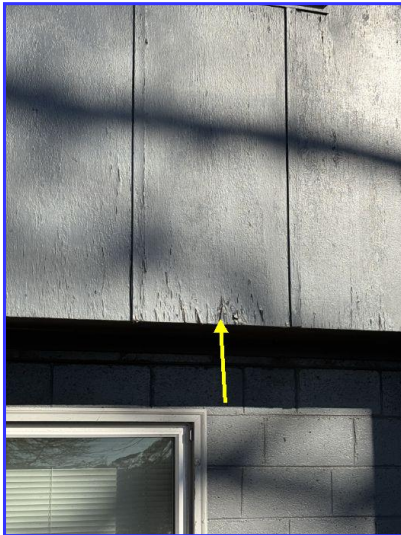
2.4. Multiple areas around the house noted where the lap siding is weathered. Monitor siding for further weathering and deterioration. Repair as needed.

Damaged area of siding at rear

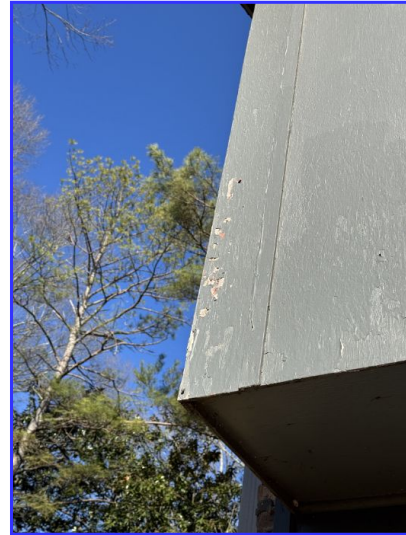
Common cracks/chips noted at the corners of the siding.

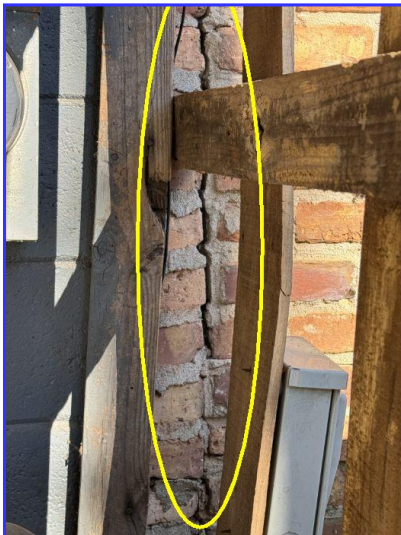
Damaged brick and mortar at rear

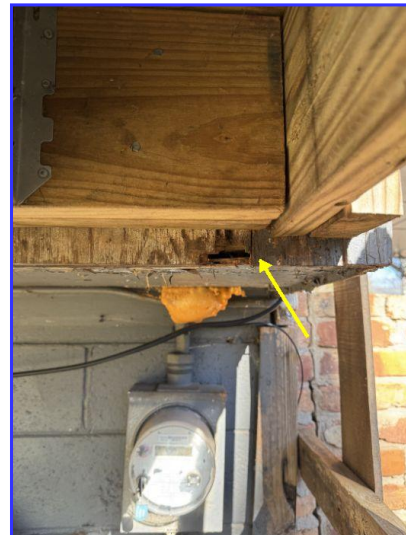
Damaged under deck

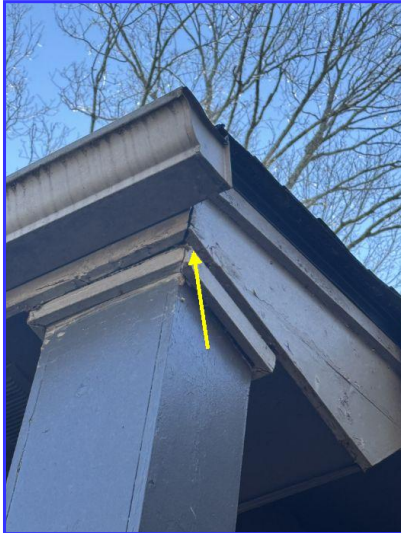
caulk fascia at the right side

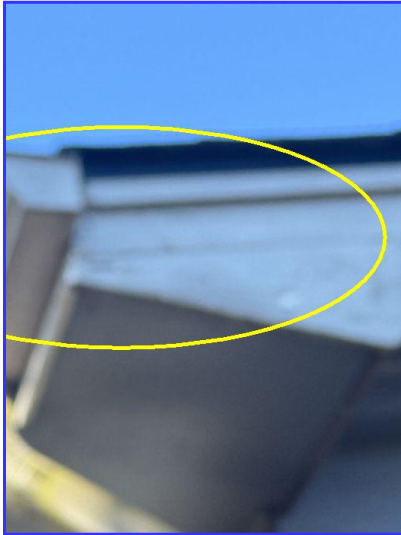
Damaged trim at rear

3.7. Due to the damaged trim noted around the home. It is suggested to have a licensed contractor fully review and repair all damaged and wood trim and any materials subsequently damaged due to the condition of the aforementioned trim. See photographs for some examples and locations.

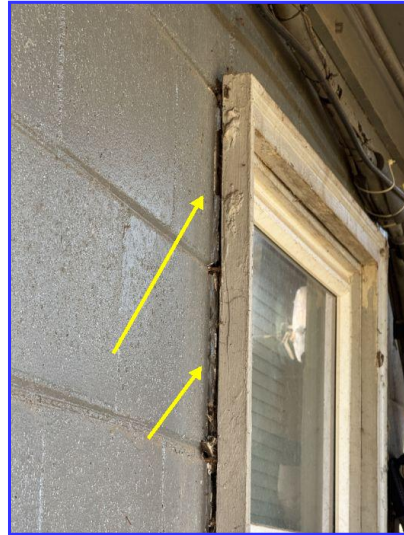
Caulk around window trims

3.3. Suggested to seal around all doors and windows as a part of routine maintenance. Gaps were noted in the sealant around some or all doors and/or windows. Sealant barriers should be maintained to prevent any water intrusion or damaged materials.

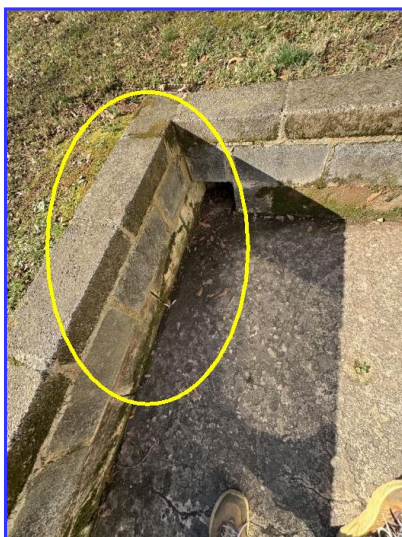
Damaged wall

11.1. Recommend review by a qualified professional for repair or replacement, as necessary.

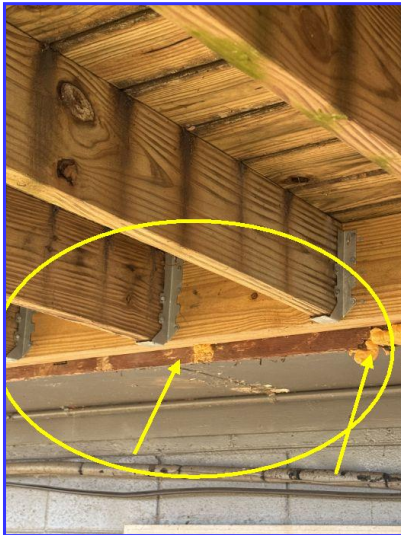
1.5. There is no visible flashing where deck meets house. The joint between the deck and the house should be flashed to prevent water penetration where the deck is bolted to the home.

Missing flashing

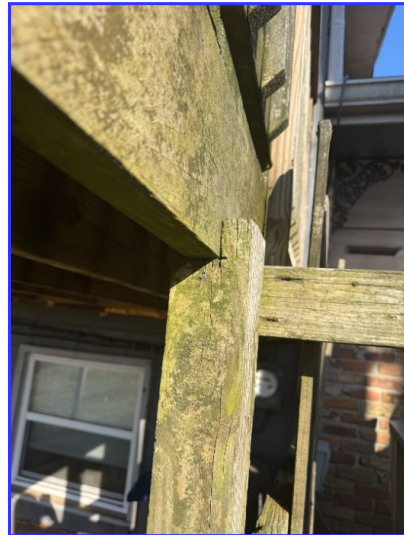
1.6. The deck appears to be nailed to the structure. Nails may pull out and fail. It is recommended to have the deck properly bolted and secured where it meets the rear of the home.

Missing straps and bolts

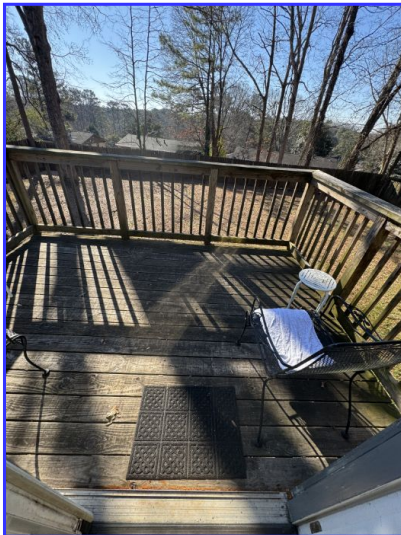
Weathered decking

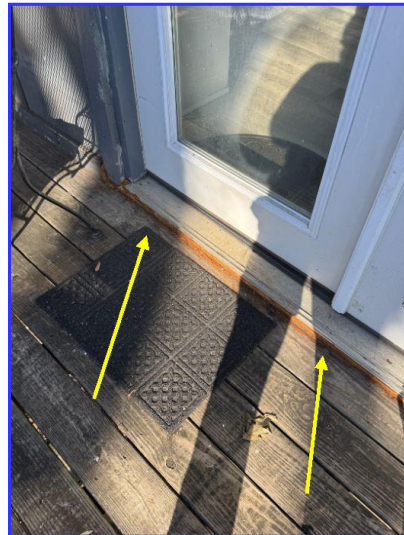
Incorrect repair at deck

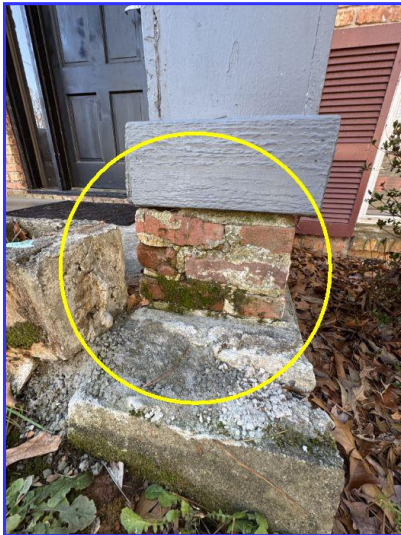
2.2. Wear noted in the mortar at the front porch. Suggested to have mortar repaired as needed to prevent further weathering and potential water issues. See photographs for examples.

Damaged pillars at porch

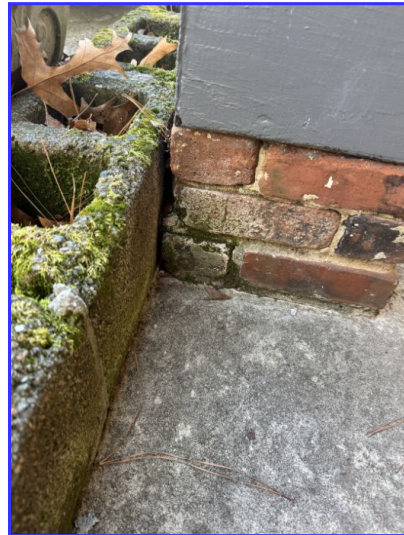
Damaged post footings

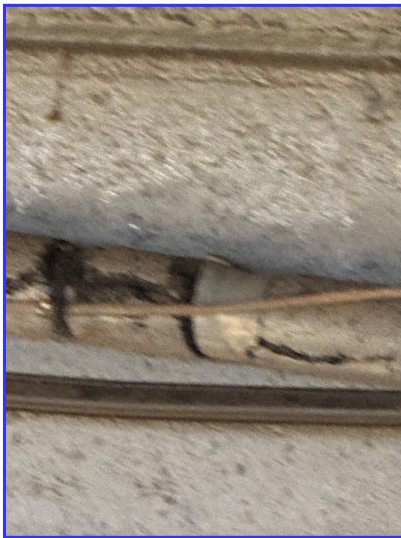
1.2. Refrigerant line insulation is damaged at the outdoor unit. Recommend repairs for improved performance

Poor insulation

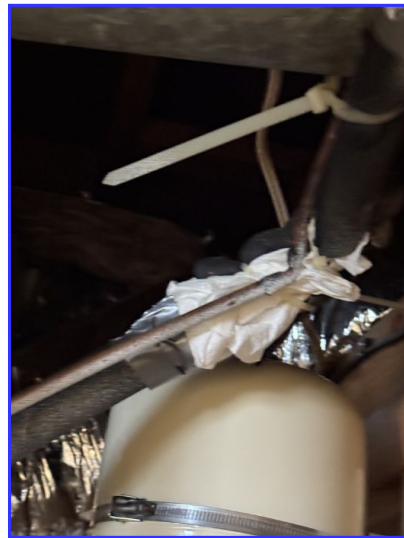
Incorrect repair a lines

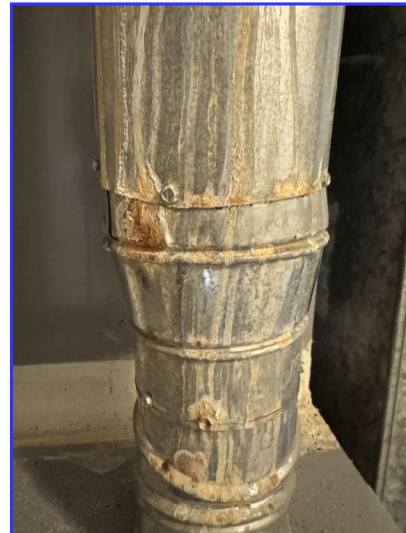
6.2. Rusting and holes observed in the furnace vent pipe, which is a serious safety concern. Have examined and repaired as needed by a HVAC contractor.

Rust noted on metal vent pipe

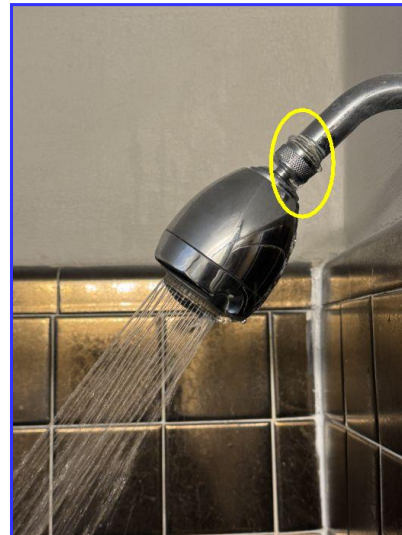
active leak

9.1. Repair the leak at the valve handle in the shower in the bath room. See photograph for locations and details.

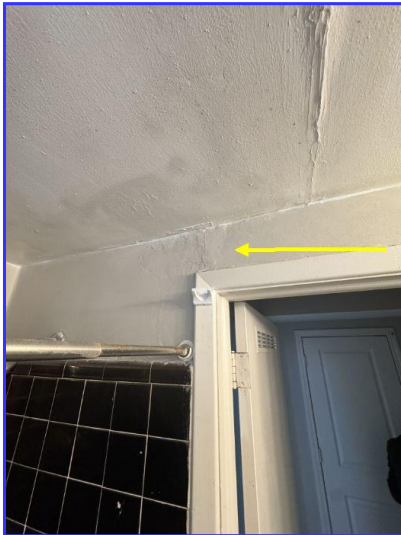
Damaged wall at bathroom

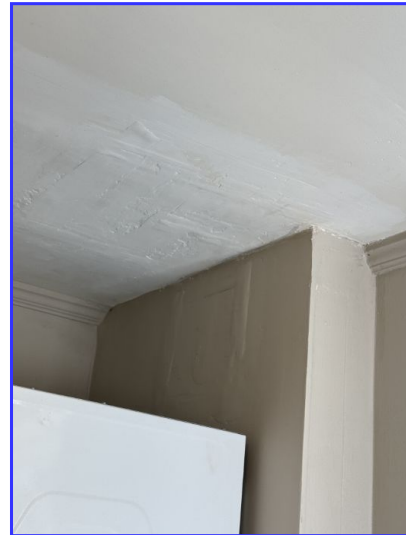
2.2. Patching observed in the walls around the home. There was no evidence of current leaks. Suggested to refer to the sellers disclosure if further information regarding the patches is desired.

Patching at ceiling

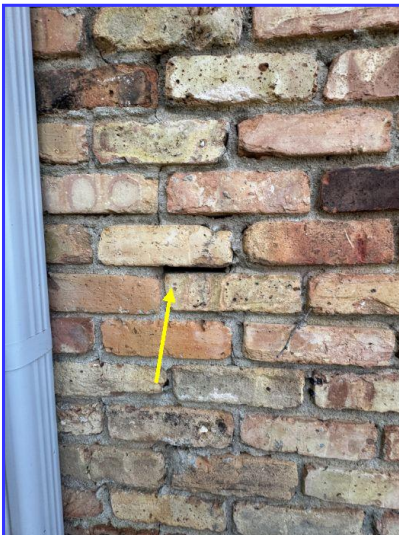
Damaged brick and mortar at home

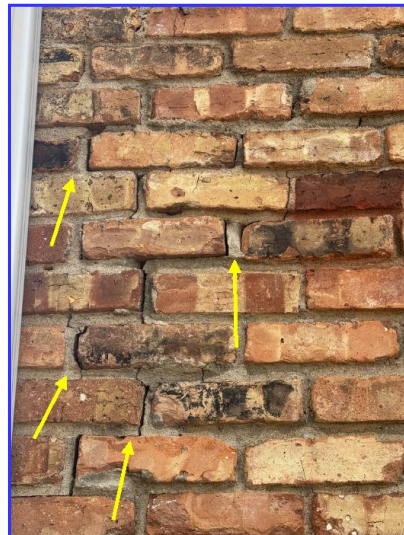
Cracked brick siding at rear

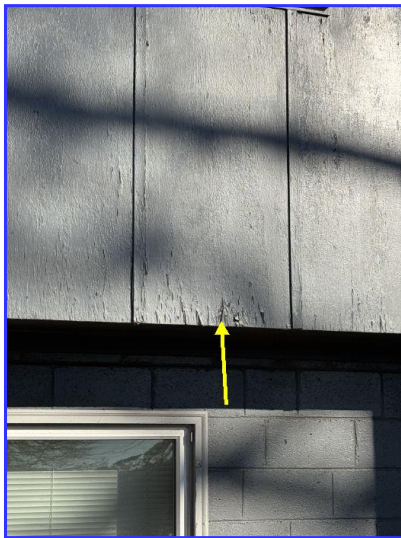
Damaged area of siding at rear

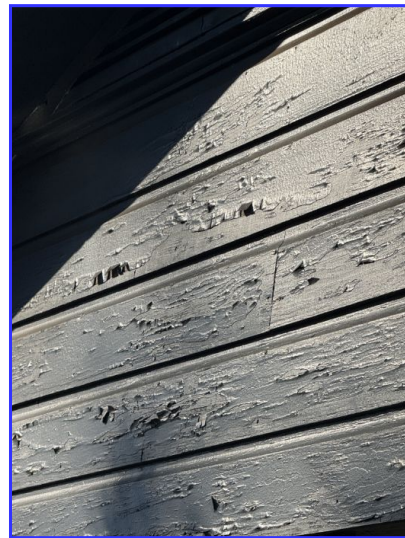
peeling paint at home

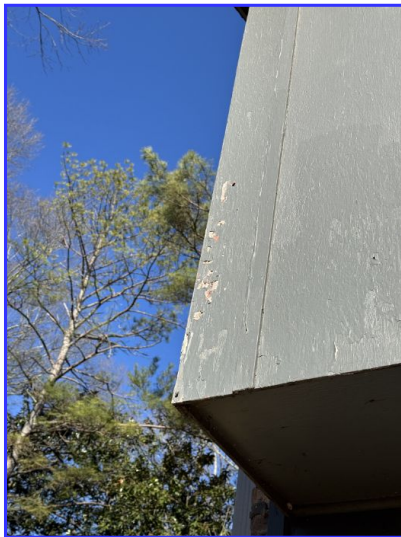
Common cracks/chips noted at the corners of the siding.

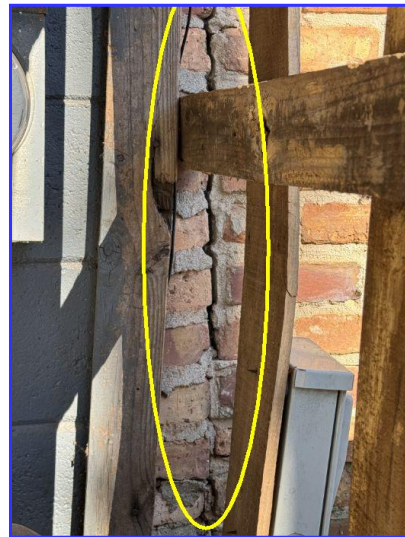
Damaged brick and mortar at rear

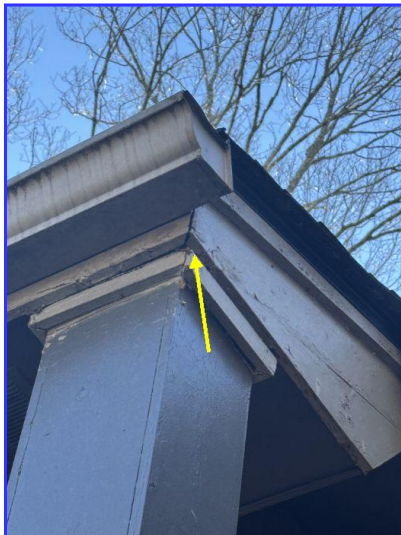
caulk fascia at the right side

3.6. Caulk the vertical joints between the wood corner trim and the siding at the rear/front corners of the home to prevent possible water entry.

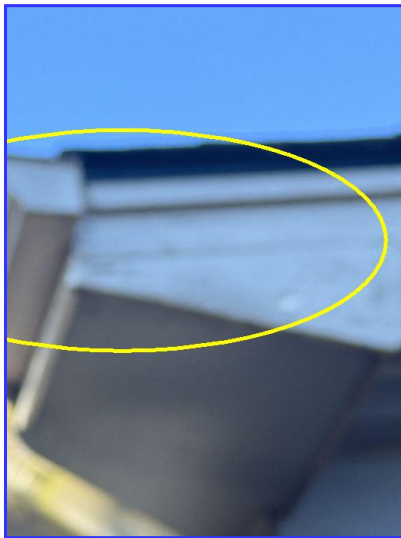
Damaged trim at rear

3.7. Due to the damaged trim noted around the home. It is suggested to have a licensed contractor fully review and repair all damaged and wood trim and any materials subsequently damaged due to the condition of the aforementioned trim. See photographs for some examples and locations.

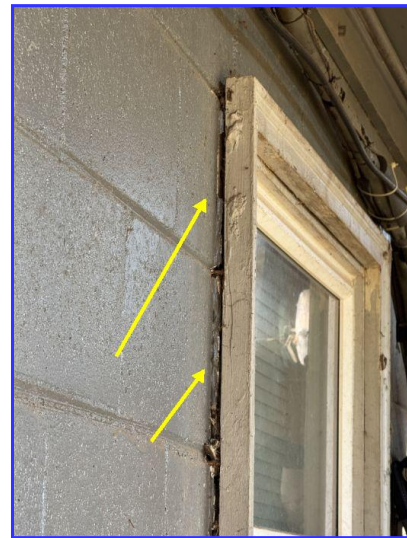
Caulk around window trims

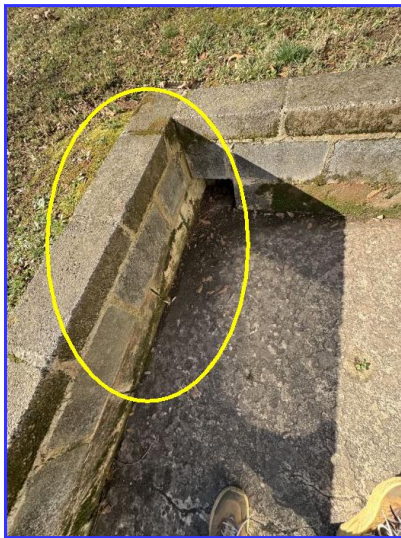
Damaged wall

11.1. Recommend review by a qualified professional for repair or replacement, as necessary.

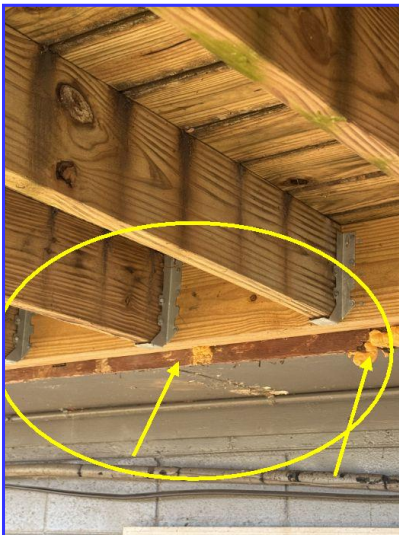
Missing flashing

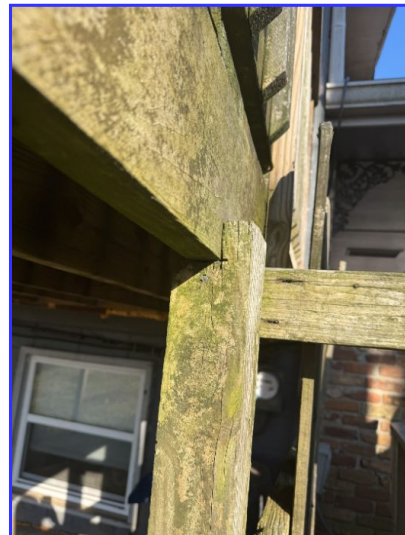
Missing straps and bolts

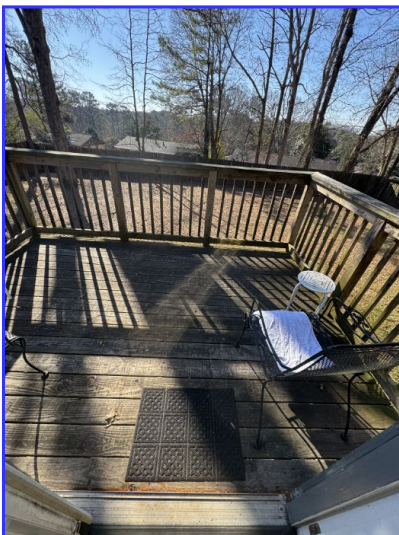
Weathered decking

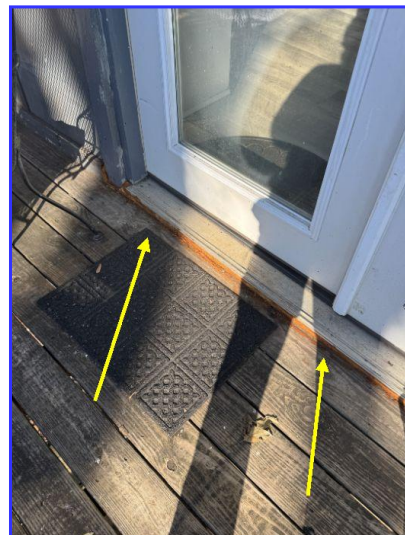
Incorrect repair at deck

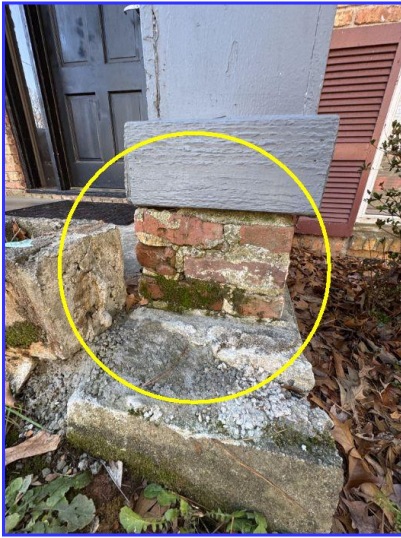
Page 20 Item: 2	Porch Conditions	2.2. Wear noted in the mortar at the front porch. Suggested to have mortar repaired as needed to prevent further weathering and potential water issues. See photographs for examples.
-----------------	------------------	---

Damaged pillars at porch

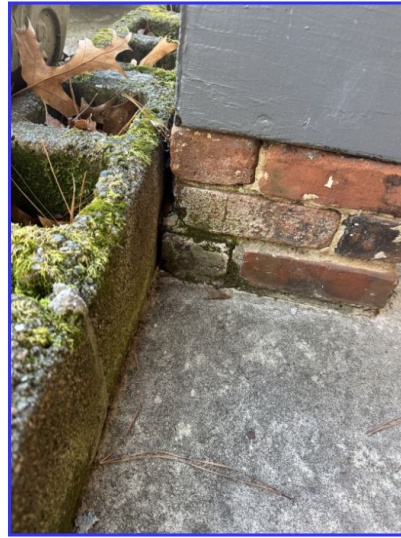
Damaged post footings

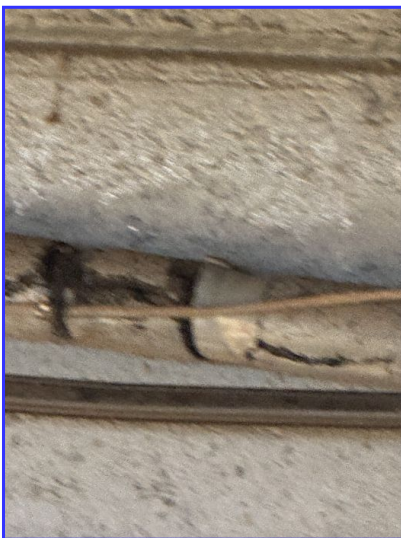
Poor insulation

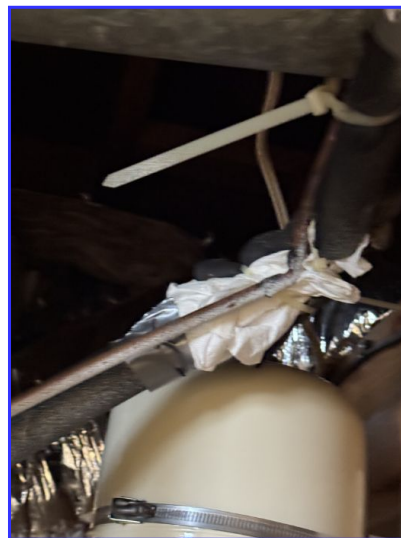
Incorrect repair a lines
