All Atlanta Inspection Services

Inspection Report

2483 Memorial Dr SE, Atlanta , GA 30317
Inspection prepared for: Joey Gumataotao
Date of Inspection: 2/9/2025 Time: 2 pm
Age of Home: 88 years old Size: 2886 SF
Weather: Clear 58 degrees

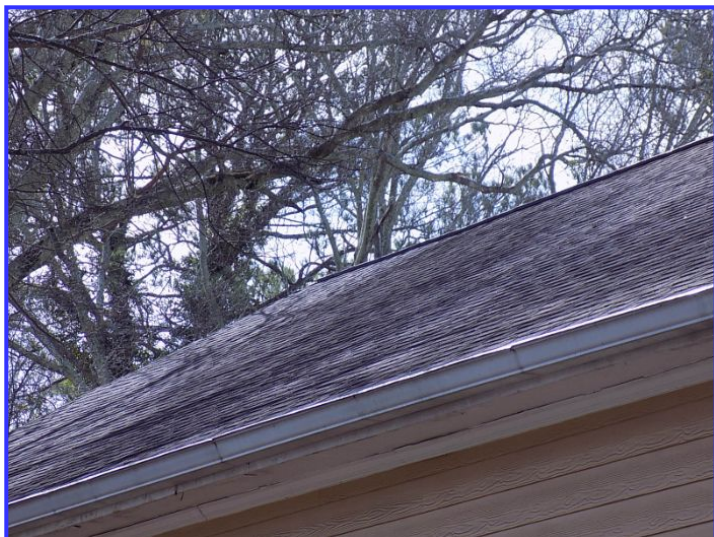
Roof view

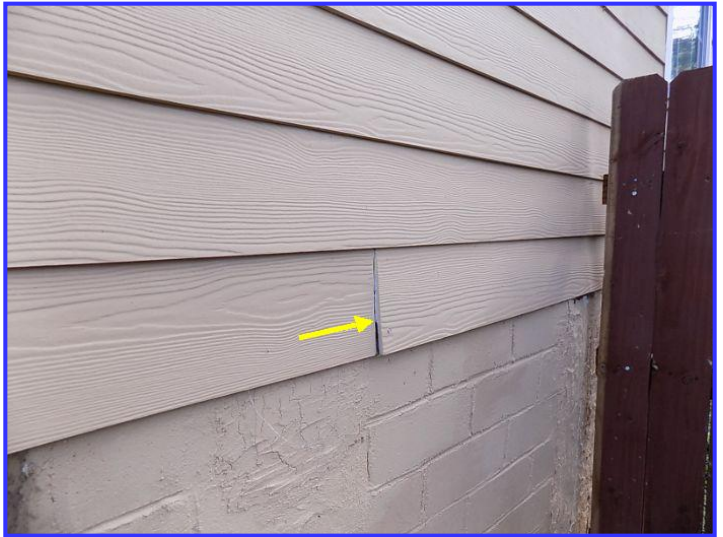
2.3. Loose siding noted at right. Recommend re securing as needed by a qualified contractor.

Loose siding at right

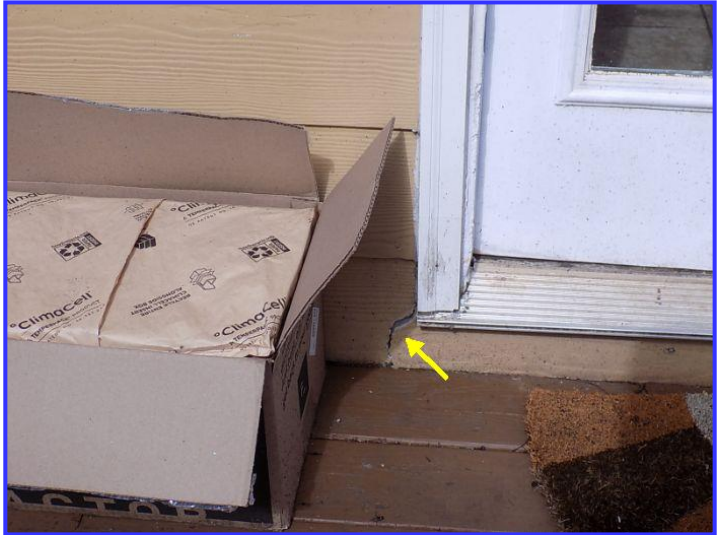
2.4. Multiple areas of damaged lap siding were noted around the home. The siding should be reviewed and all damaged siding repaired by a licensed contractor as needed. See photographs for some examples and locations.

Cracked siding at rear

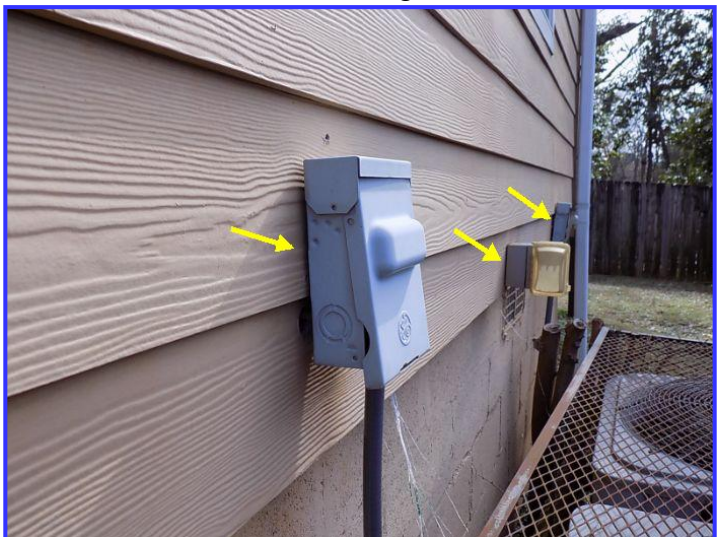
2.1. Suggest sealing/caulking all penetrations through the siding as part of routine maintenance and to prevent deterioration or water intrusion. Examples include, gas lines, AC lines, Internet/TV/Phone lines, condensate drain line as well as any other areas where the siding has been altered to allow something to pass through it. It is also suggested to caulk and seal any siding transitions between dissimilar materials, siding butt joints, nail holes and chips, as well as any decorative trim pieces.

Gap at penetrations at right

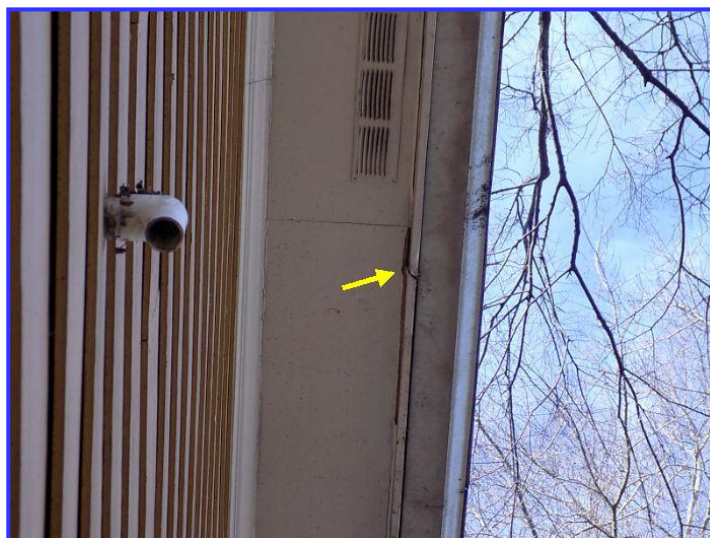
Damaged soffit noted at the left side

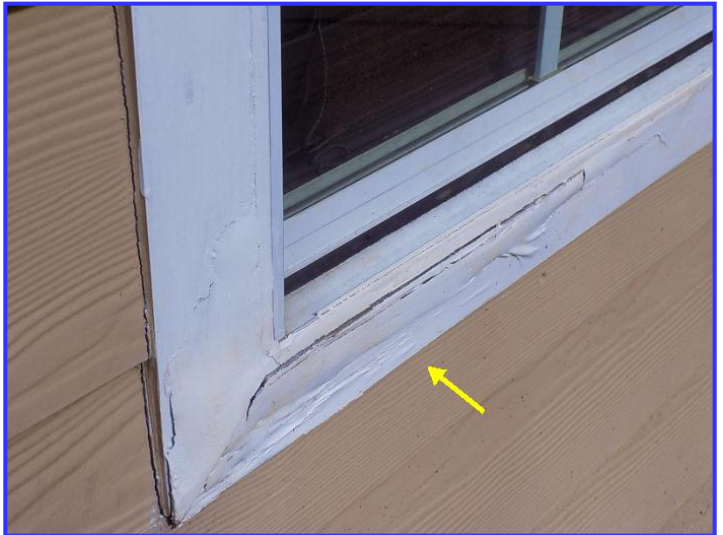
Patching at rear windows

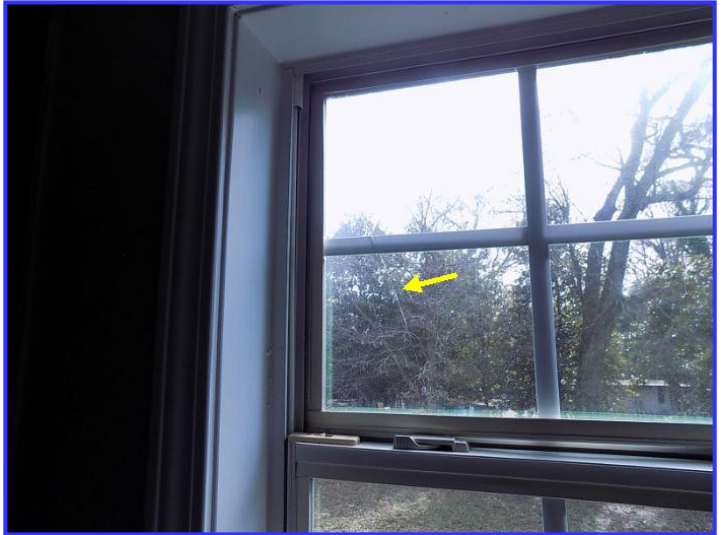
Broken glass at upstairs hall bath

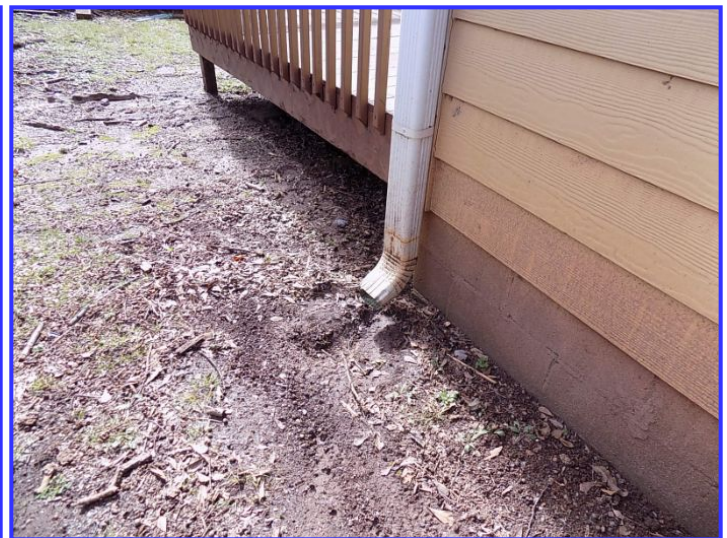
Missing splash block or extension at left side

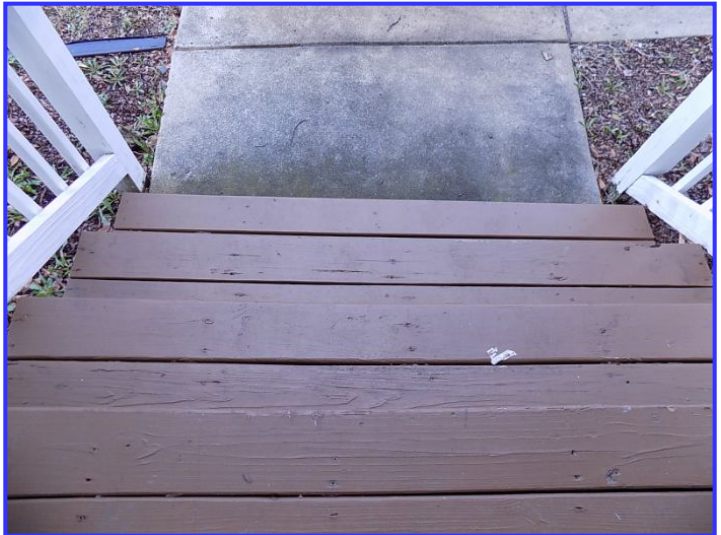
Loose stair treads at front

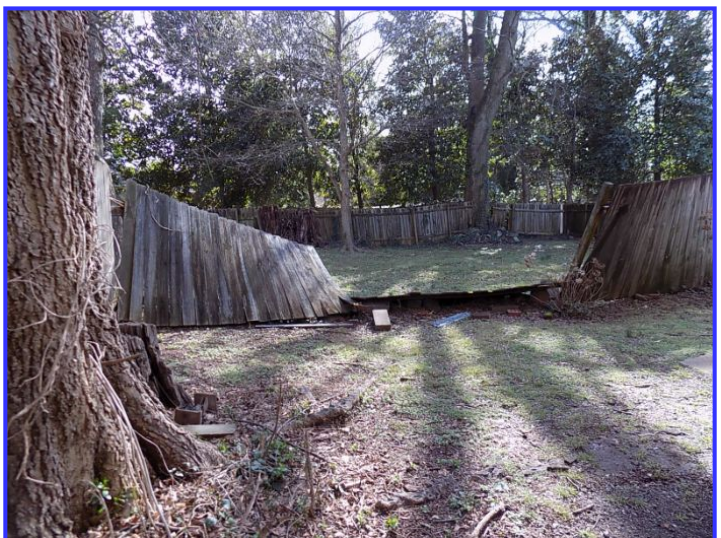
Damaged fence noted

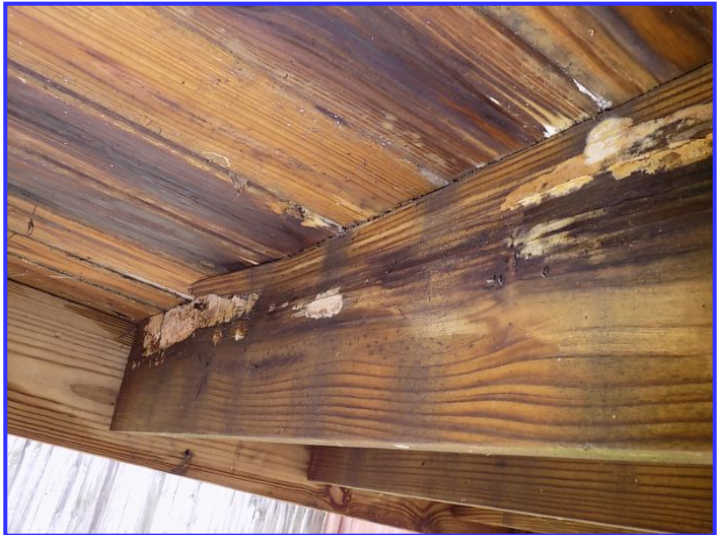
Wood rot at multiple deck joists

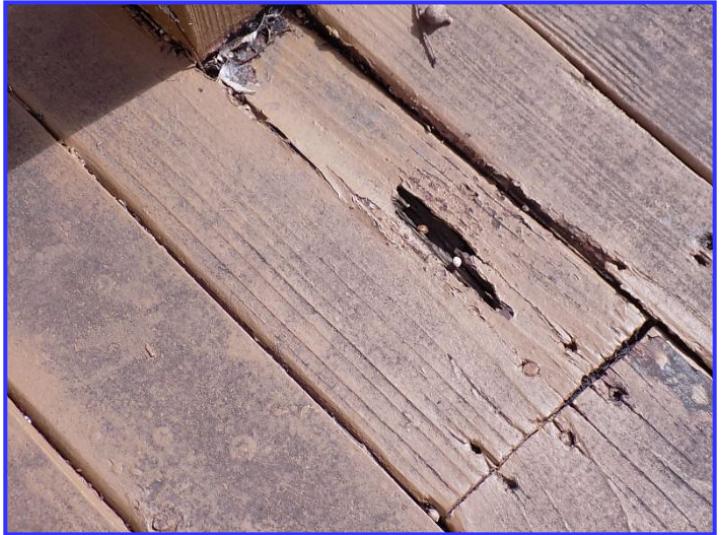
Damaged deck boards noted

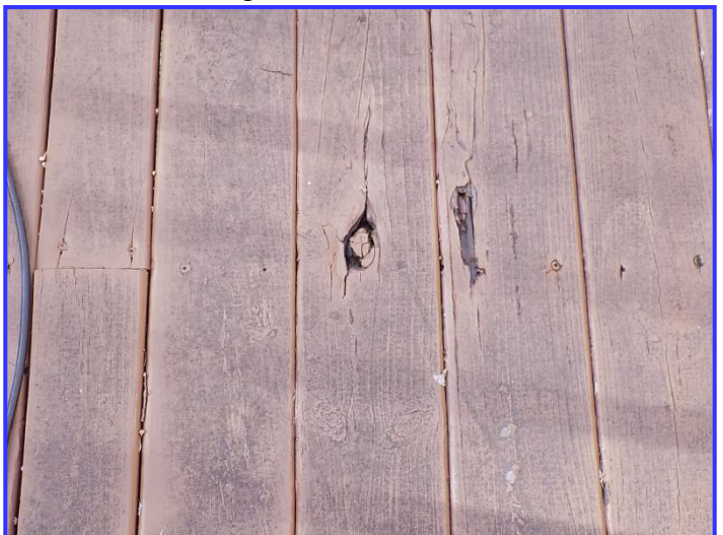
Wood rot at multiple deck boards

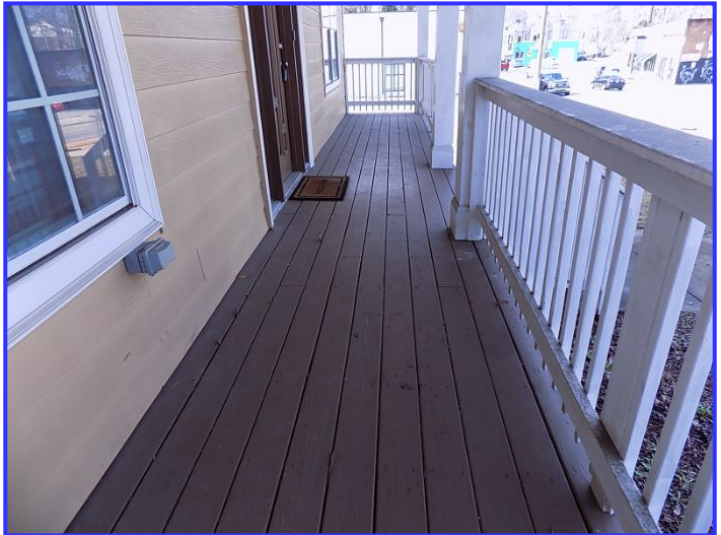
Front porch view

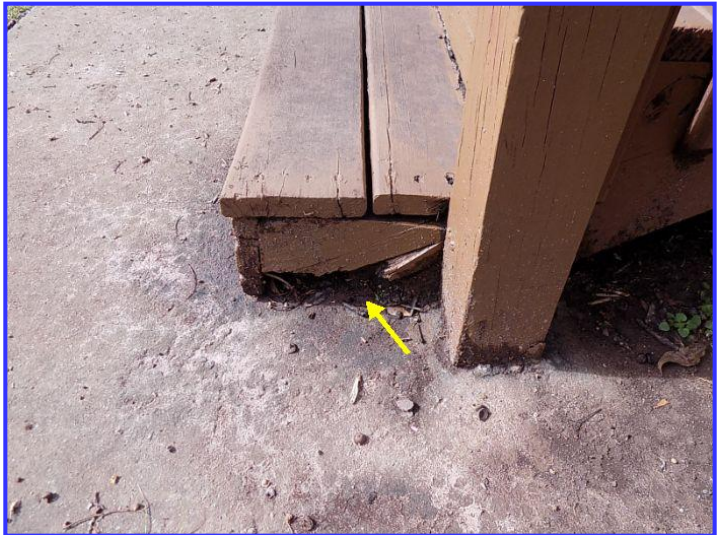
Water damaged stringer at rear deck stairs

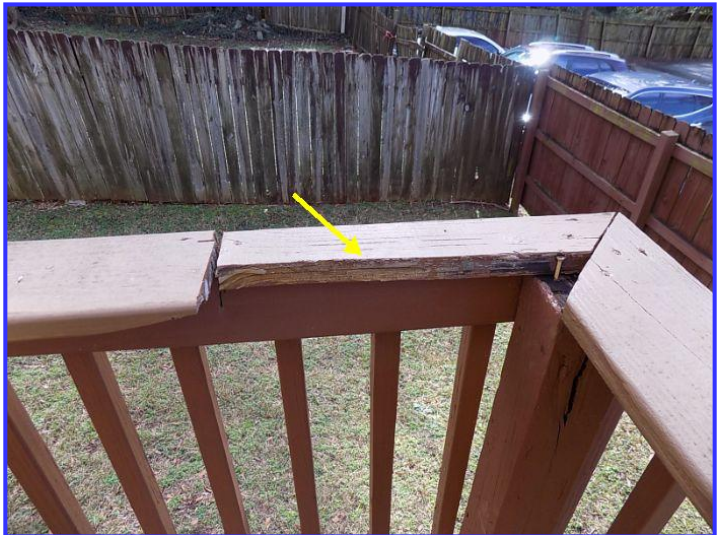
Damaged handrail at rear deck

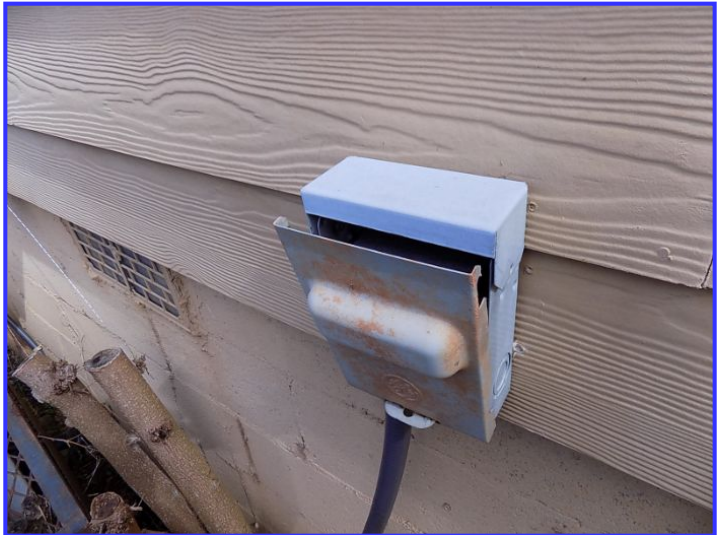
Loose cover at AC disconnect

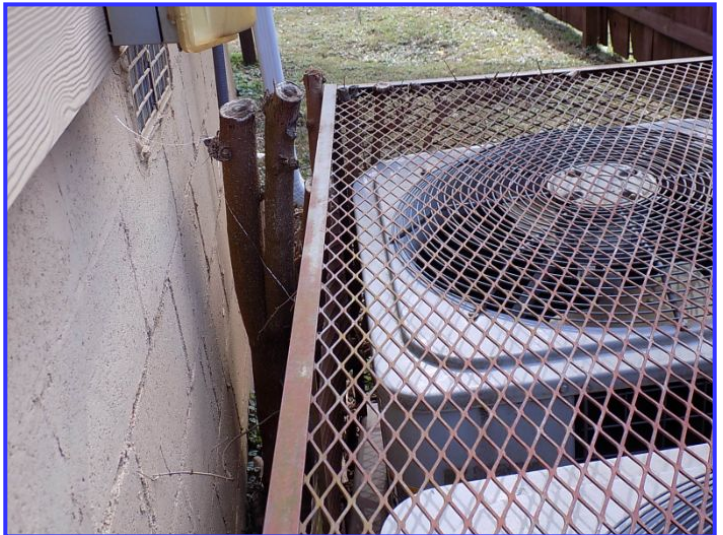
Unable to view tag for second AC due to cage

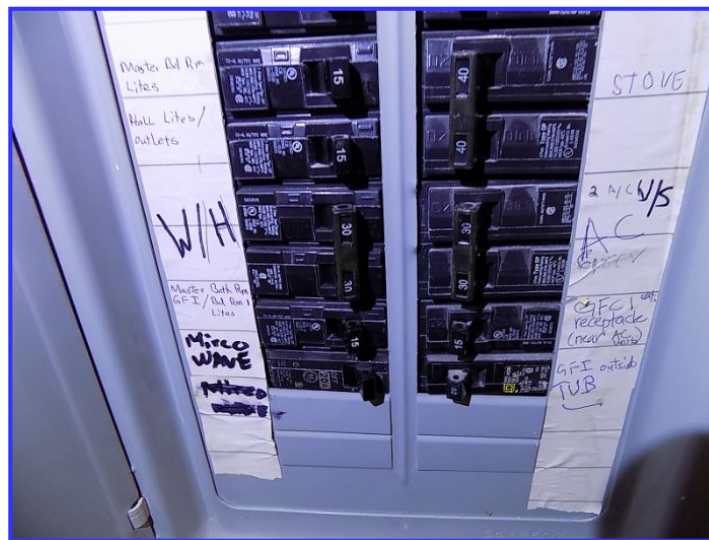
3.2. Different brand names on panel and breakers. Improper breaker-panel matching can cause arcing and overheating in the panel as well a potentially void the panels warranty. We recommend a licensed electrician install new breakers in panel.

Mismatched breakers

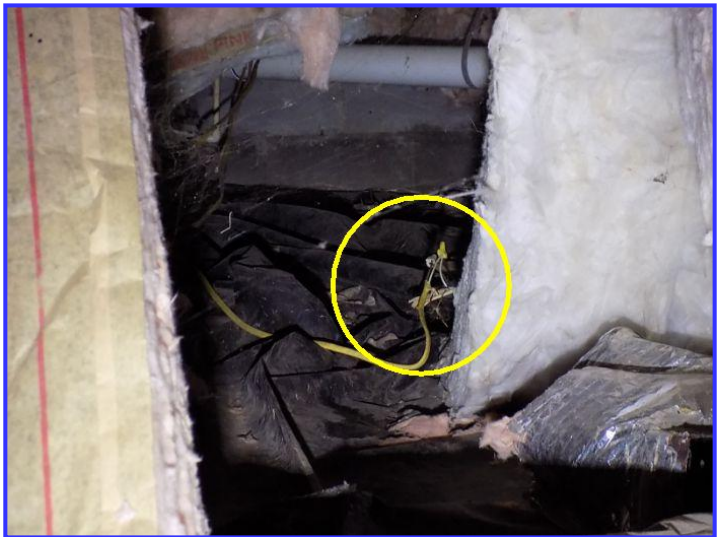
Open splices at rear crawlspace wall

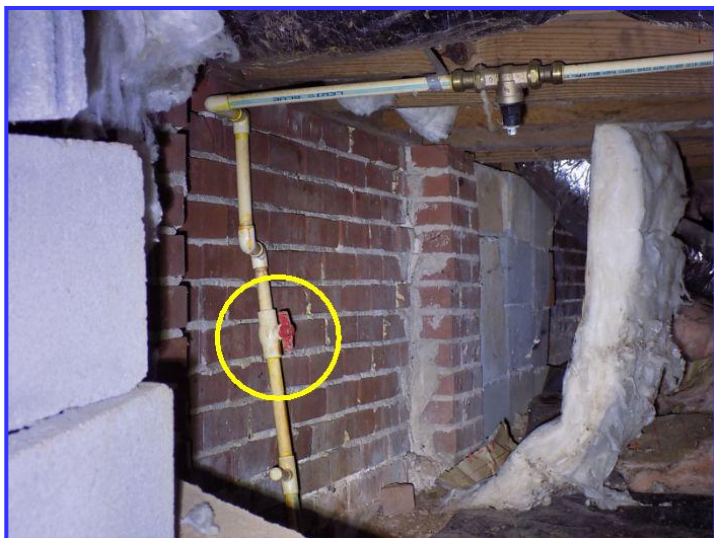
Main water shut off noted at the front crawl space wall

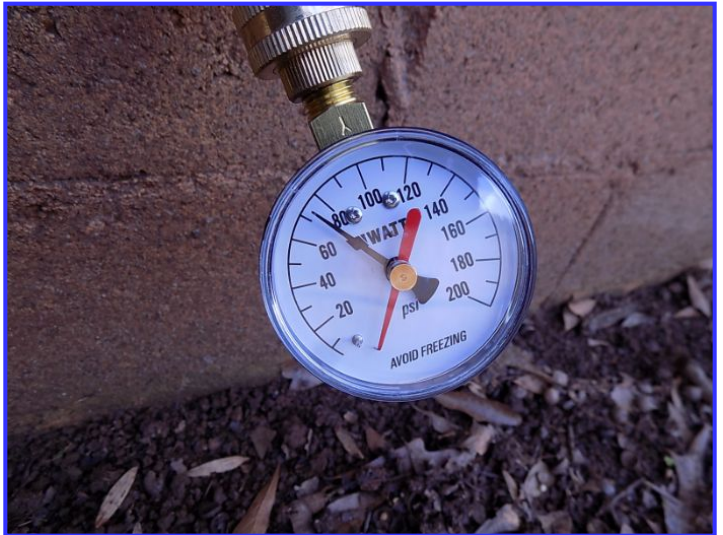
Water pressure

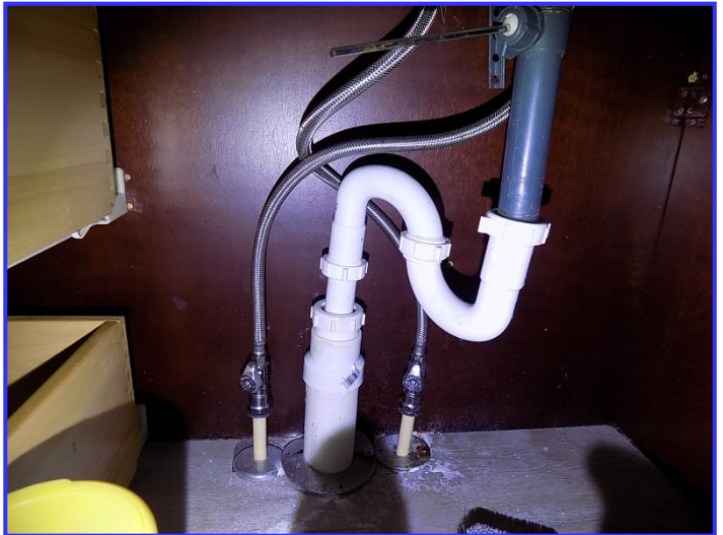
S Trap at upstairs hall bath

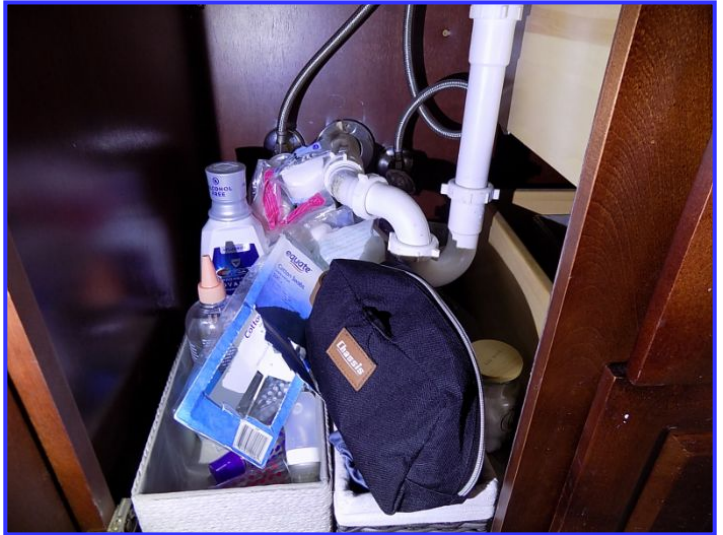
Limited view beneath some or all bathroom sinks due to personal storage.

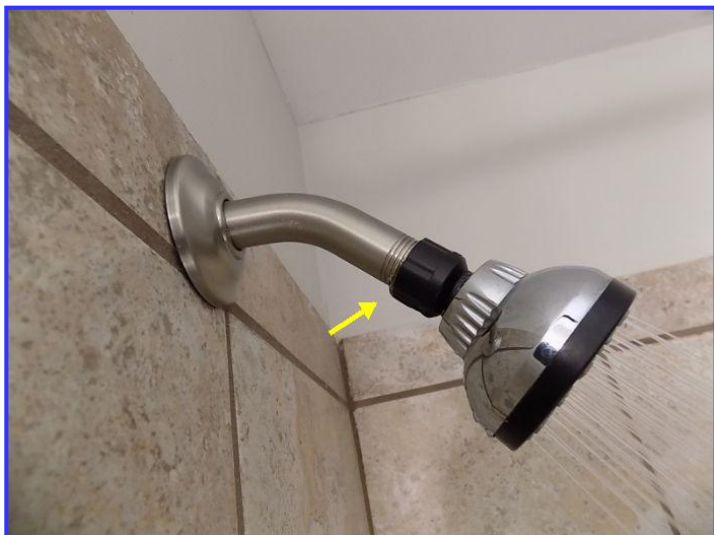
9.1. Repair the leak at the bathroom shower heads as needed.

Leak at shower faucet at upstairs hall bath

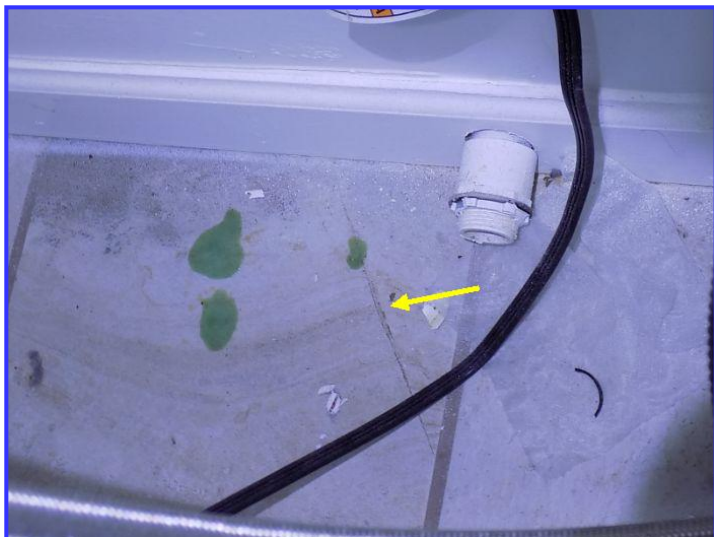
1.1. Cracked tiles noted at one or more locations inside the home. This could be from mechanical damage or improper installation. Suggested to have any cracked or damaged tiles repaired/replaced by a licensed flooring contractor as needed. See photographs for examples and locations.

Cracked tiles at laundry room

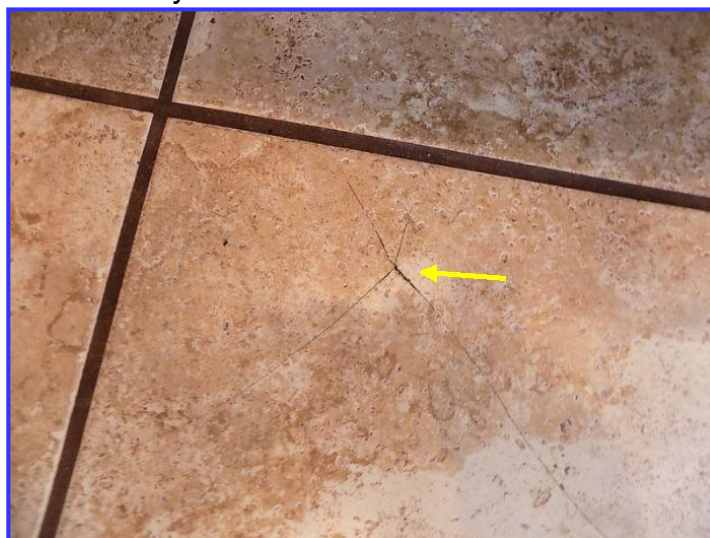
Cracked tiles at kitchen

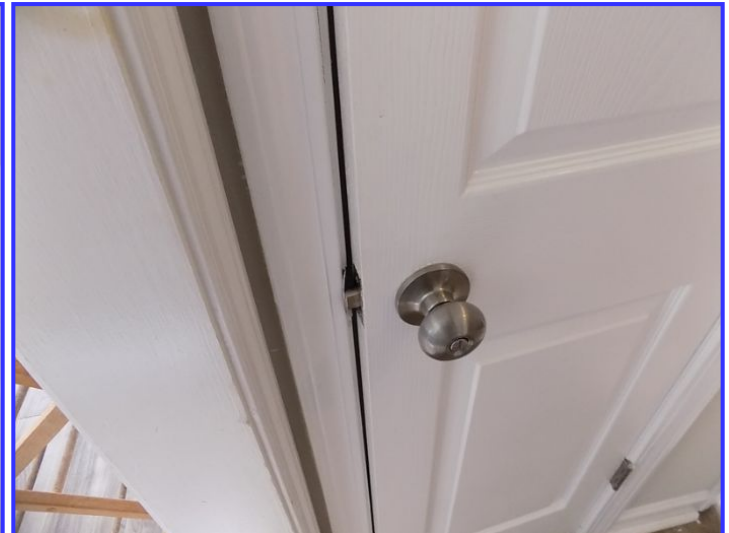
Misaligned door at upstairs hall closet

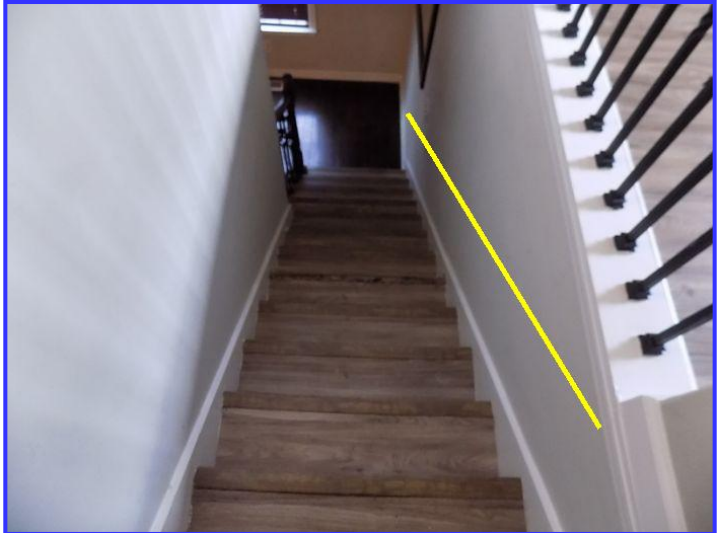
Recommend handrail at stairs

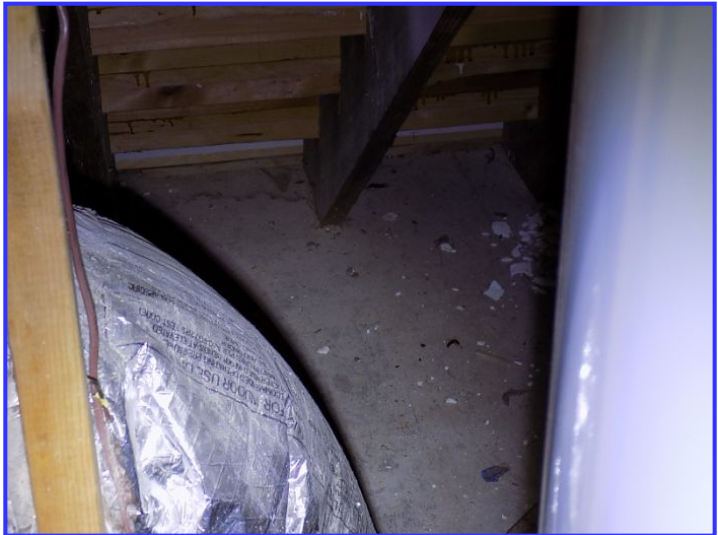
Rodent droppings under stairs at main level

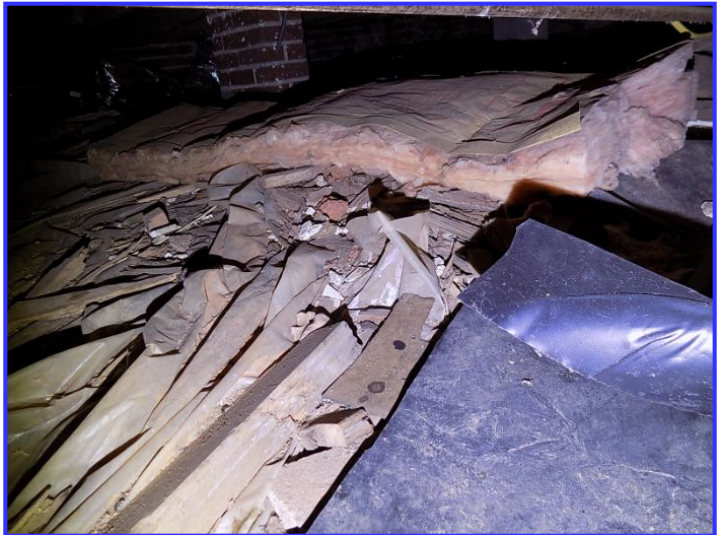
Wood debris noted

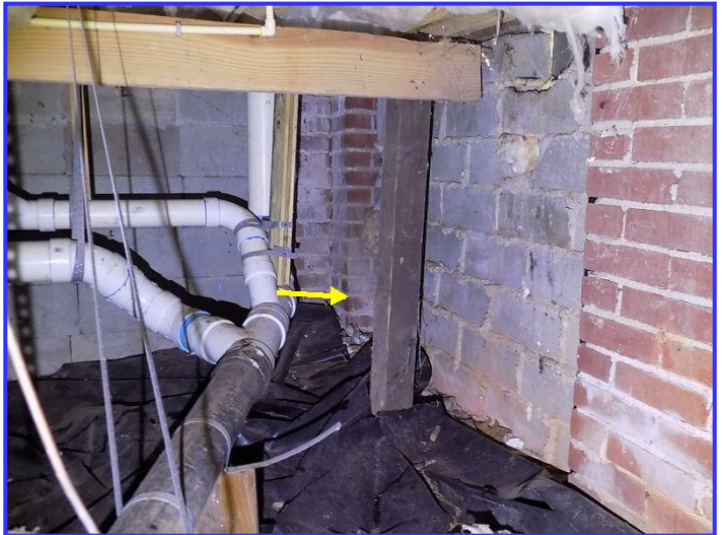
Leaning support at right wall

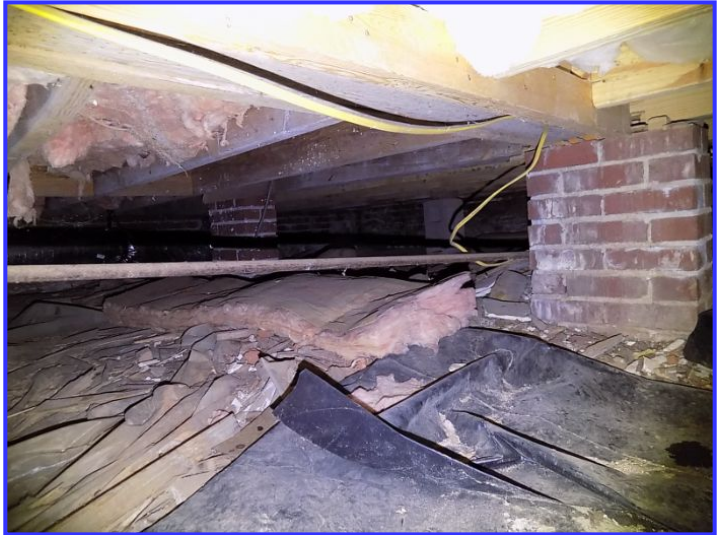
Pier view

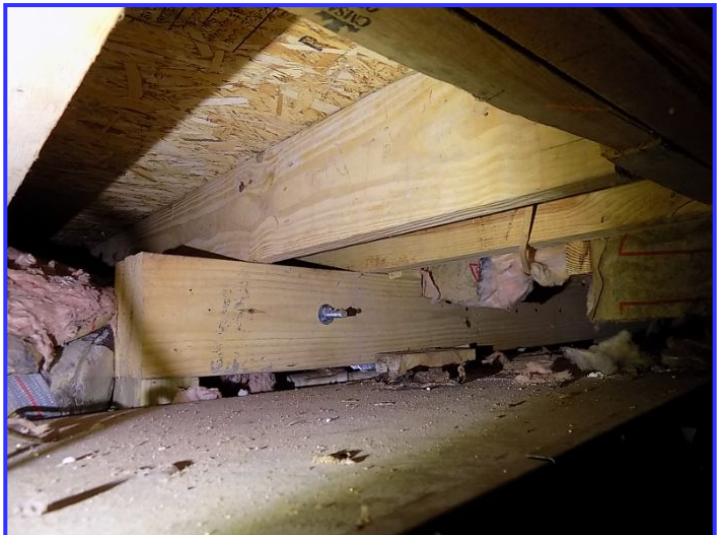
Added support near furnace

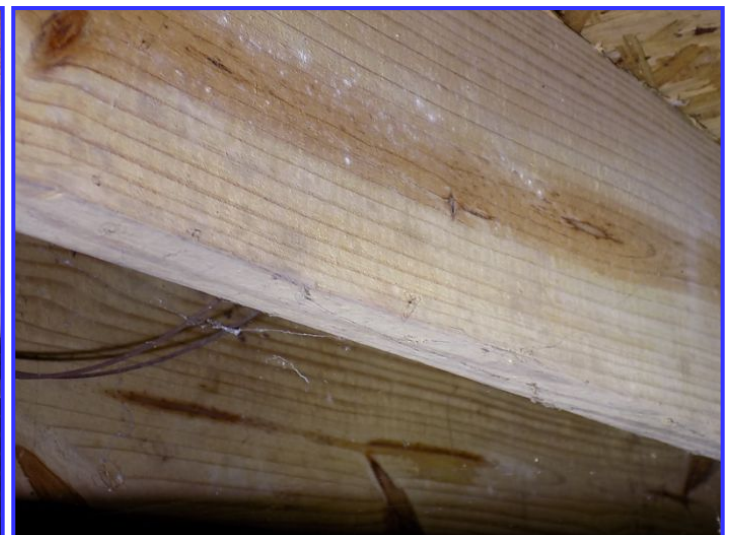
Organic growth on framing

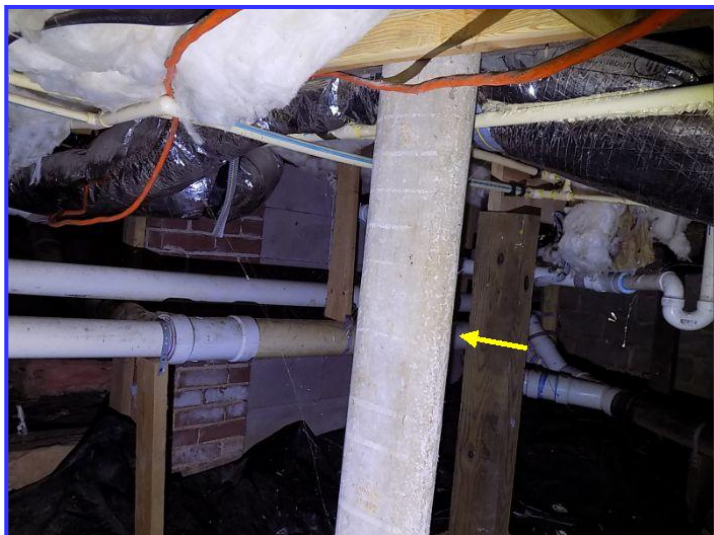
6.4. Possible asbestos "transite" pipe in crawlspace. Recommend review by an asbestos mitigation specialist for repair/removal as needed.

Possible asbestos transite pipe in crawlspace

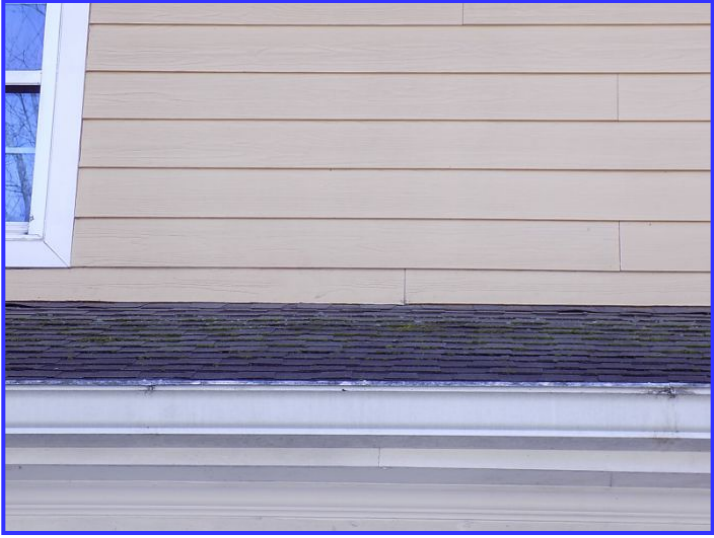
| Roof | | |
|---|---|--|
| Page 7 Item: 1 | Roof Conditions | 1.3. Moss is noted on the shingles of the roof. The moss will hold moisture and quickly deteriorate the shingles and should be professionally removed. |
| Moss growth at front lower roof | | |

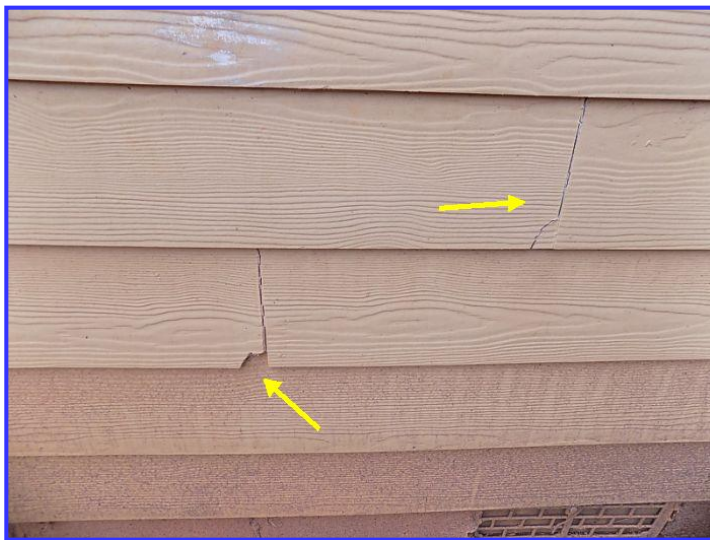
| Roof | | |
|---|---|--|
| Page 9 Item: 2 | Exterior Wall Condition | 2.4. Multiple areas of damaged lap siding were noted around the home. The siding should be reviewed and all damaged siding repaired by a licensed contractor as needed. See photographs for some examples and locations. |

Damaged area of siding at left

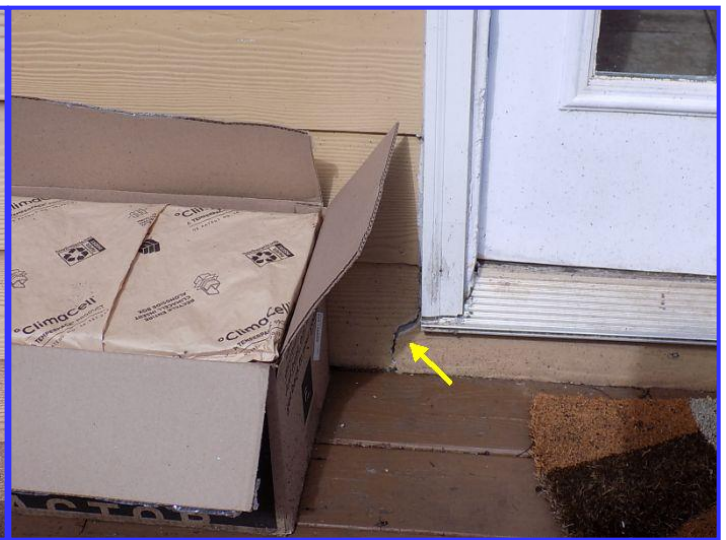
Cracked siding at rear

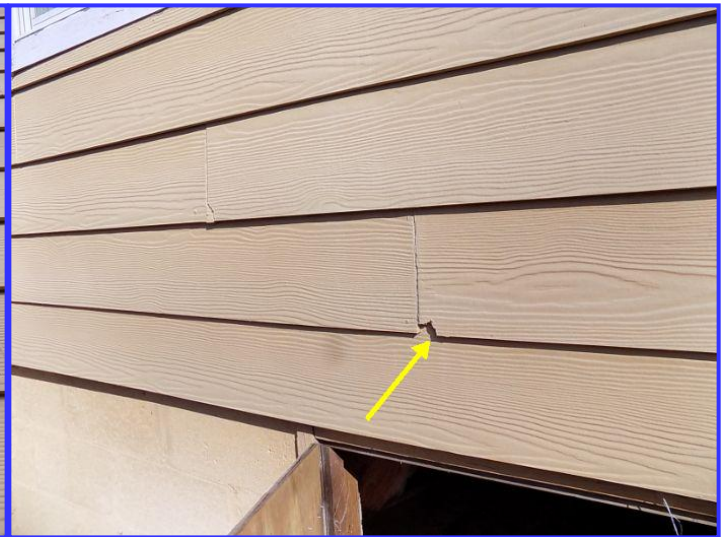
Damaged area of siding at right

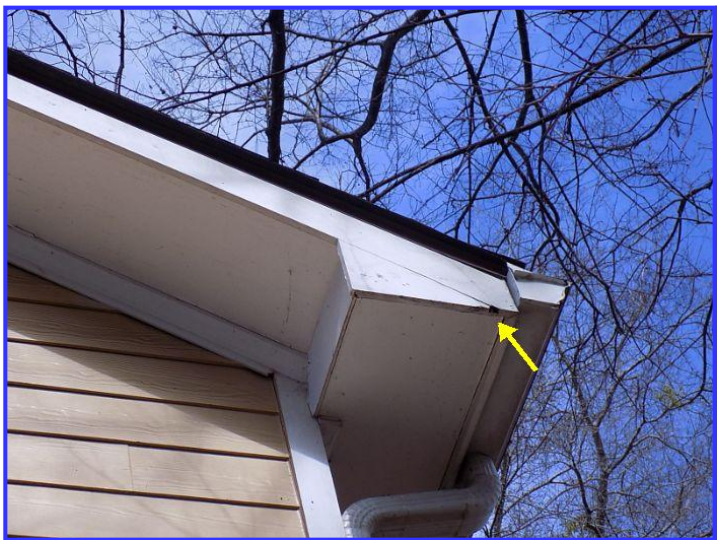
| <p>Page 11 Item: 3</p> | <p>Trim Conditions</p> | <p>3.4. Multiple areas of trim damage noted around the home. See photographs for locations and details. Recommend review and repair by a qualified contractor as needed.</p> <p>3.5. One or more areas of unpainted/weathered trim were noted around the home. Any areas of bare wood noted at the exterior of the home should be painted and sealed to prevent premature deterioration. See photographs for some examples and locations.</p> |

Damaged fascia at the rear left corner

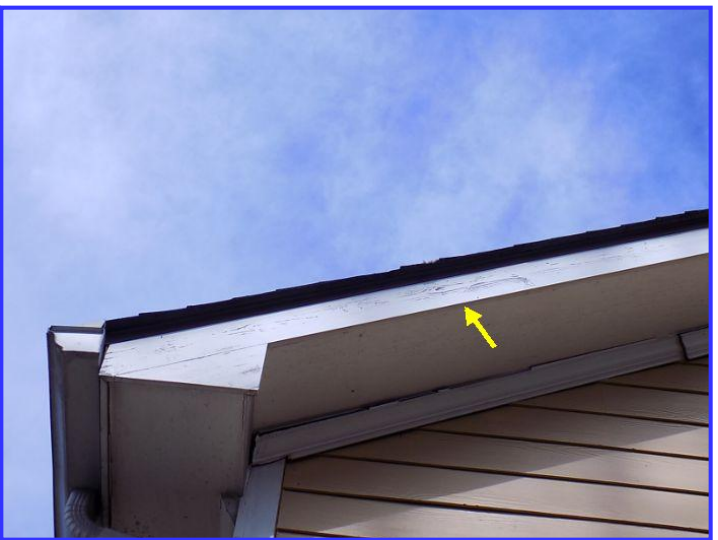
Weathered fascia at rear

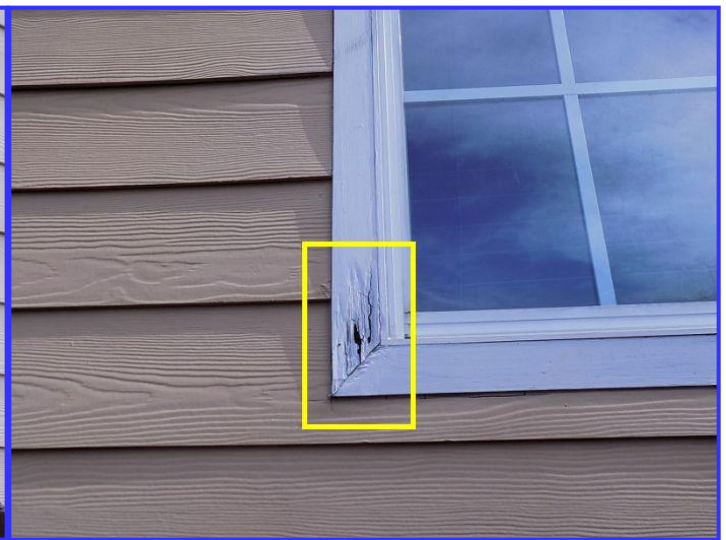
Damaged window framing at right side

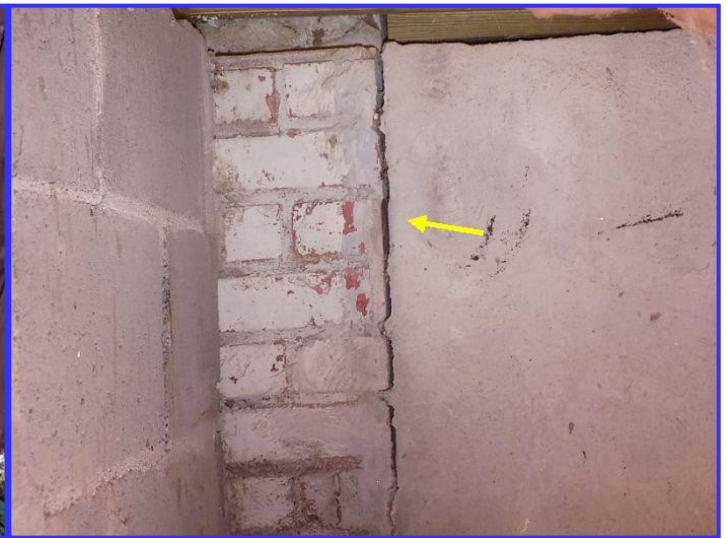
Crack at right wall at brick pier

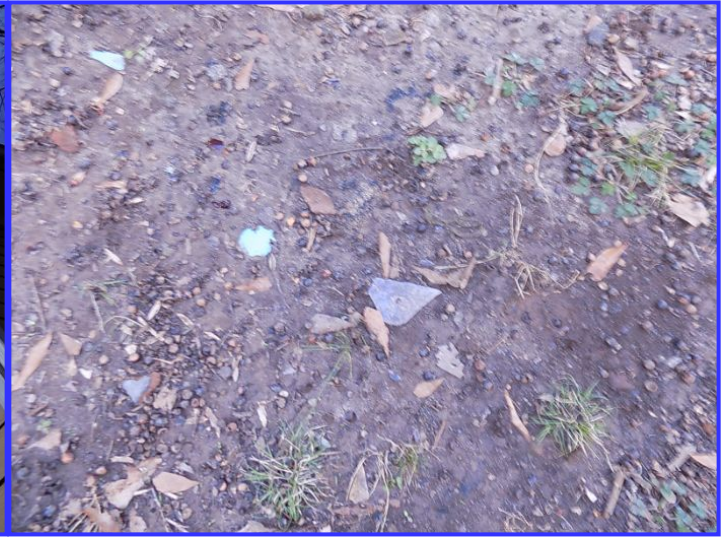
Broken glass at left side yard

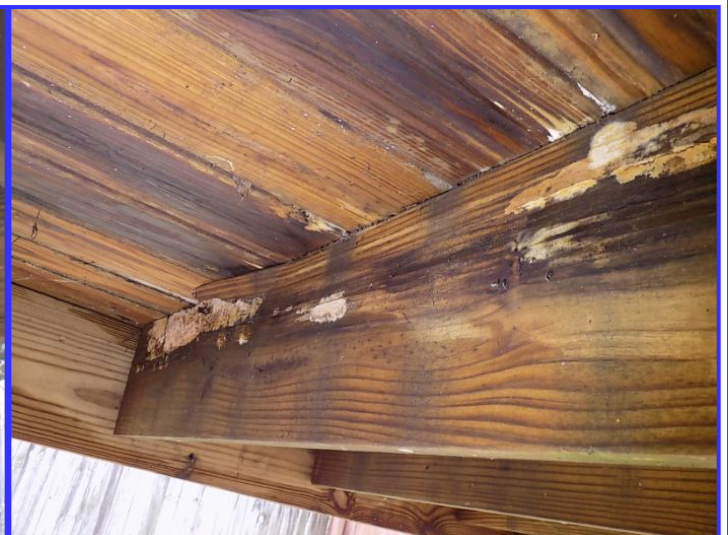
Wood rot at multiple deck joists

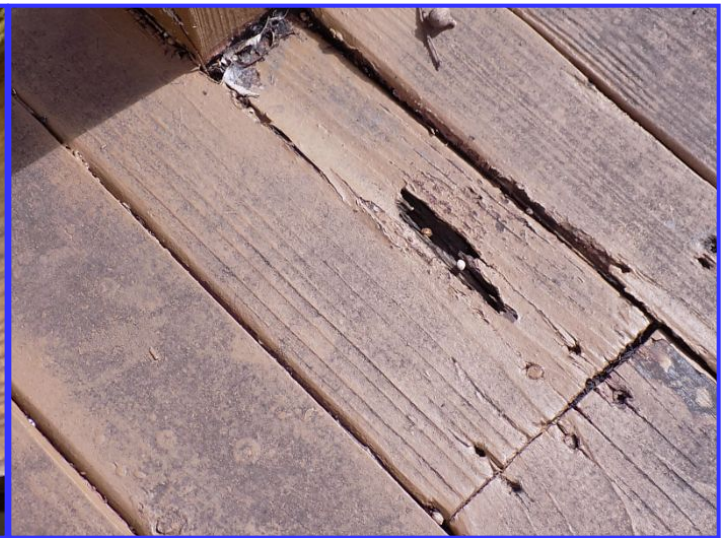
Damaged deck boards noted

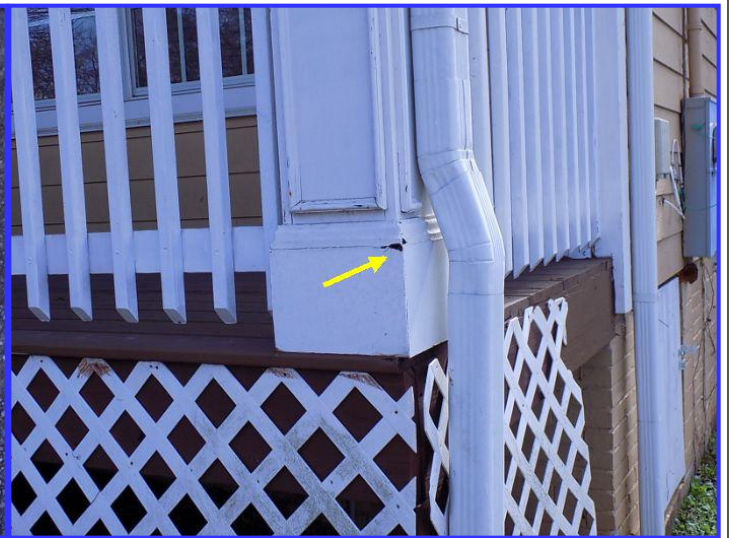
Damaged support post at front porch

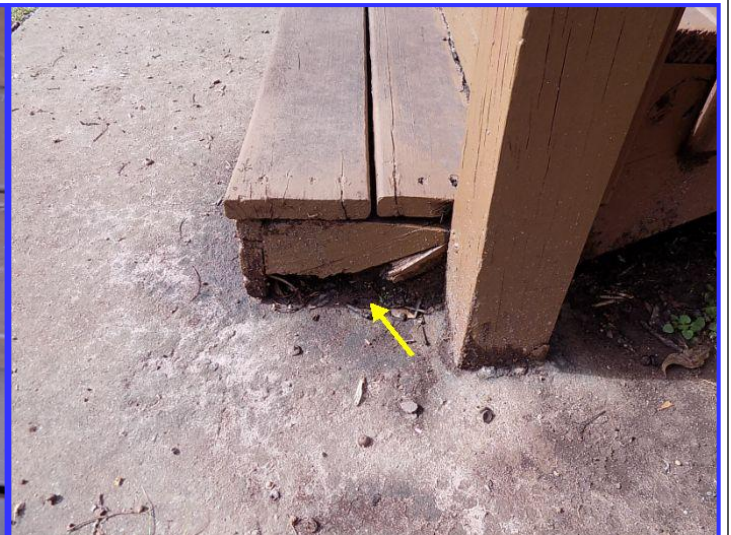
Water damaged stringer at rear deck stairs

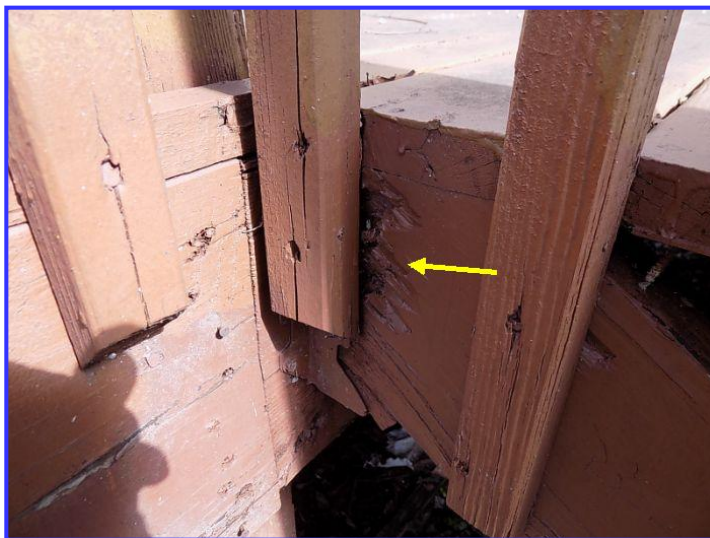
Stringer rot at rear deck

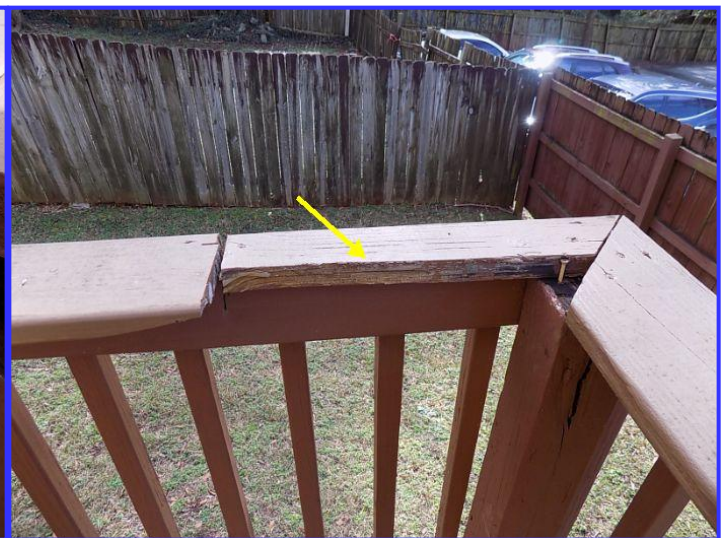
Damaged handrail at rear deck

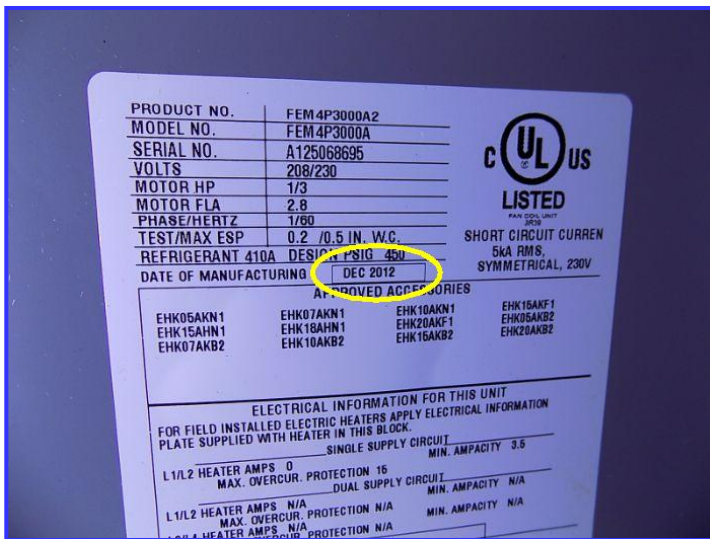
| <p>Page 29 Item: 5</p> | <p>Furnace System Conditions</p> | <p>5.1. The HVAC systems in the home should be fully examined and serviced due to their age. Annual service is recommended on all units over ten years old. Heat pump was tested using normal operating controls. Unit appeared to operate properly at time of inspection. As with all mechanical equipment, the unit may fail at anytime without warning. Inspectors cannot determine future failures. A heat pump is basically a compressor-cycle air conditioning system that can operate in reverse. As long as the unit is functioning properly in either the heating or cooling mode, it is an indication that the major components (compressor, fans, and coils) are operational. Adequate air flow is important to the efficiency of these units; the filter should be kept clean as with all air conditioners. Emergency heat is often provided by electric heat strips. These should be checked and serviced as needed by a HVAC tech. We recommend a detailed evaluation of the heating and cooling systems by a licensed HVAC contractor prior to closing. The systems should be checked to ensure they are sized properly for their installation, to ensure proper operation, and to check the efficiency of the units.</p> |

2012 Electric heat pump unit in attic

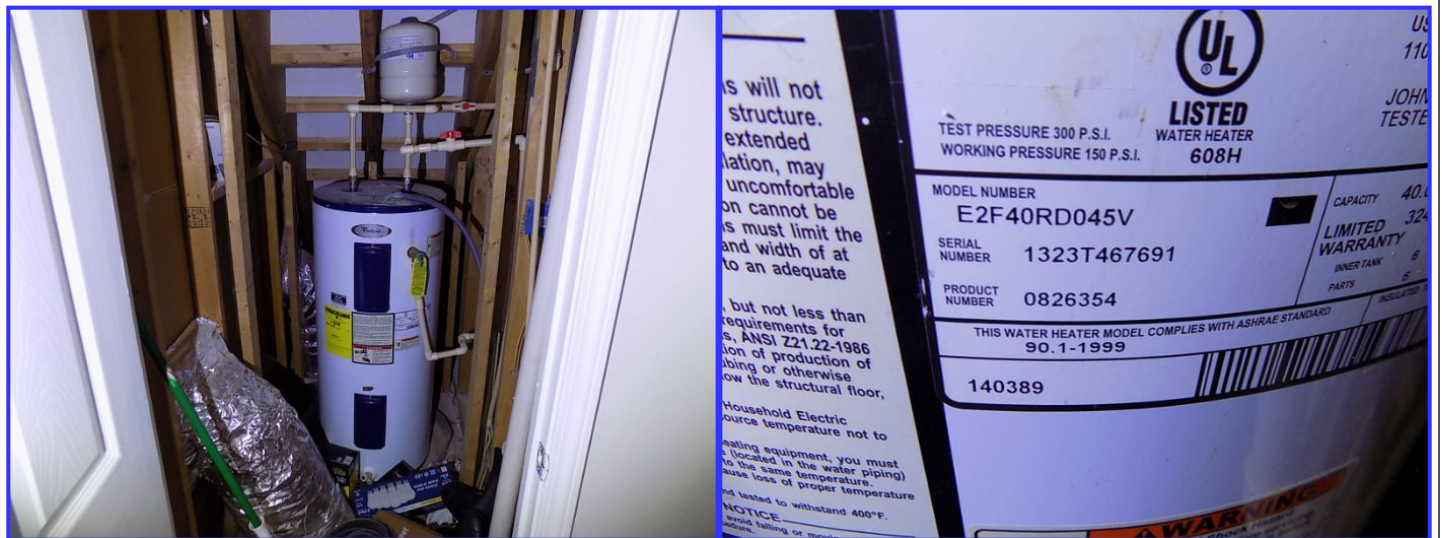
| <p>Page 39 Item: 3</p> | <p>Water Heater</p> | <p>3.2. The water heater has surpassed or is near the end of the expected service life, and will likely need to be replaced in the future. However, it is functioning at the time of the inspection. We offer warranty as to the expected remaining service life of the unit. Suggested to have water heater reviewed and serviced as needed to prolong the remaining life of the unit.</p> |

Water heater located in the main level closet

2013 Whirlpool electric unit

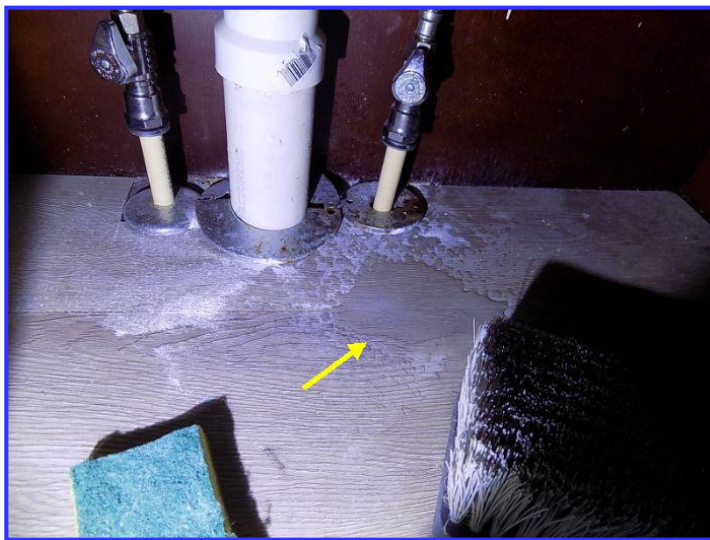
| Page 50 Item: 4 | Bathroom Traps/Drains/Supply | <p>4.4. Leaking noted beneath one or more bathroom sink(s). See photographs for locations and details. Recommend review and repair by a qualified plumber as needed.</p> <p>4.5. Improper "S" trap noted. This trap configuration may cause the trap to siphon dry, allowing sewer gas and odour to enter the dwelling. Suggest repair by a qualified professional.</p> |

Leak at drain under sink in the upstairs hall bath
