All Atlanta Inspection Services

Inspection Report

2483 Memorial Dr SE, Atlanta , GA 30317
Inspection prepared for: Joey Gumataotao
Date of Inspection: 2/9/2025 Time: 2 pm
Age of Home: 88 years old Size: 2886 SF
Weather: Clear 58 degrees

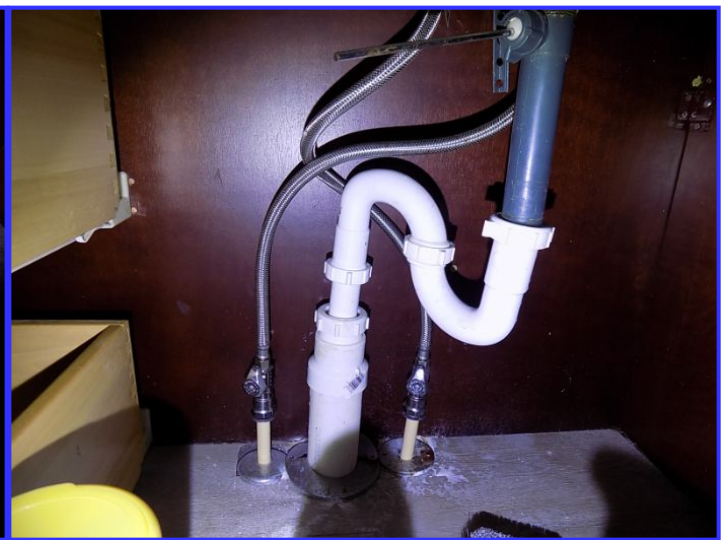
S Trap at upstairs hall bath

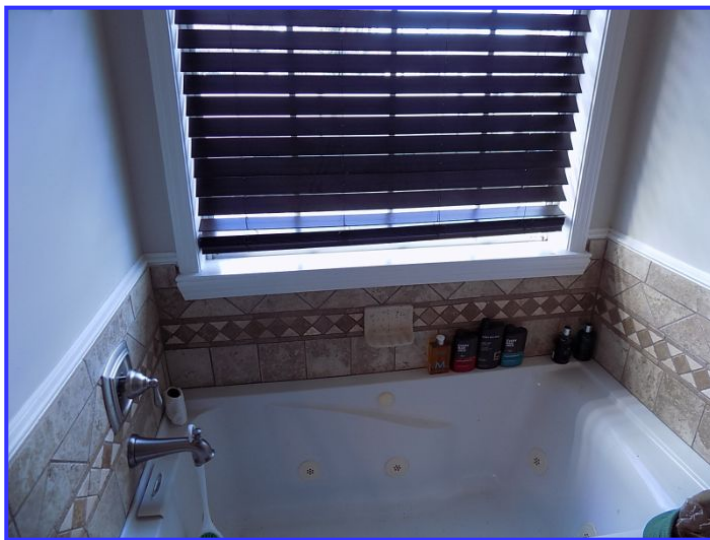
No safety glass over master bath tub

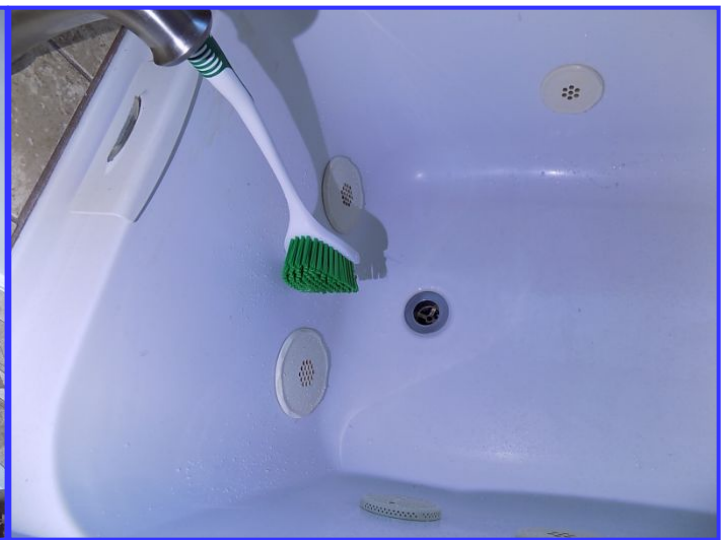
6.3. The drain stopper is missing/does not seal fully and the tub cannot be filled for testing. Have repaired as needed.

Missing plug at master bath, unable to test jets

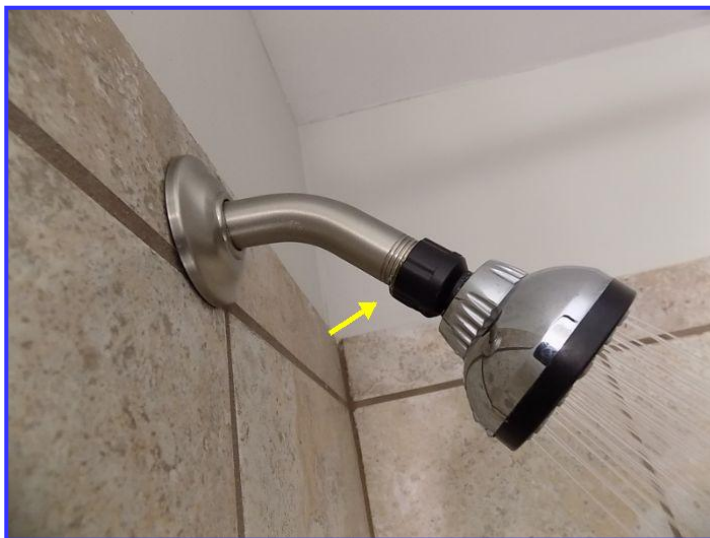
9.1. Repair the leak at the bathroom shower heads as needed.

Leak at shower faucet at upstairs hall bath

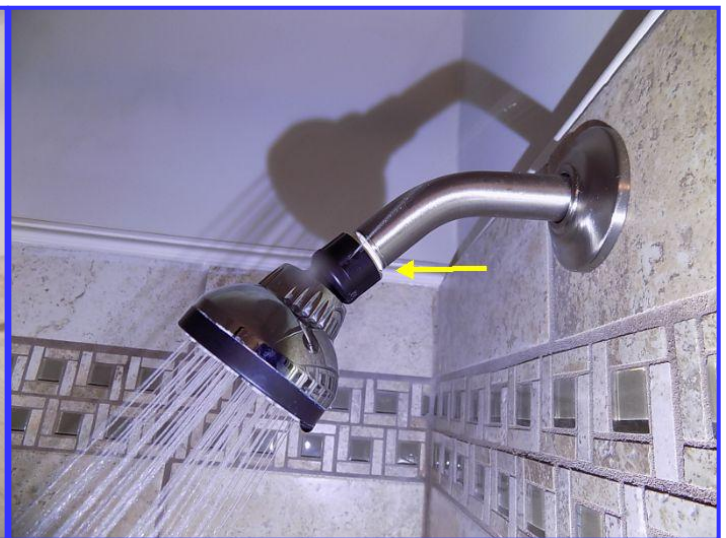
Leak at main level guest bath shower

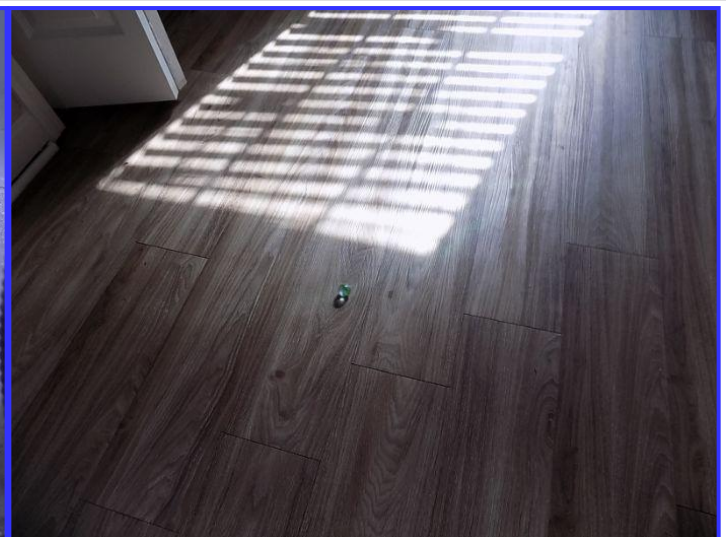
Uneven flooring at upstairs foyer

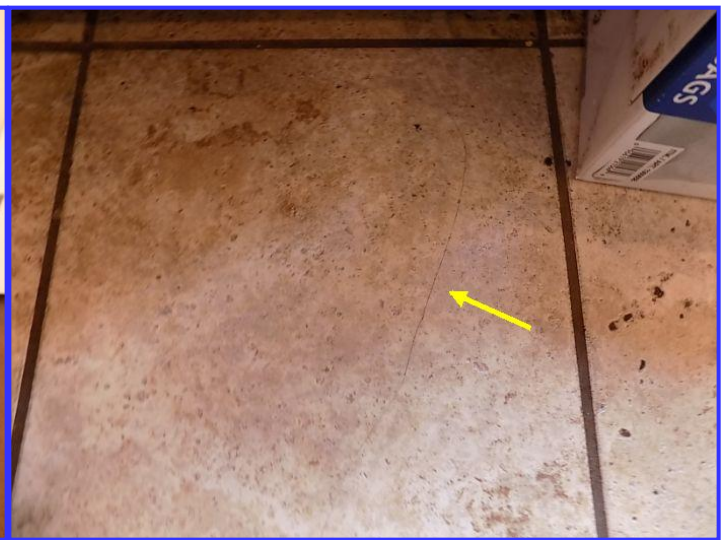
Cracked tiles at kitchen

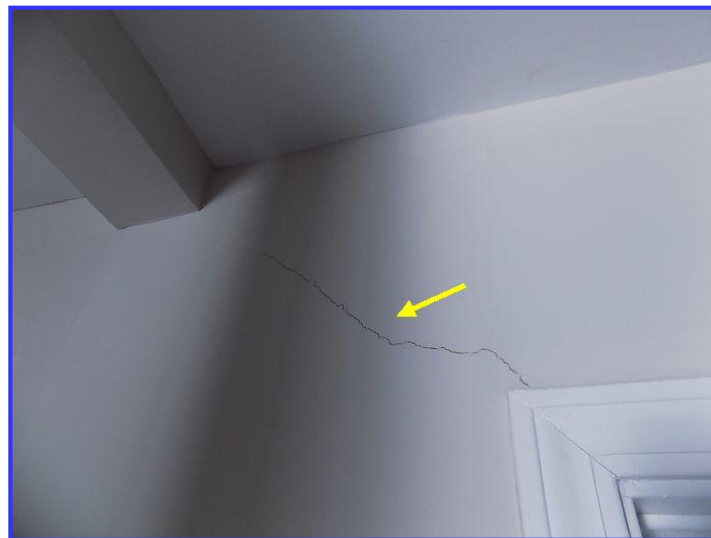
2.2. One or more settlement cracks were noted in the home. Have the cracks spackled and repaired and monitor this area for any continued movement. See photographs for locations.

Settlement crack at upstairs foyer

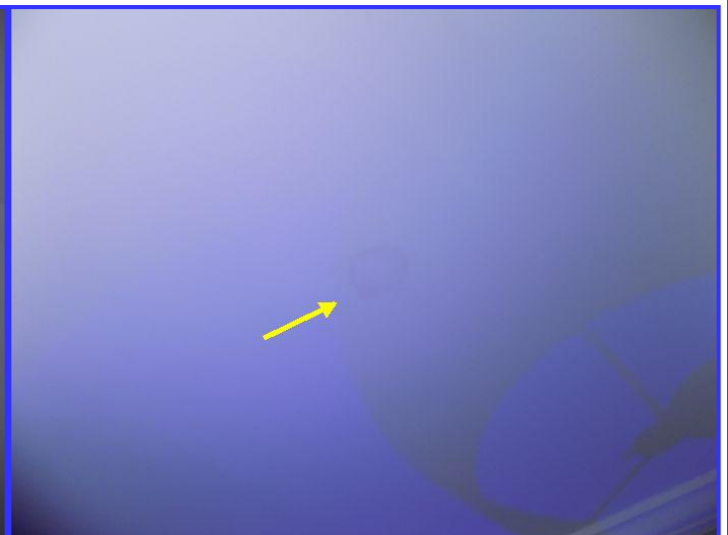
Water stain at unit 2 ceiling

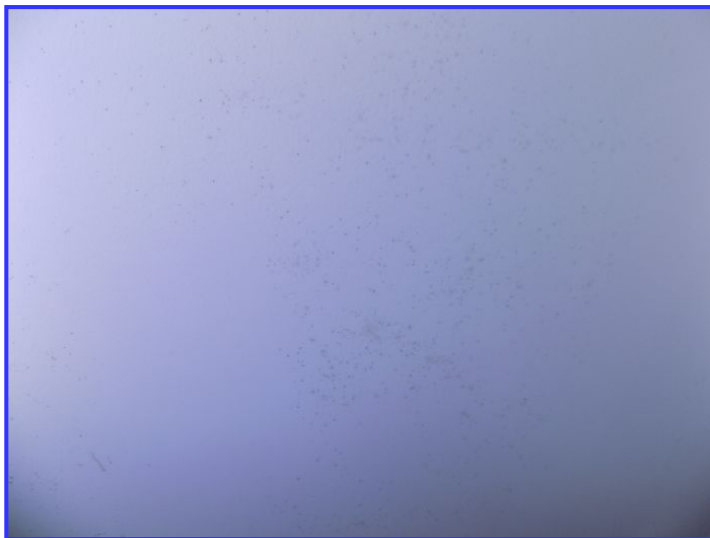
| <p>Page 59 Item: 7</p> | <p>Other Interior Area Comments</p> | <p>7.5. Evidence of rodents/animals is noted in the home. See some details in this report. There may be additional evidence not noted due to rodent infestation usually impacts multiple areas in the home. A more thorough inspection from a qualified Pest Control Company is recommended to seal any openings to prevent animal entry and subsequent damage noted and repaired.</p> <p>7.6. Possible mold/mildew on ceiling at upstairs hall bath. Recommend professional cleaning with a fungicide as needed.</p> |

Possible mold/mildew at upstairs hall bath ceiling

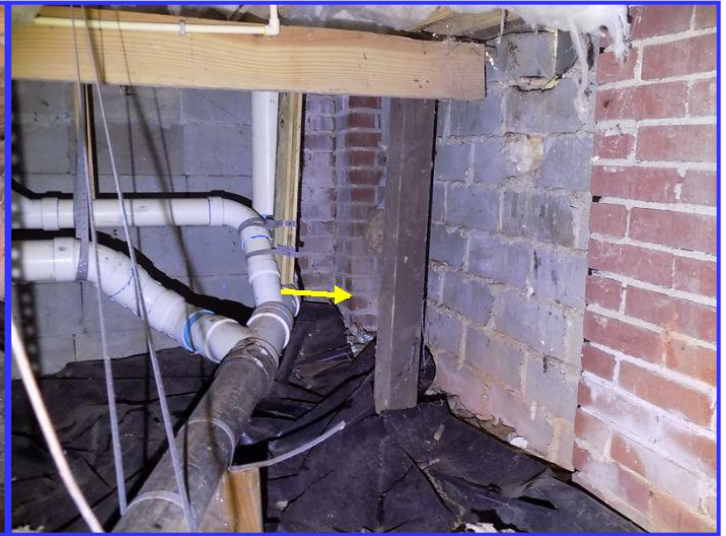
Leaning support at right wall

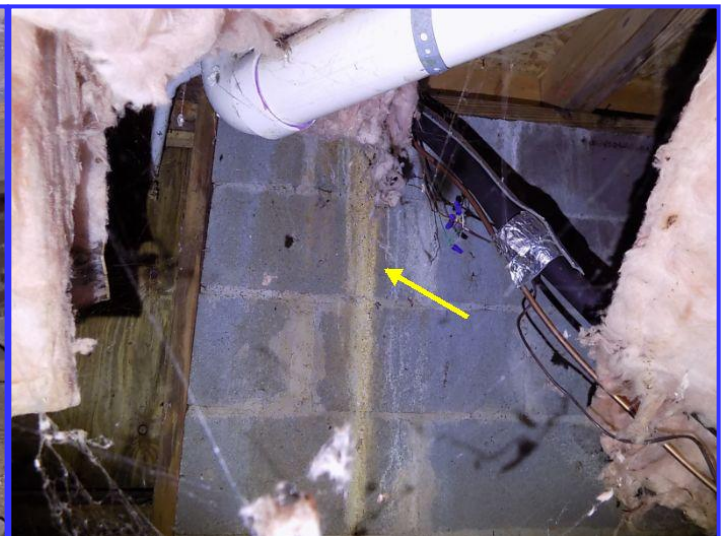
Efflorescence noted at rear wall

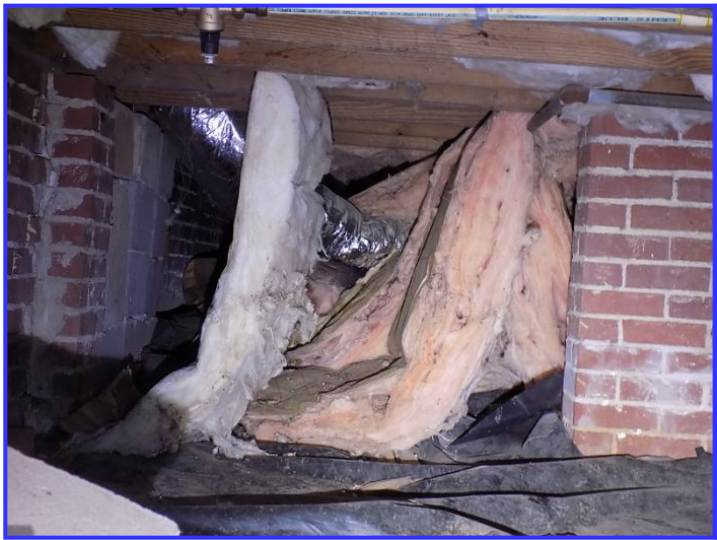
| Page 66 Item: 5 | Under Floor Vent/Insulation Conditions | <p>5.2. Loose and fallen insulation observed at the ceiling over the crawl space. Suggest securing as necessary.</p> <p>5.3. There is evidence of rodent activity in the insulation over the crawl space. Any damaged insulation should be replaced and the home examined and sealed by a pest control company to prevent further rodent entry.</p> |

Rodent bored holes in fallen insulation
