PROPERTY INSPECTION REPORT FORM

02/26/2025 8:00 am

1302 E 2nd St, Austin, TX 78702

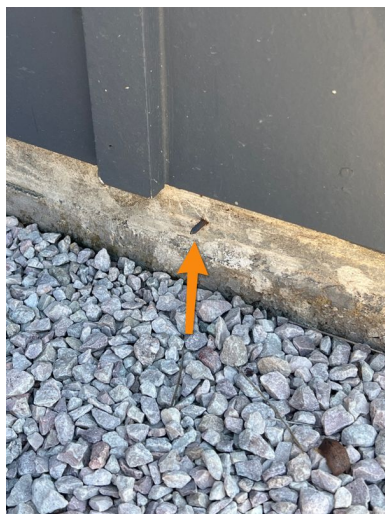
1: Foundation Nails

Foundation nails are not properly cut off to prevent physical injuries.

Multiple locations around the foundation

Recommendation: Contact a qualified professional.

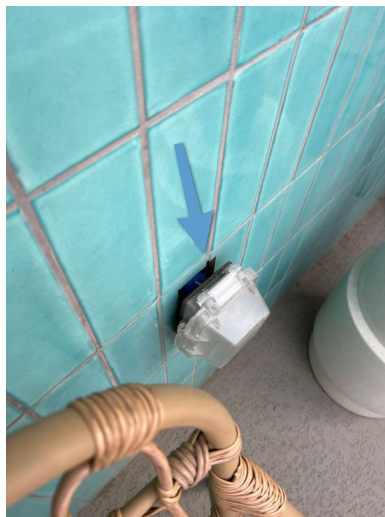
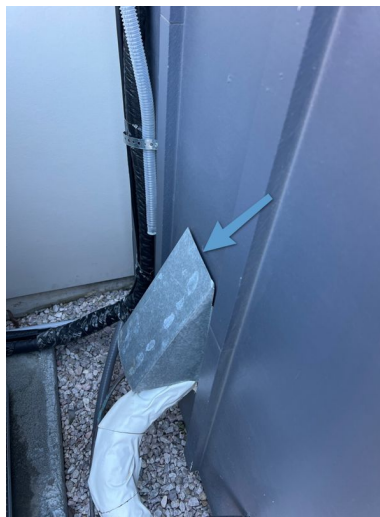
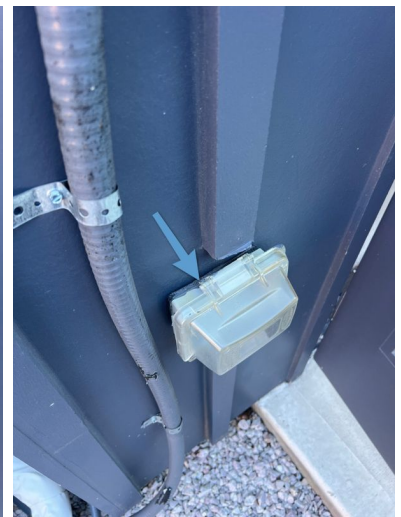
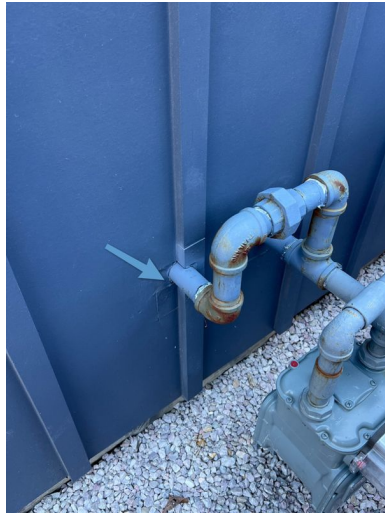
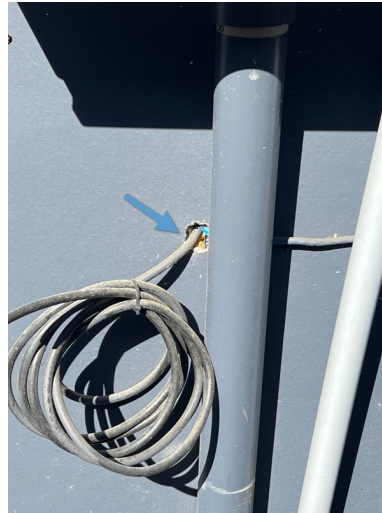
1: Improperly Sealed Penetration(s)

All pipes, cables, vent lines, and electrical fixtures should be properly sealed, where they penetrate the exterior siding throughout the home.

Second floor front balcony

Missing caulking

Recommendation: Contact a handyman or DIY project

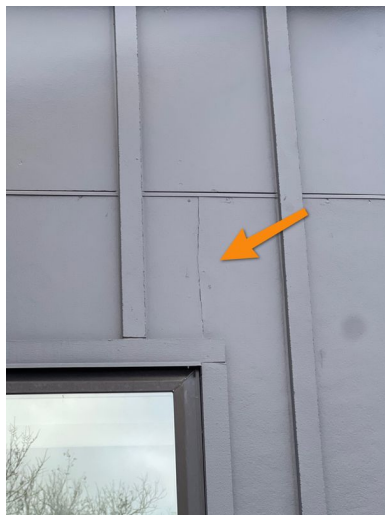
2: Damage Present

Damage observed to the siding materials.

Siding above window, second floor side balcony

Recommendation: Contact a qualified siding specialist.

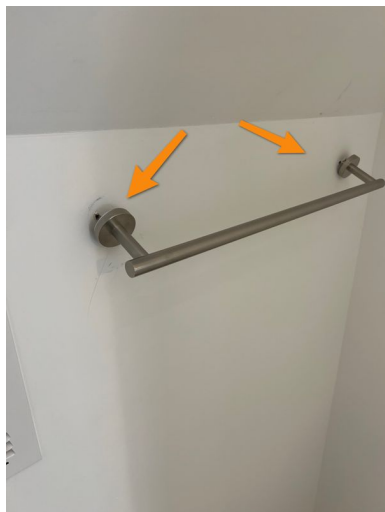
3: Towel bar, pulling off the wall

Third floor bathroom

Recommendation: Contact a qualified professional.

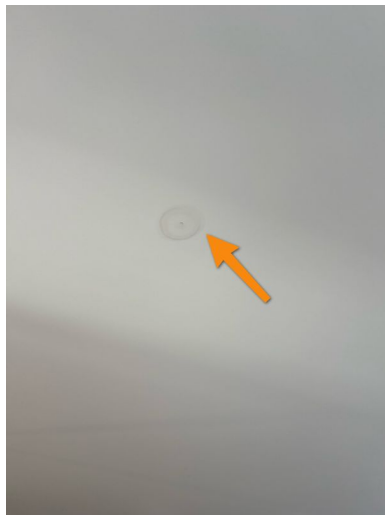
1: Water Stains On Ceiling (Previous)

Water stains were observed to the ceiling. No active moisture observed at the time of the inspection. Recommend monitoring.

Over dining table

Recommendation: Recommend monitoring.

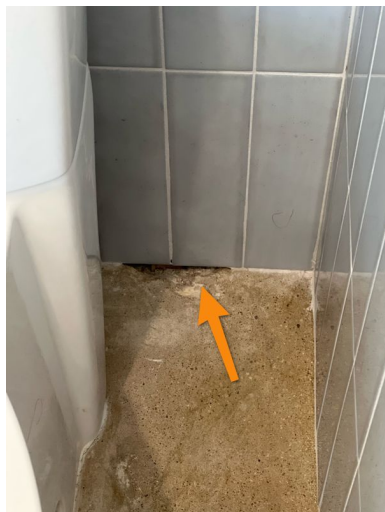
2: Floor Gaps

Gaps observed in the flooring material.

Behind toilet at downstairs half bath

Recommendation: Contact a qualified flooring contractor

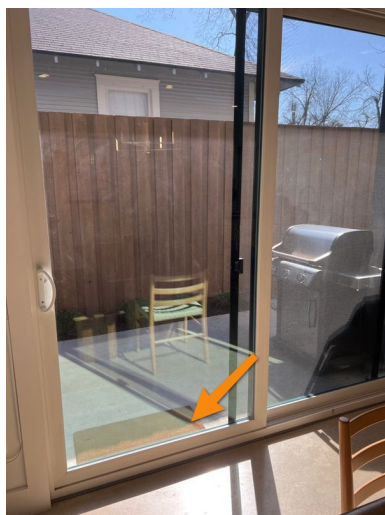
2: Slides Poorly

The sliding door slides poorly and/or has an obstruction in the track when opening/closing.

Downstairs side glass sliding door

Recommendation: Contact a qualified professional.

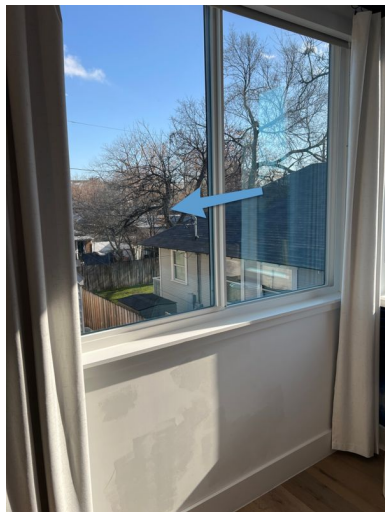
1: Missing Screen(s)

Missing screen(s) at the time of the inspection.

Second floor back bedroom

Recommendation: Contact a qualified professional.

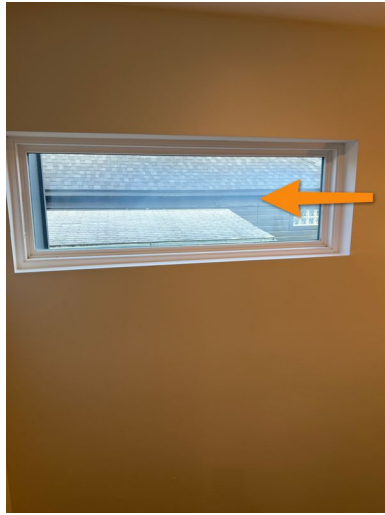
2: Foggy / Condensation

Condensation/staining was present to the windows. Possible broken seal between panes.

Stair landing

Recommendation: Contact a qualified window repair/installation contractor.

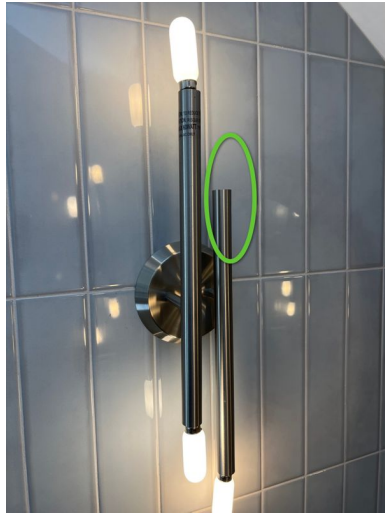
The functionality of the light fixture could not be determined. Bulbs are missing.

Downstairs half bath

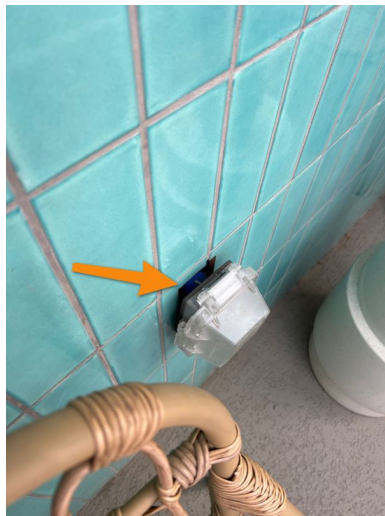
1: Loose Outlet/Switch

Loose electrical receptacle/switch was observed.

Second floor front balcony

Recommendation: Contact a handyman or DIY project

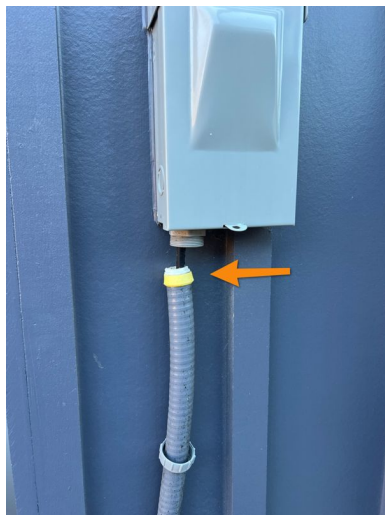
Exposed branch circuit wiring was observed. All branch circuit wiring should be placed in protective conduit.

Broken conduit connector

Recommendation: Contact a qualified electrical contractor.

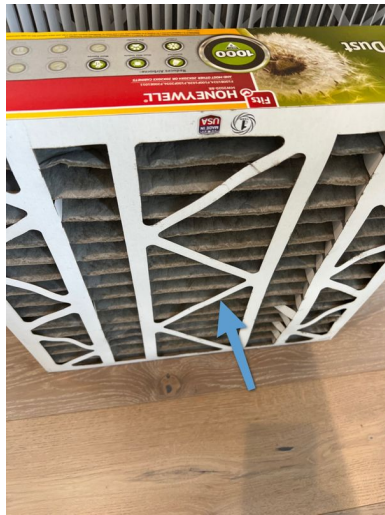
The return filter(s) for the HVAC unit were excessively dirty. Recommend replacement to ensure proper performance of the HVAC equipment.

Air filter at air handler needs to be replaced

Recommendation: Recommended DIY Project

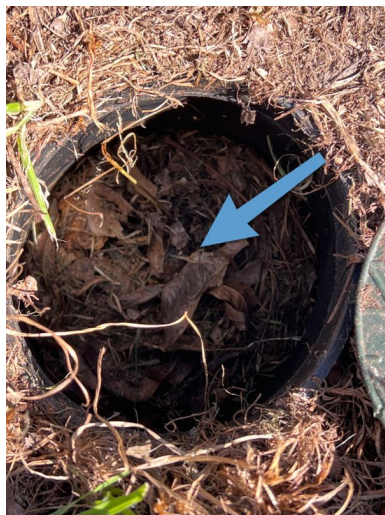
Pressure reducing valve is buried

Recommendation: Contact a handyman or DIY project

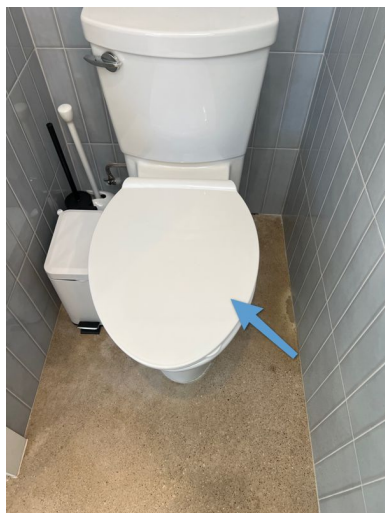
1: Toilet Loose
🔧 Minor Concern

The toilet was not properly secured.

Loose toilet at downstairs half bathroom

Recommendation: Contact a qualified plumbing contractor.

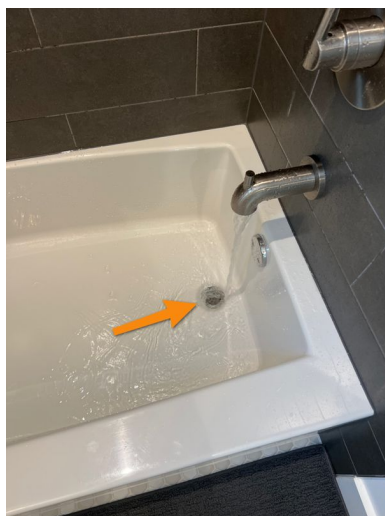
2: Drain Stop Missing

Missing drain stop was noted.

Second floor hallway, bathroom

Recommendation: Contact a qualified plumbing contractor.

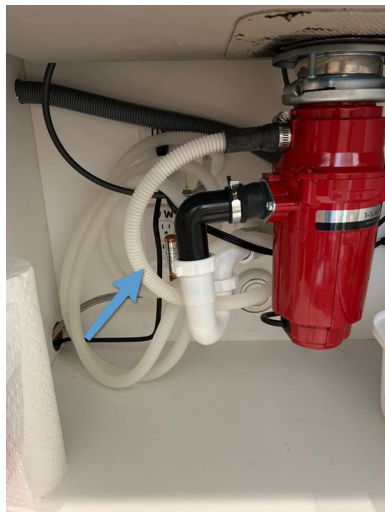
The dishwasher drain line appeared to be missing a sanitation loop (high loop) near the unit. Recommend reconfiguration.

Recommendation: Contact a handyman or DIY project

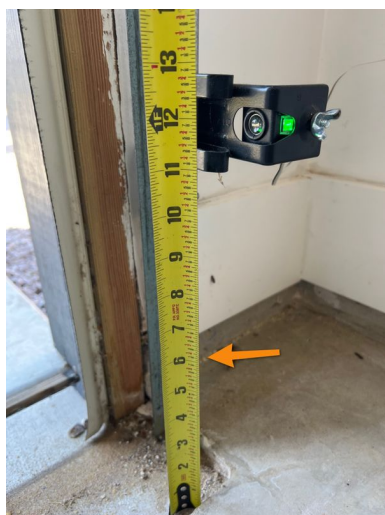
Garage opener safety sensors are too high

Recommendation: Contact a qualified garage door contractor.

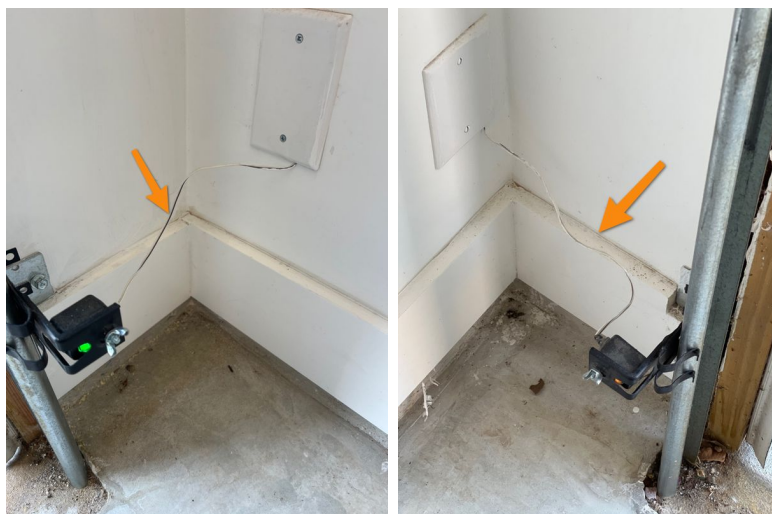
2: Sensor Wire(s)

Sensor wires should be secured to wall

Recommendation: Contact a qualified professional.

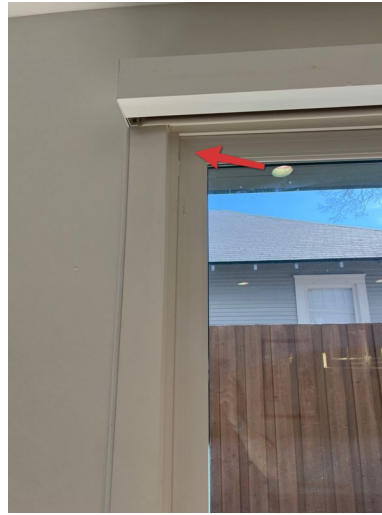
Missing door alarm

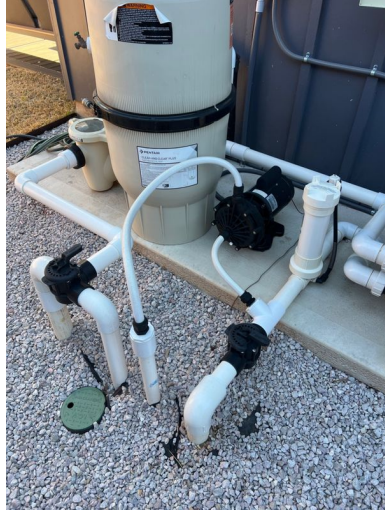
3: PVC Not Painted

Missing paint on PVC pipes
