All Atlanta Inspection Services Inspection Report

2203 Clanton Ter, Decatur, GA 30034
Inspection prepared for: Joey Gumataotao
Date of Inspection: 2/17/2025 Time: 10am
Age of Home: 62 years Size: 2024sq
Weather: 33 degrees

Inspector: Rico Hardrick

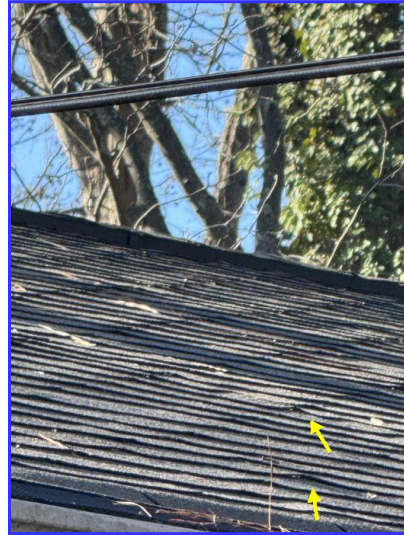
1.3. Minor curling is noted at the edges of the shingles. This is a result of the roofs age. No significant repairs are needed. Suggested to monitor area and repair if needed.

Curling shingles

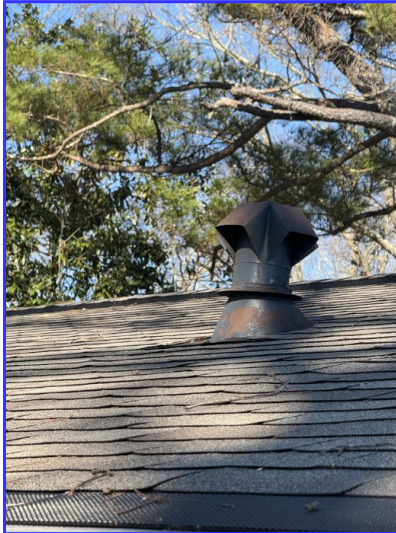
2.3. Heating vents are rusted. We recommend a review for repair or replacement as necessary.

rusting

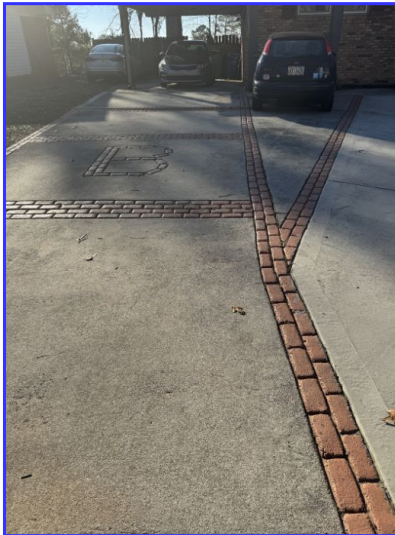
Driveway

1.1. Common cracks observed in driveway, these are primarily a cosmetic concern. No immediate action is recommended, however we suggest sealing all cracks in surfaces to prevent water penetration as a part of routine maintenance.

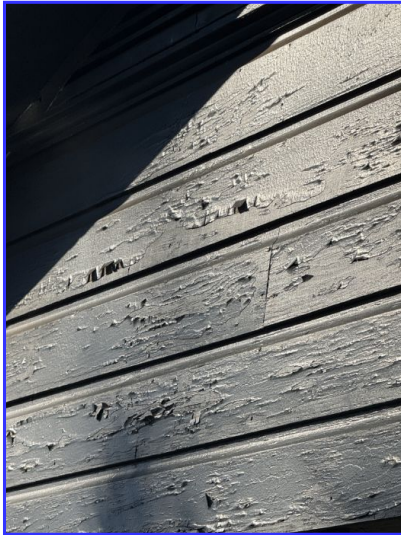
2.5. Multiple areas of faded or chipped paint were noted around the exterior of the home. In the inspectors opinion, the siding and trim are due to be painted. Suggested to consult with a licensed painter to review for paint as needed.

peeling paint at home

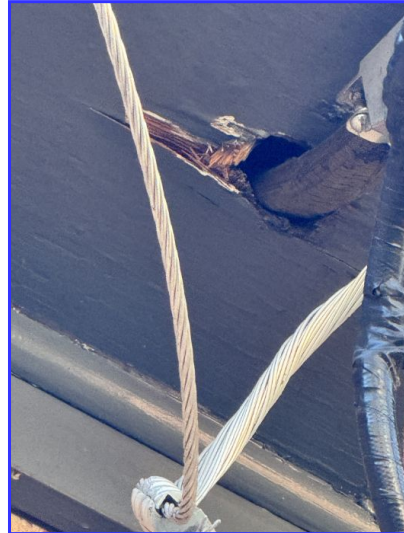
3.3. Suggested to seal around all doors and windows as a part of routine maintenance. Gaps were noted in the sealant around some or all doors and/or windows. Sealant barriers should be maintained to prevent any water intrusion or damaged materials.

Close gaps at trim

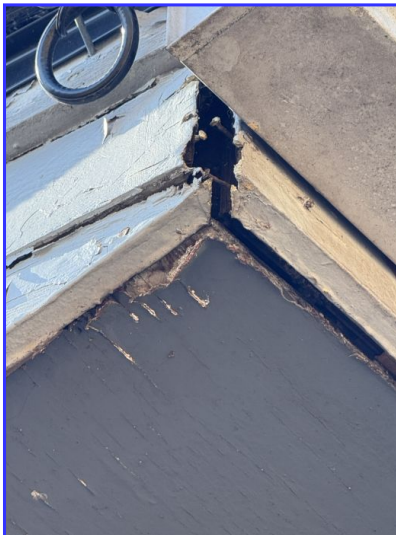
3.7. Due to the damaged trim noted around the home. It is suggested to have a licensed contractor fully review and repair all damaged and wood trim and any materials subsequently damaged due to the condition of the aforementioned trim. See photographs for some examples and locations.

Water damage trim at corners

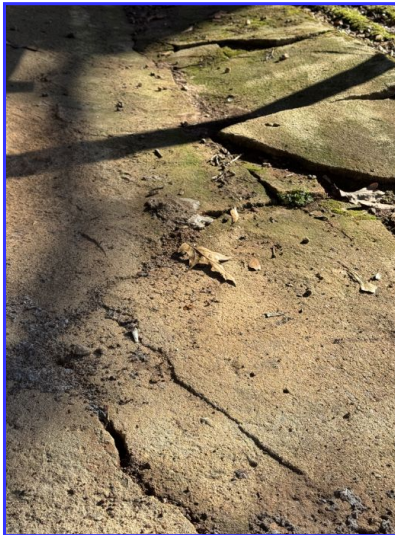
7.4. Erosion was noted at one or more areas around the house. Have soil placed back in this area and erosion control installed until effective ground cover can be established. It is recommended that a landscape contractor correct.

Erosion under deck

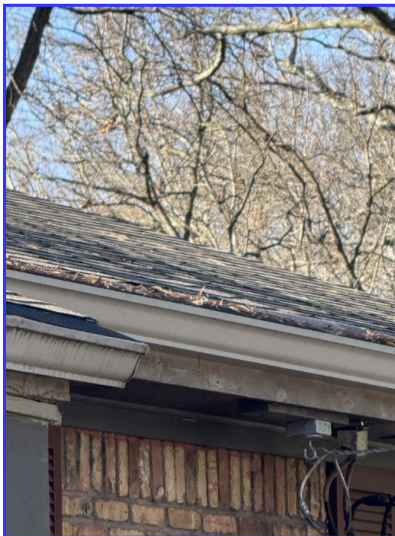
8.3. Clogged gutters are noted around the home. Suggest gutters be cleaned as a part of normal maintenance to ensure proper drainage.

Gutters are clogged around the home

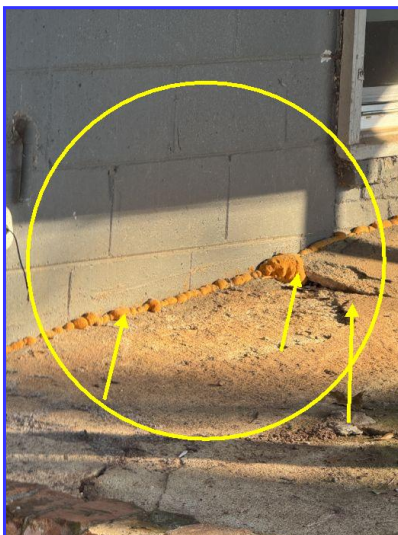
10.2. Incorrect repair noted at rear exterior foundation. Recommend to have foundation contractor review to make sure no water intrusion continues.

Incorrect repair at rear foundation

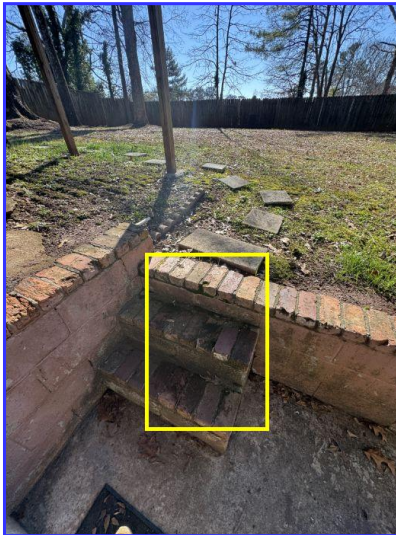
12.1. Missing guardrails observed. This is a "Safety Concern". Although guardrails may not have been required when the home was built, we recommend client consider installing guardrails as a safety enhancement.

Missing handrail

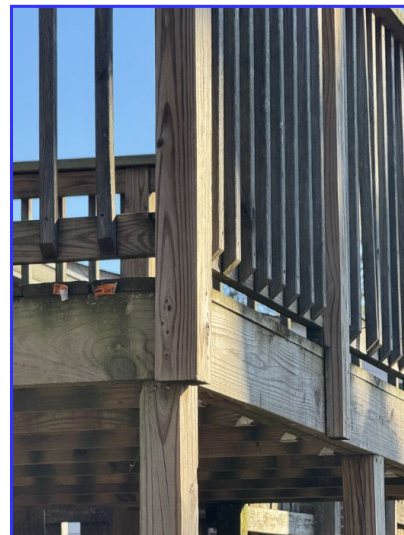
1.6. The deck appears to be nailed to the structure. Nails may pull out and fail. It is recommended to have the deck properly bolted and secured where it meets the rear of the home.

No bolts at deck

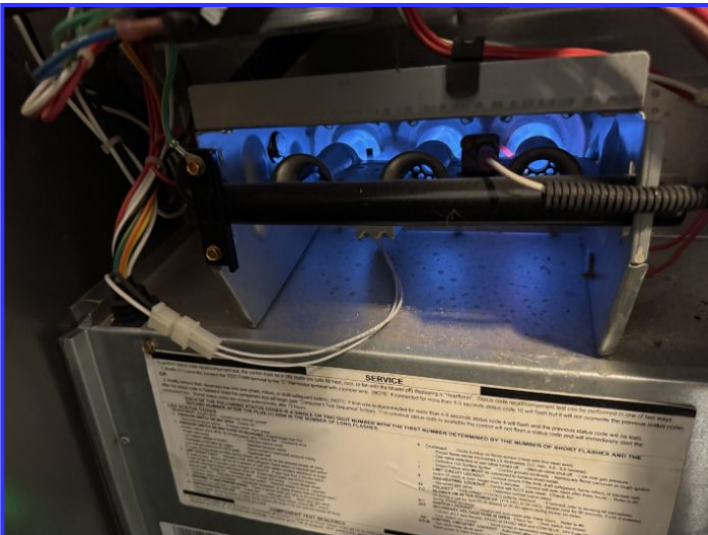
5.3. Due to presence of rust, scale, and some debris in this appliance, a service review by a licensed HVAC contractor is advised to ensure proper and safe operation of this unit. Inspection for holes and/or cracks in heat exchangers is not within the scope of this inspection and should be performed prior to closing to ensure the proper and safe operation of the system.

Interior of unit

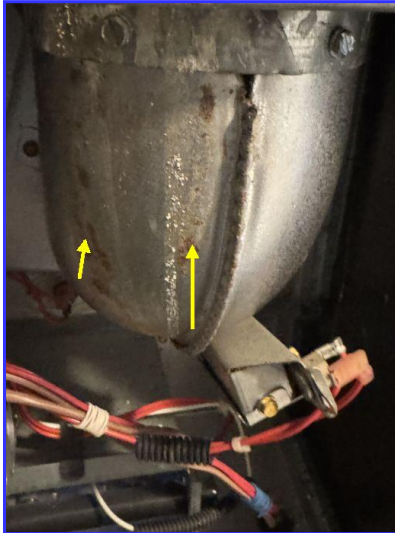
Rusting in unit

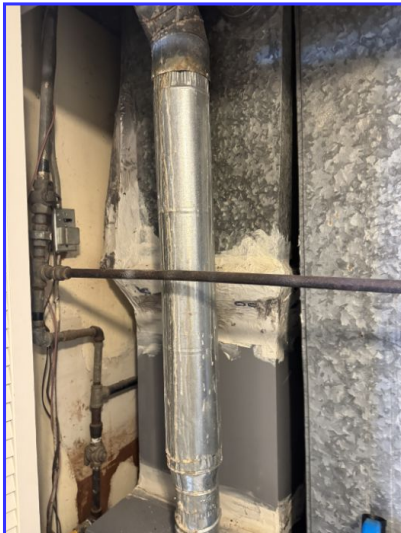
Operational

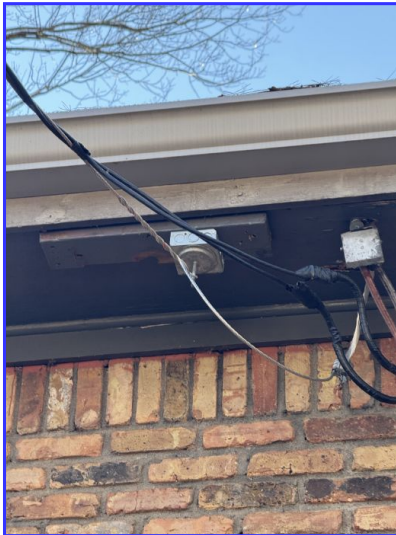
Keep tree limbs away from over head lines

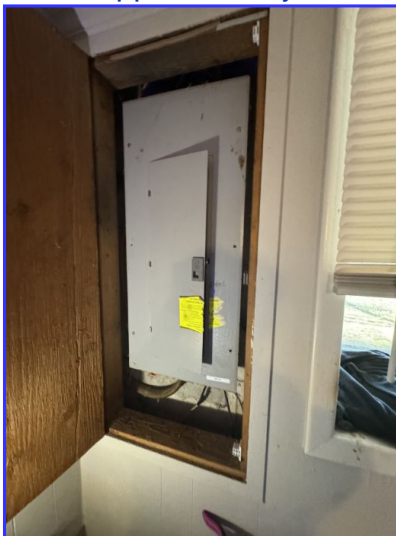
2.1. The main service is approximately 150 Amps

Main panel box located in the Basement

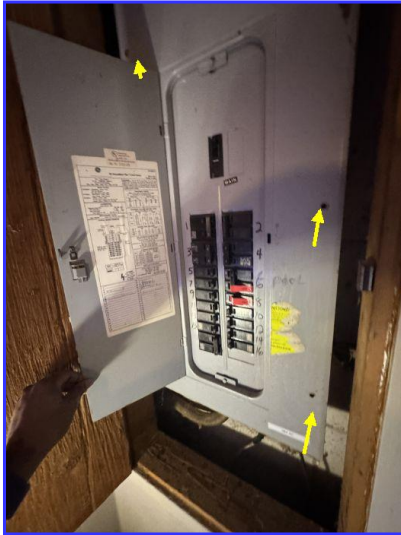
3.1. Labeling present on electric circuits locations in the main panel. (These are not checked for accuracy)

Labeled

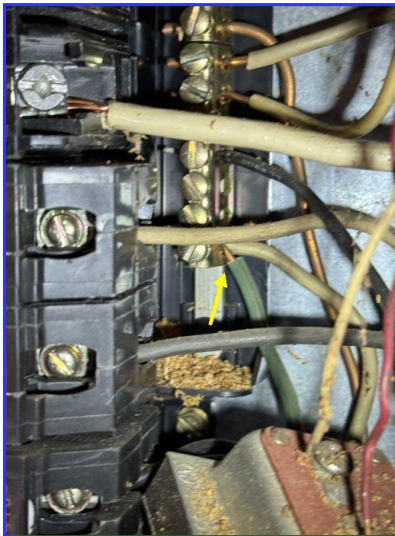
3.2. Neutral wires are doubled or bundled together on the neutral buss bar. Current installation practices no longer allows this wiring method, however it was common when the home was built. We recommend having a licensed electrician review as a safety upgrade.

Double tapped neutrals

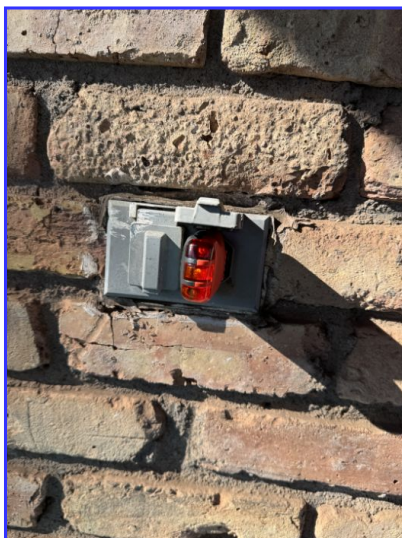
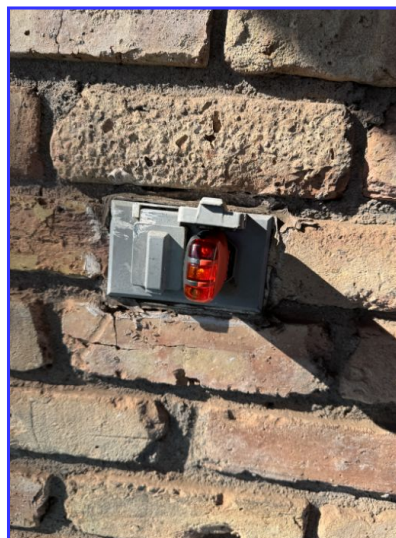
6.1. Ground Fault Circuit Interrupters (**GFCI**'s) were not required when the home was built. Suggest client consider upgrading with GFCI's at all garage and exterior receptacles to enhance safety. Upgrades should be performed by a licensed electrician.

no gfci at exteriors

No gfci at exterior outlets

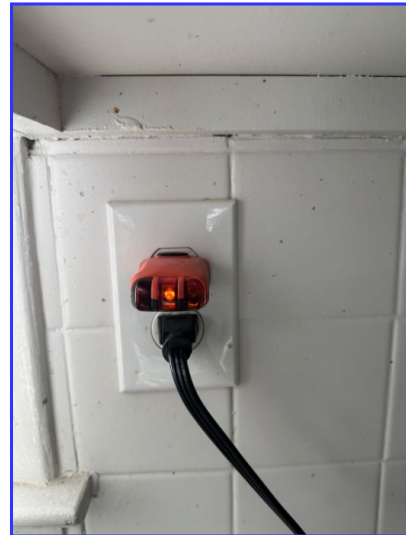
7.4. Grounding outlets was not a common practice when this home was built. Two prong outlets are noted throughout the home. Many outlets have been replaced with three prong receptacles and are not connected to a ground. Grounding protects the electrical system and is required for many modern appliances. Have a licensed electrical contractor evaluate and ensure the system is properly grounded.

no grounding or gfci at kitchen

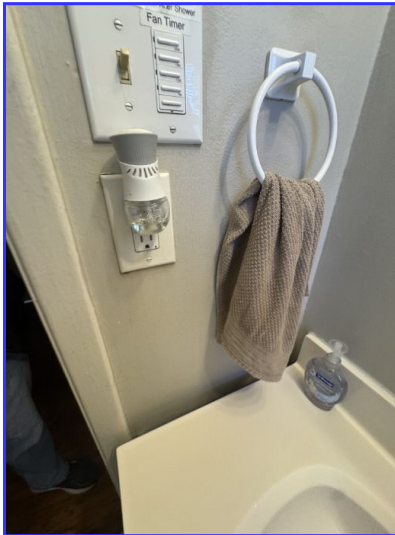
The bathroom GFCI outlet did not trip when tested.

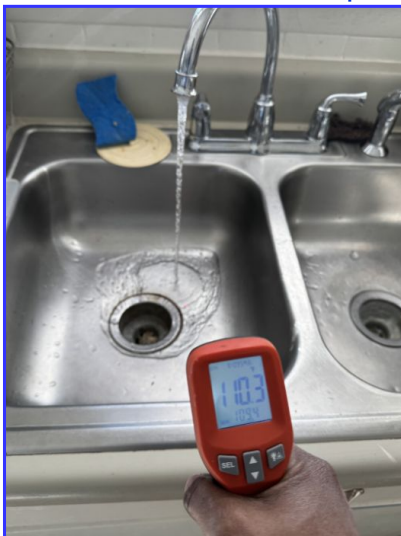
Operational

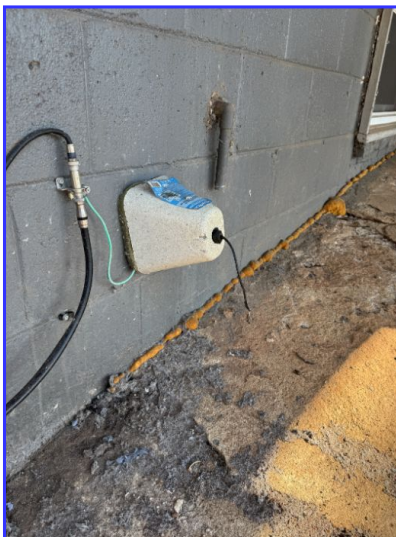
5.1. The hose spigots were not operational at the time of the inspection. These may be winterized from the interior and are not tested.

Winterized

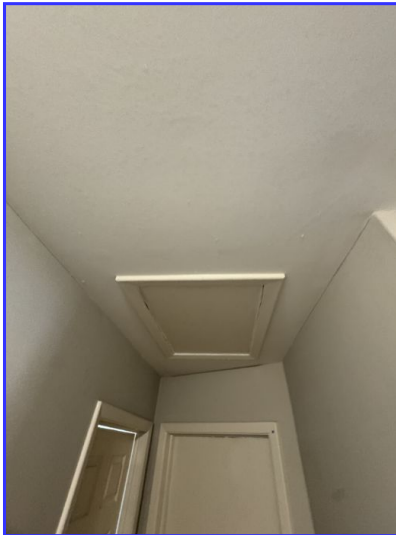
1.2. All attic access openings should be insulated and weather stripped. It is recommended to properly seal and insulate any access between conditioned spaces and the attic

Weather strip and insulate all attic access at living spaces

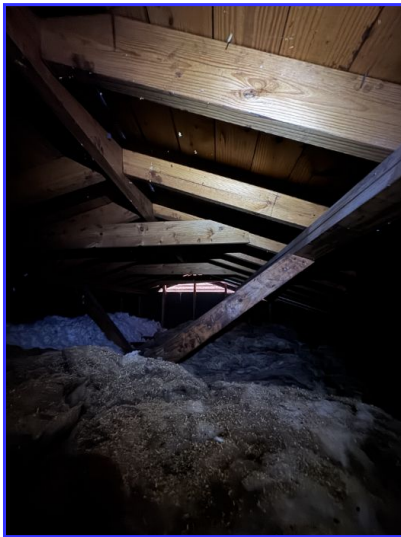
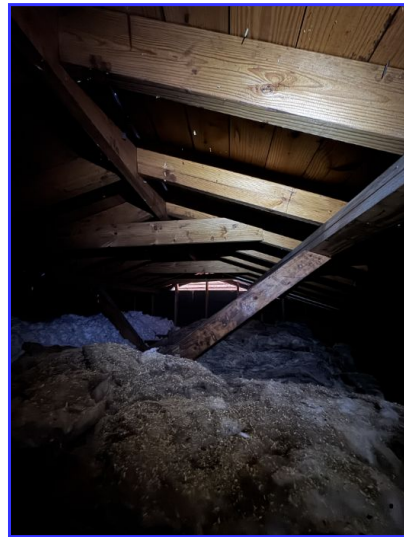
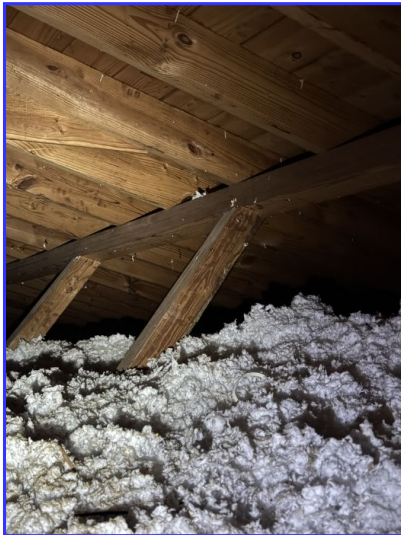
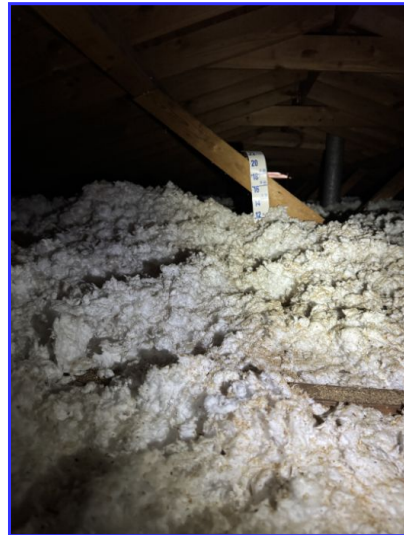
Attic insulation condition

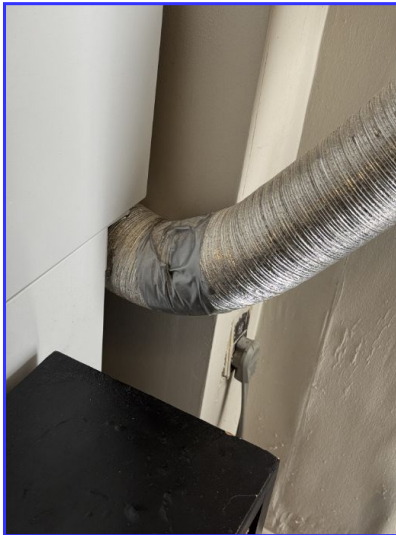
3.1. There is a incorrect repair at dryer vent in the laundry room. Ventilation is required in a laundry (M1301.1)

Incorrect repair at laundry

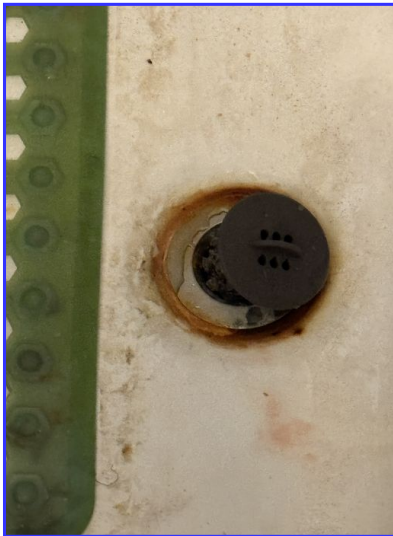
6.3. Rusting at tub Drain. Have contractor clean and repair.

Rusting

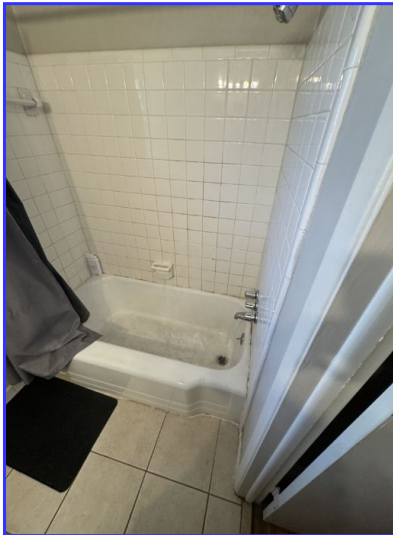
8.3. It is recommended to clean and re-seal the grout around the enclosure of the master shower stall as normal maintenance.

seal around corners

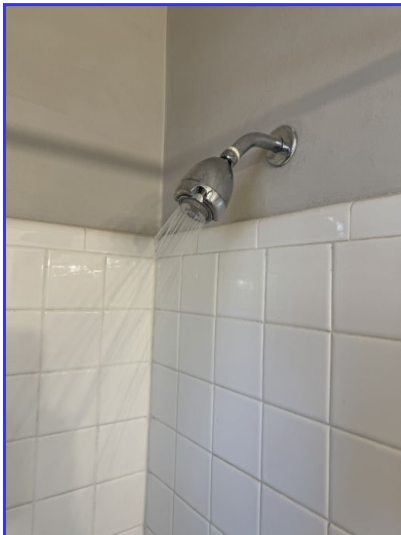
9.1. Repair the leak at the valve handle in the shower in the bath room. See photograph for locations and details.

Operational

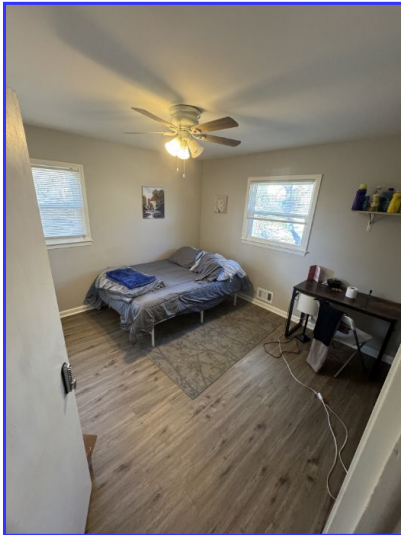
Pergo

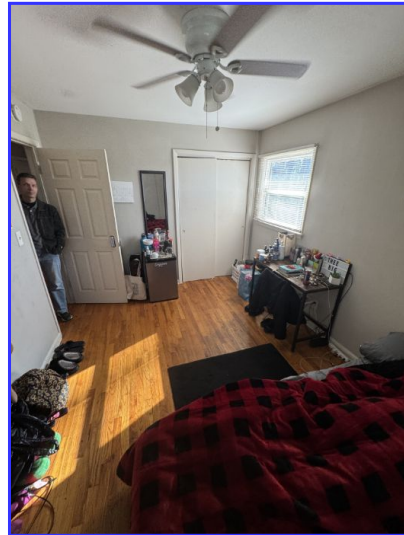
Wood

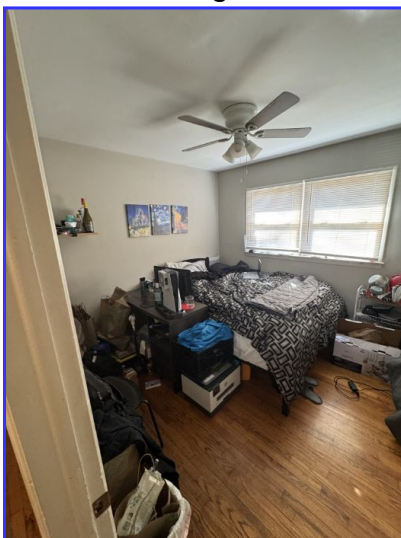
Wood

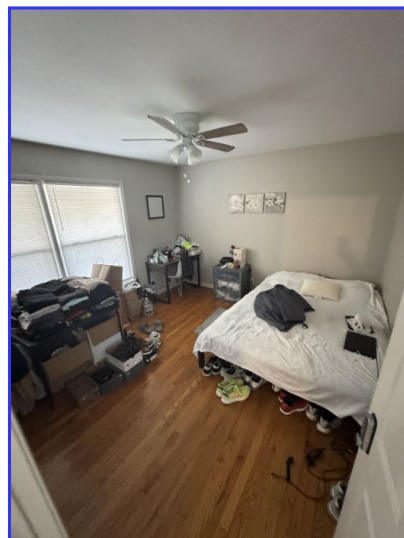
Wood floor

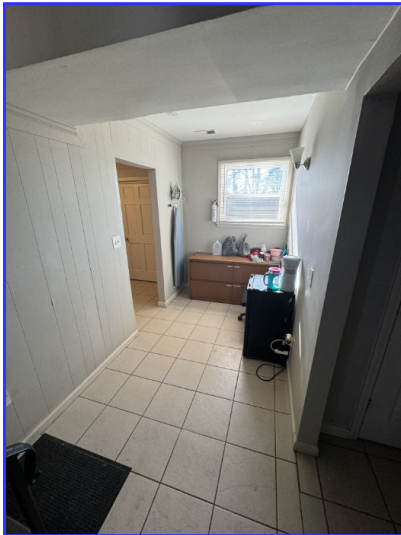
tile

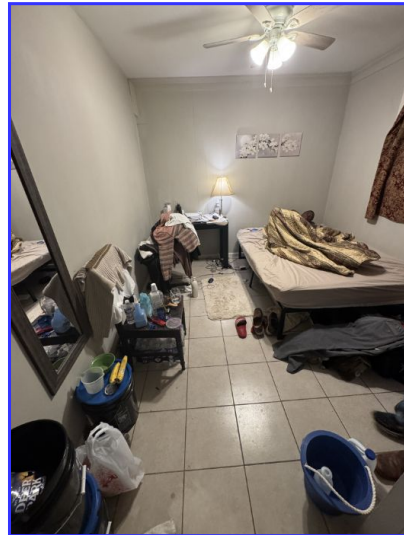
tile

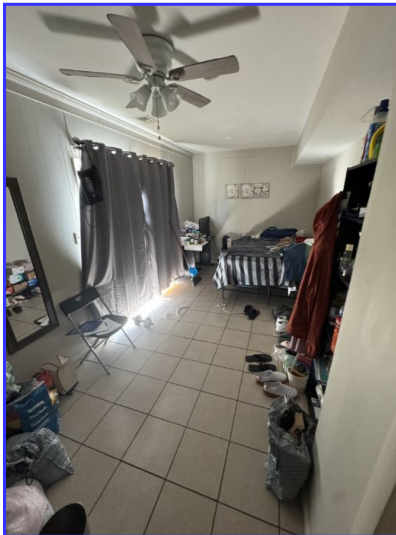
tile

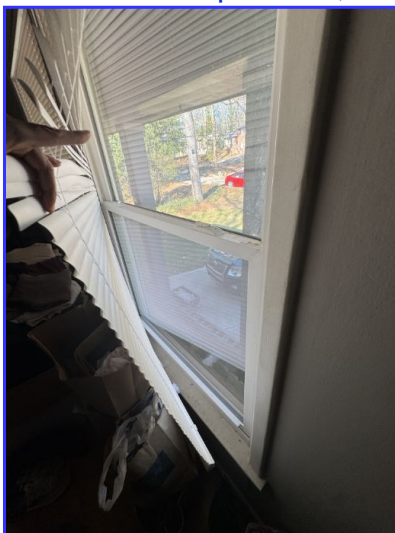
5.1. Determining the condition of all thermal pane windows is not usually possible, due to variations in temperature, weather and lighting at the windows.

Vinyl thermal pane

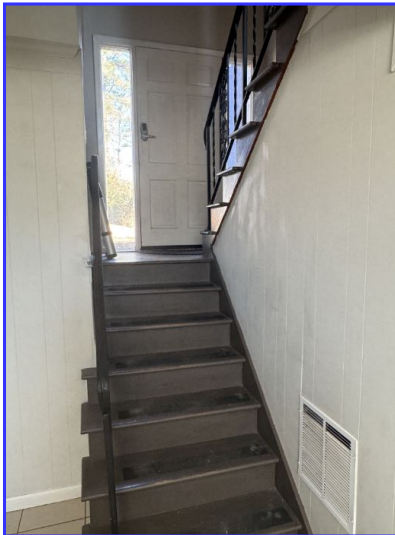
Stair views

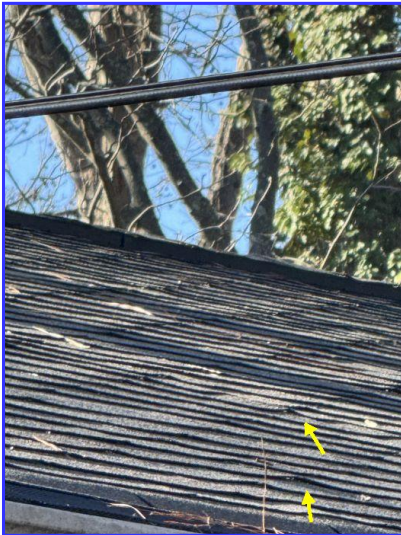
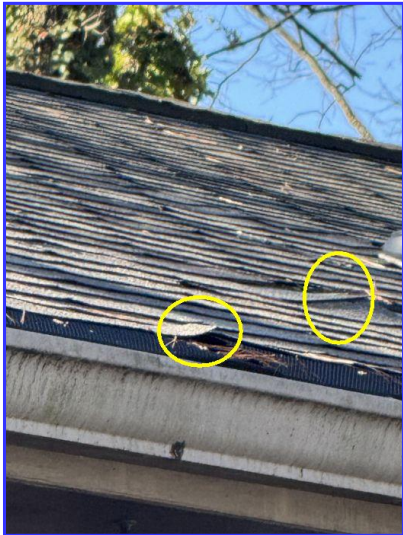
Roof		
Page 4 Item: 1	Roof Conditions	<p>1.3. Minor curling is noted at the edges of the shingles. This is a result of the roofs age. No significant repairs are needed. Suggested to monitor area and repair if needed.</p> <p>1.4. Lifted shingles are noted at several areas around the home and should be re-nailed.</p>

Curling shingles		Curling noted on shingles on roof
Page 6 Item: 2	Roof Boots & Flashing	2.3. Heating vents are rusted. We recommend a review for repair or replacement as necessary.

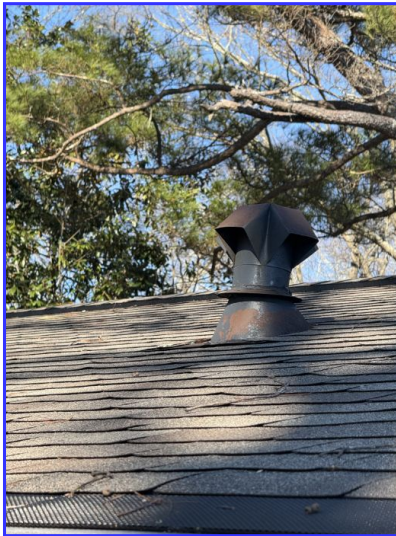
rusting

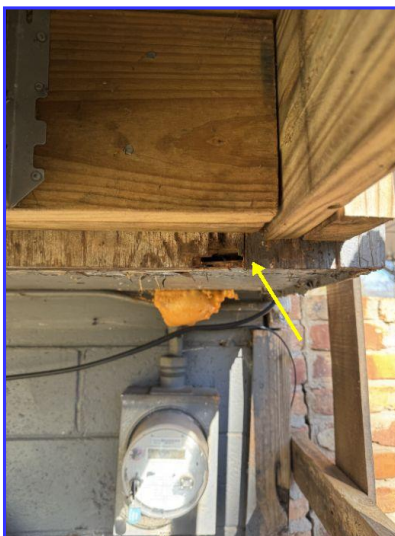
Damaged under deck

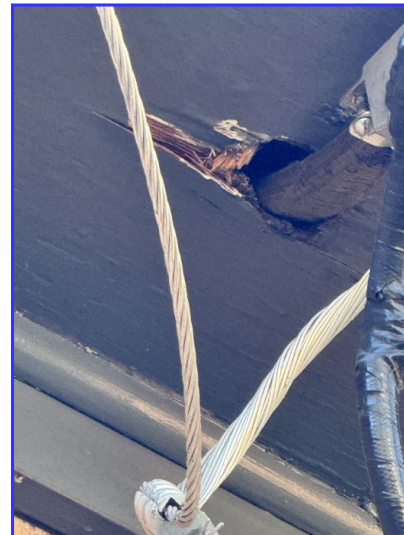
3.5. Multiple areas of unpainted/weathered trim were noted around the home. Any areas of bare wood noted at the exterior of the home should be painted and sealed to prevent premature deterioration. See photographs for some examples and locations.

Close gaps at trim

3.7. Due to the damaged trim noted around the home. It is suggested to have a licensed contractor fully review and repair all damaged and wood trim and any materials subsequently damaged due to the condition of the aforementioned trim. See photographs for some examples and locations.

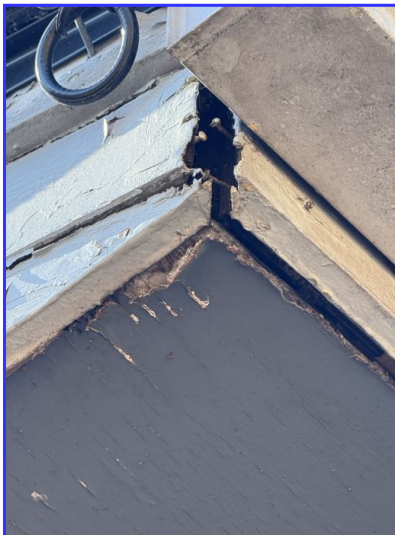
Water damage trim at corners

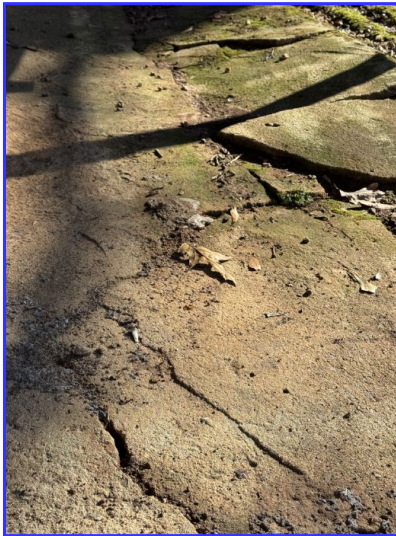
Page 13 Item: 4	Vent Conditions	4.1. The vent for the dryer is not fully visible at the time of the inspection and should be cleaned for proper and safe operation of the clothes dryer. Dryer vent ducts should be inspected at least once a year to reduce the risk of fire.
Page 14 Item: 7	Exterior Grading	<p>7.4. Erosion was noted at one or more areas around the house. Have soil placed back in this area and erosion control installed until effective ground cover can be established. It is recommended that a landscape contractor correct.</p> <p>7.5. The house sits lower than the level of the rear yard and the yard is sloped towards the back of the home. The drainage should be monitored during any heavy rains and repaired as needed to prevent possible water entry</p>

Erosion under deck

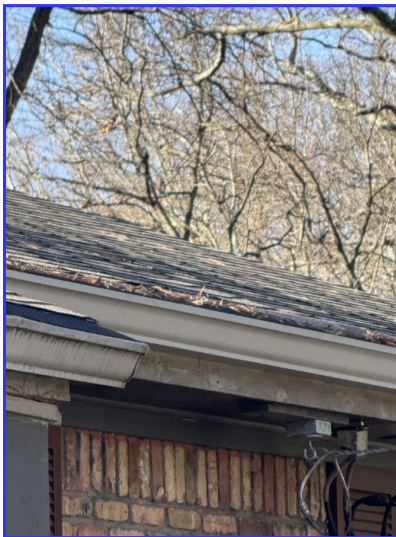
Page 15 Item: 8	Gutter Conditions	8.3. Clogged gutters are noted around the home. Suggest gutters be cleaned as a part of normal maintenance to ensure proper drainage.
-----------------	-------------------	---

Gutters are clogged around the home

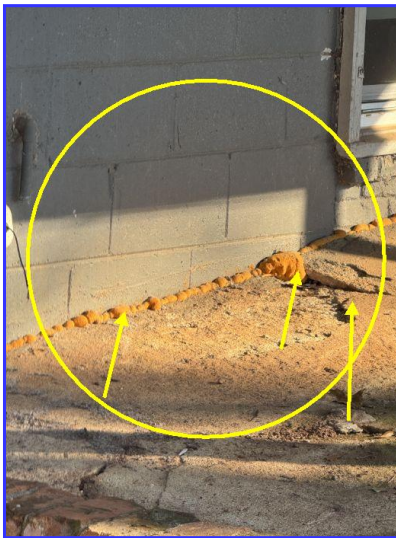
Page 16 Item: 10	Foundation Type	10.2. Incorrect repair noted at rear exterior foundation. Recommend to have foundation contractor review to make sure no water intrusion continues.
------------------	-----------------	---

Incorrect repair at rear foundation

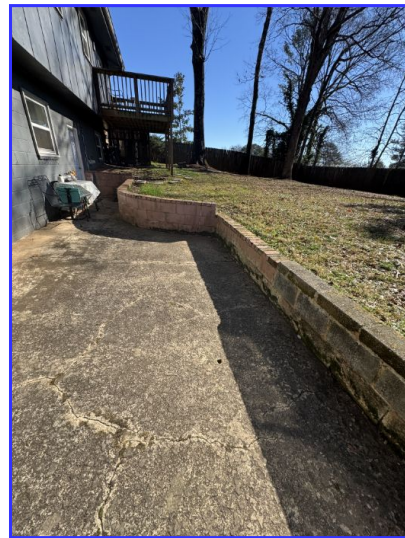
Retain wall

11.1. Recommend review by a qualified professional for repair or replacement, as necessary.

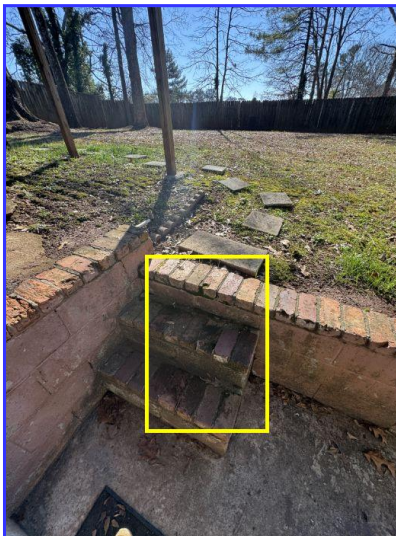
12.1. Missing guardrails observed. This is a "Safety Concern". Although guardrails may not have been required when the home was built, we recommend client consider installing guardrails as a safety enhancement.

Missing handrail

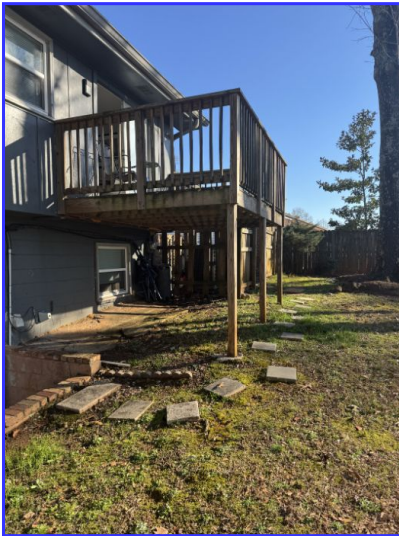
<p>Page 19 Item: 1</p>	<p>Deck Conditions</p>	<p>1.2. Deck is weathered and is due for a water proofing sealer.</p> <p>1.3. There were multiple issues noted with the deck on the home. It is suggested to have the entire deck reviewed and all repairs made by a licensed decking contractor. See photographs for example issues and locations.</p> <p>1.4. Additional bolts are recommended where the deck is secured to the home. The deck should have 1/2 inch carriage bolts installed with washers and nuts every 16-32 inches.</p> <p>1.5. There is no visible flashing where deck meets house. The joint between the deck and the house should be flashed to prevent water penetration where the deck is bolted to the home.</p> <p>1.6. The deck appears to be nailed to the structure. Nails may pull out and fail. It is recommended to have the deck properly bolted and secured where it meets the rear of the home.</p>

Deck view

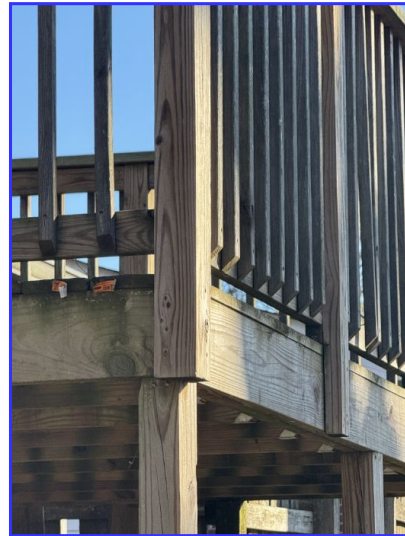
No bolts at deck

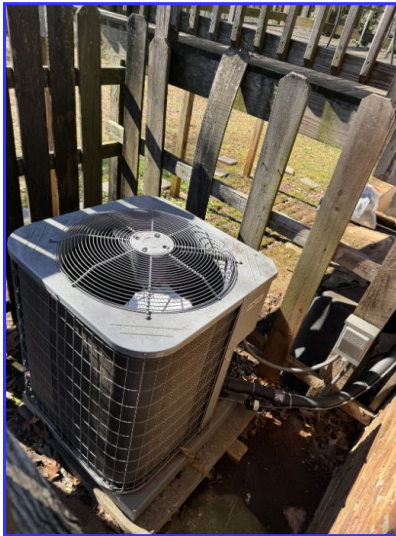
Ac at rear

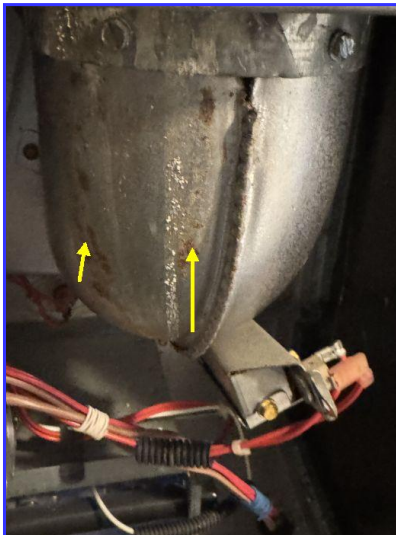
5.3. Due to presence of rust, scale, and some debris in this appliance, a service review by a licensed HVAC contractor is advised to ensure proper and safe operation of this unit. Inspection for holes and/or cracks in heat exchangers is not within the scope of this inspection and should be performed prior to closing to ensure the proper and safe operation of the system.

Rusting in unit

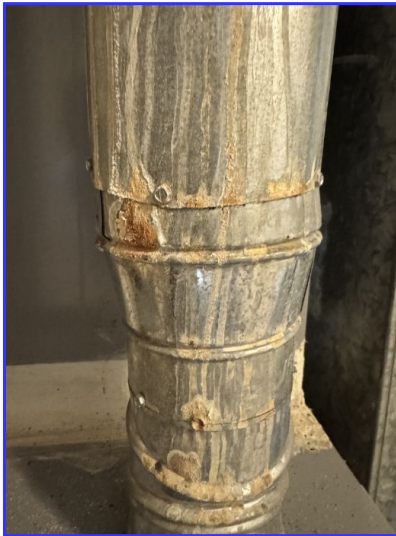
6.2. Rusting and holes observed in the furnace vent pipe, which is a serious safety concern. Have examined and repaired as needed by a HVAC contractor.

Rust noted on metal vent pipe

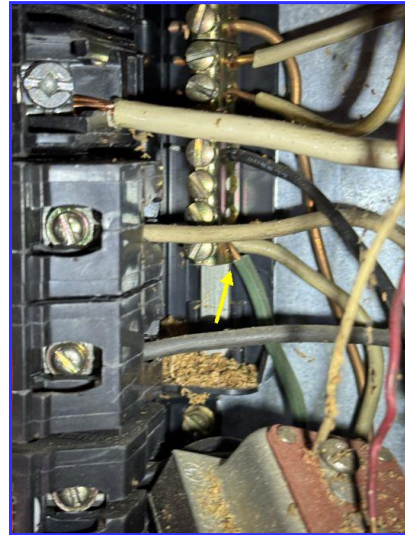
3.2. Neutral wires are doubled or bundled together on the neutral buss bar. Current installation practices no longer allows this wiring method, however it was common when the home was built. We recommend having a licensed electrician review as a safety upgrade.

Double tapped neutrals

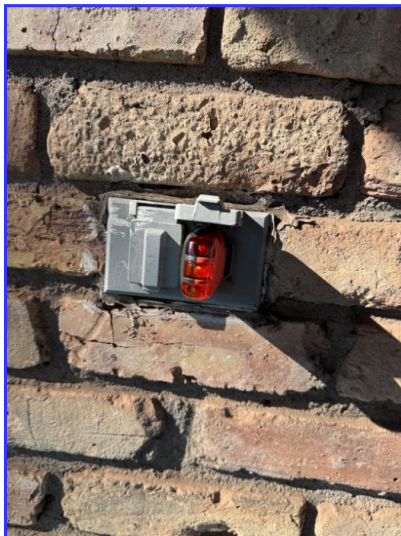
6.1. Ground Fault Circuit Interrupters (**GFCI**'s) were not required when the home was built. Suggest client consider upgrading with GFCI's at all garage and exterior receptacles to enhance safety. Upgrades should be performed by a licensed electrician.

no gfci at exteriors

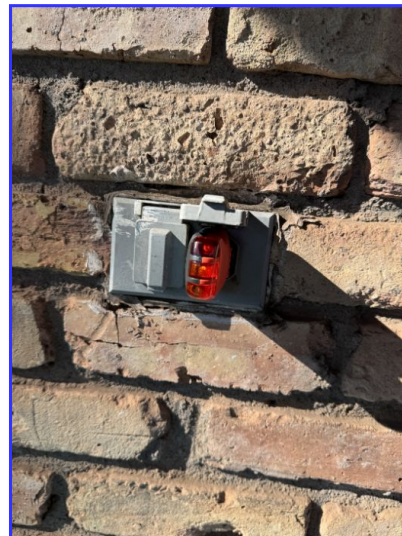
No gfci at exterior outlets

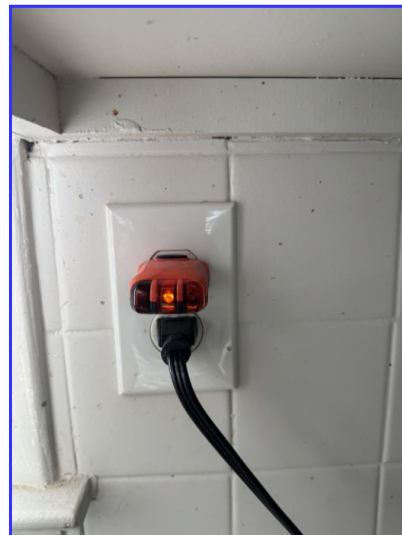
7.2. GFCI protected receptacles may not have been required when the house was built. We suggest buyer consider upgrading with GFCI's at all receptacles near water sources. See photographs for examples and locations of missing or needed GFCI outlets.

7.4. Grounding outlets was not a common practice when this home was built. Two prong outlets are noted throughout the home. Many outlets have been replaced with three prong receptacles and are not connected to a ground. Grounding protects the electrical system and is required for many modern appliances. Have a licensed electrical contractor evaluate and ensure the system is properly grounded.

no grounding or gfci at kitchen

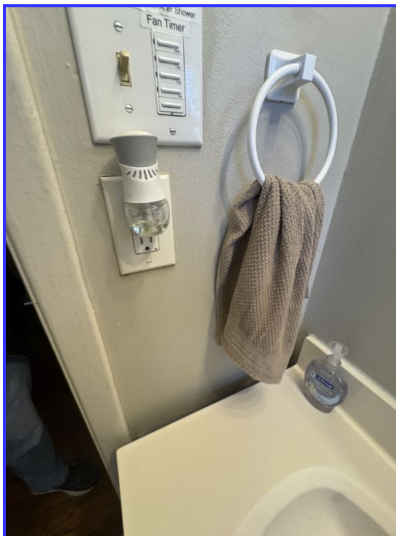
The bathroom GFCI outlet did not trip when tested.

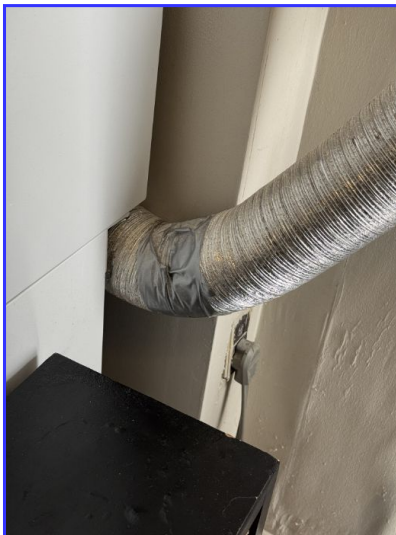
Page 44 Item: 3	Laundry Comments	3.1. There is a incorrect repair at dryer vent in the laundry room. Ventilation is required in a laundry (M1301.1)
-----------------	------------------	---

Incorrect repair at laundry

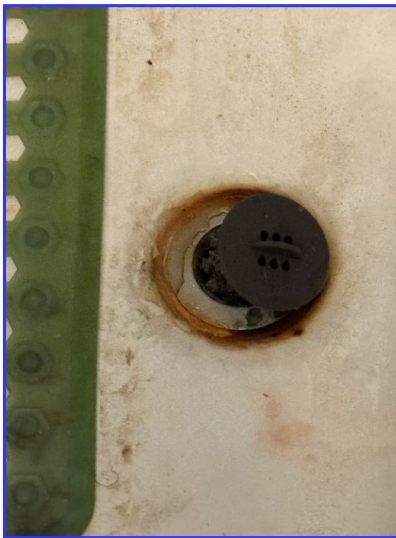
Page 47 Item: 6	Bathroom Tub and Enclosure	<p>6.2. Excessive dirt and residue buildup noted at the tub in one or more bathrooms. This limits the view of the tub base. Suggested to have tubs cleaned as needed.</p> <p>6.3. Rusting at tub Drain. Have contractor clean and repair.</p>
-----------------	----------------------------	---

Rusting

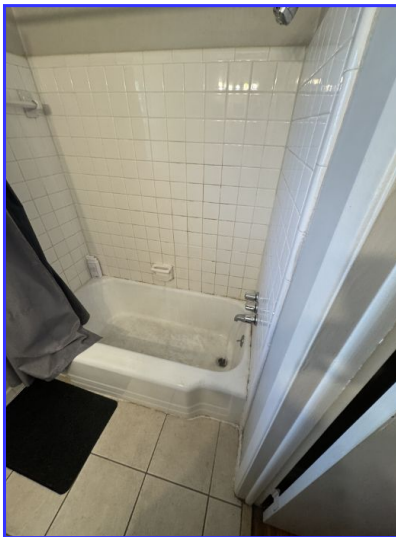
Page 48 Item: 8	Shower Enclosure	8.3. It is recommended to clean and re-seal the grout around the enclosure of the master shower stall as normal maintenance.
-----------------	------------------	--

seal around corners

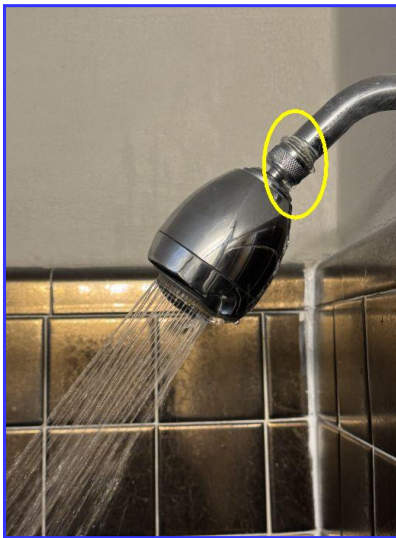
Page 49 Item: 9	Shower Faucet Condition	9.1. Repair the leak at the valve handle in the shower in the bath room. See photograph for locations and details.
-----------------	-------------------------	--

active leak

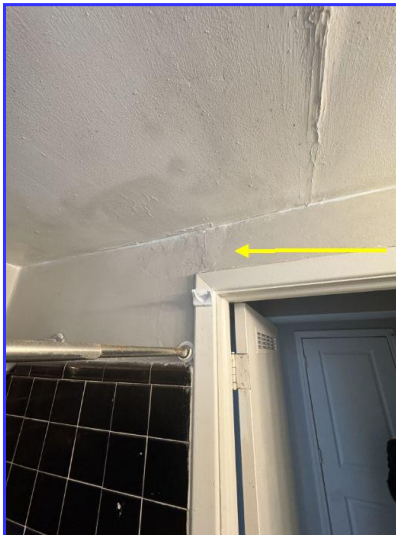
2.2. Patching observed in the walls around the home. There was no evidence of current leaks. Suggested to refer to the sellers disclosure if further information regarding the patches is desired.

Damaged wall at bathroom
