All Atlanta Inspection Services

Inspection Report

2483 Memorial Dr SE, Atlanta , GA 30317
Inspection prepared for: Joey Gumataotao
Date of Inspection: 2/9/2025 Time: 2 pm
Age of Home: 88 years old Size: 2886 SF
Weather: Clear 58 degrees

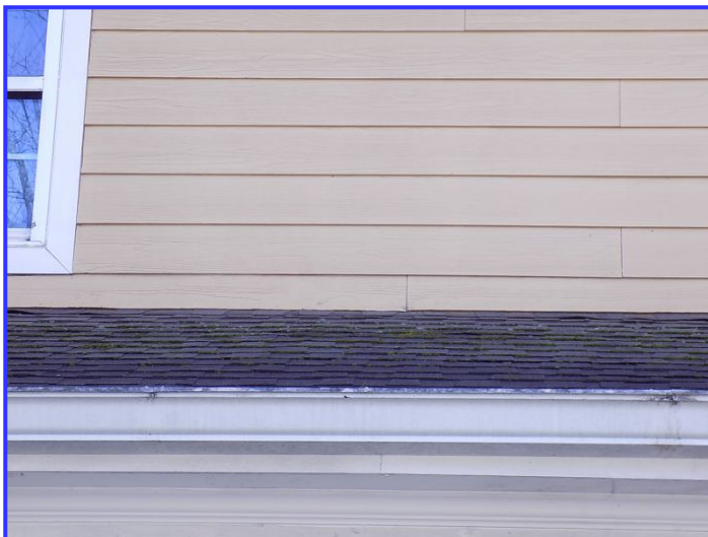
1.3. Moss is noted on the shingles of the roof. The moss will hold moisture and quickly deteriorate the shingles and should be professionally removed.

Moss growth at front lower roof

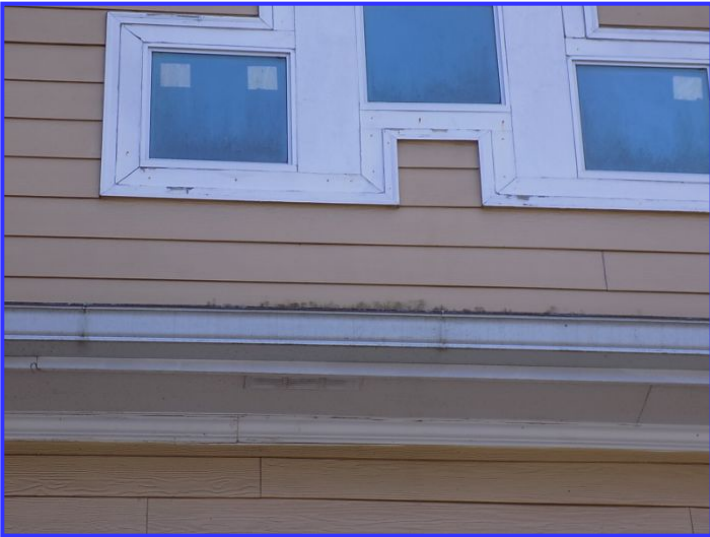
Algae noted at front siding

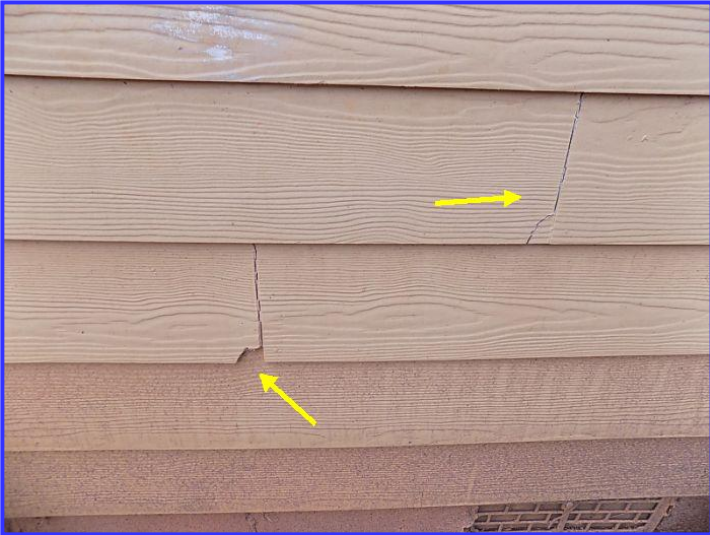
2.4. Multiple areas of damaged lap siding were noted around the home. The siding should be reviewed and all damaged siding repaired by a licensed contractor as needed. See photographs for some examples and locations.

Damaged area of siding at left

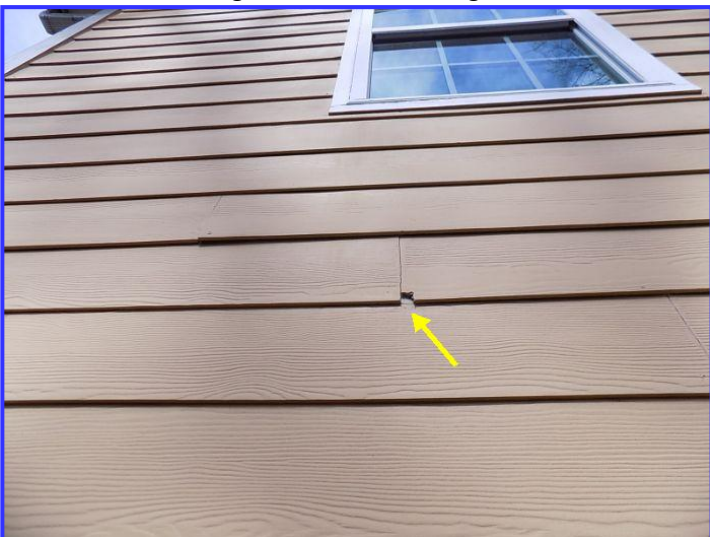
Damaged area of siding at rear

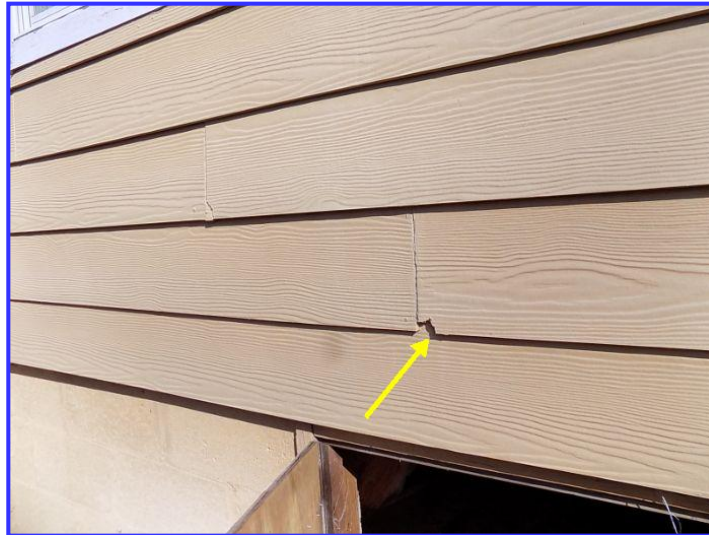
Damaged area of siding at right

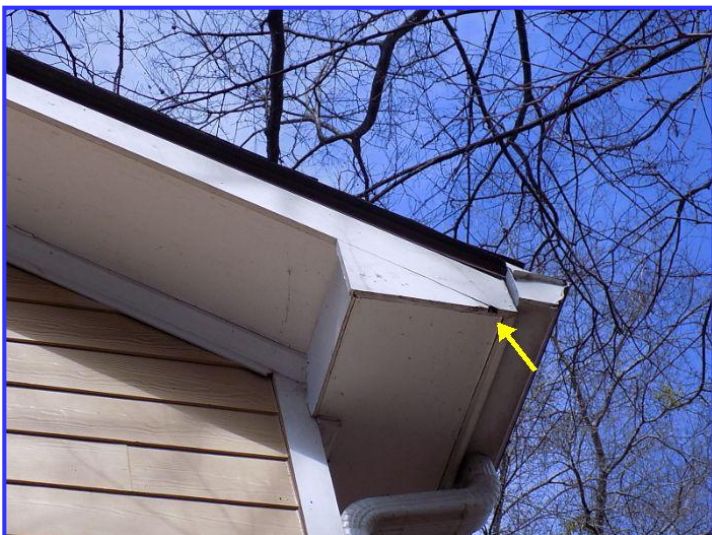
- 3.4. Multiple areas of trim damage noted around the home. See photographs for locations and details. Recommend review and repair by a qualified contractor as needed.

Damaged fascia at the rear left corner

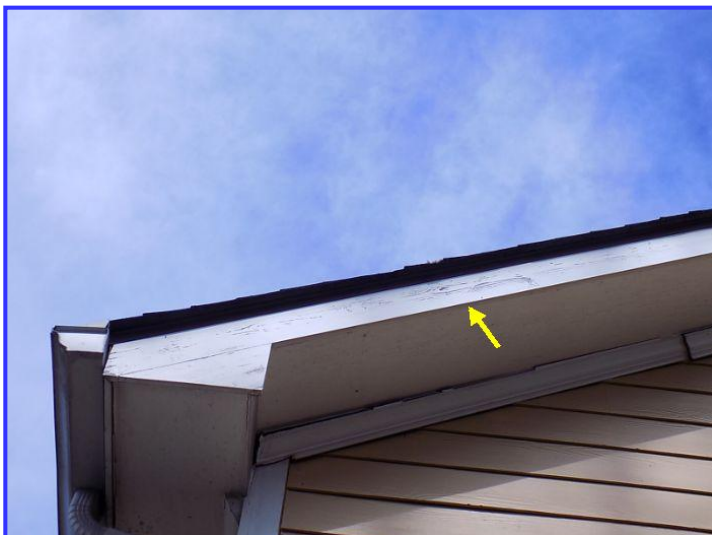
- 3.5. One or more areas of unpainted/weathered trim were noted around the home. Any areas of bare wood noted at the exterior of the home should be painted and sealed to prevent premature deterioration. See photographs for some examples and locations.

Weathered fascia at rear

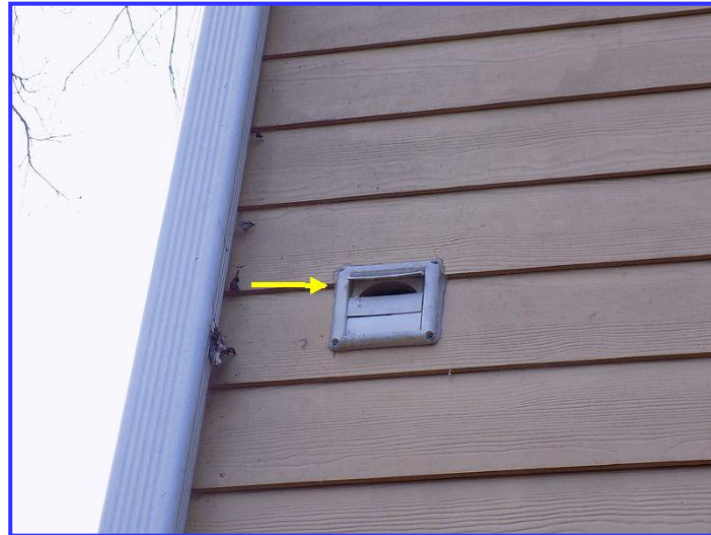
4.1. The flap is open at the exterior vent hood and should be repaired to close properly when not in use.

Flap open at left

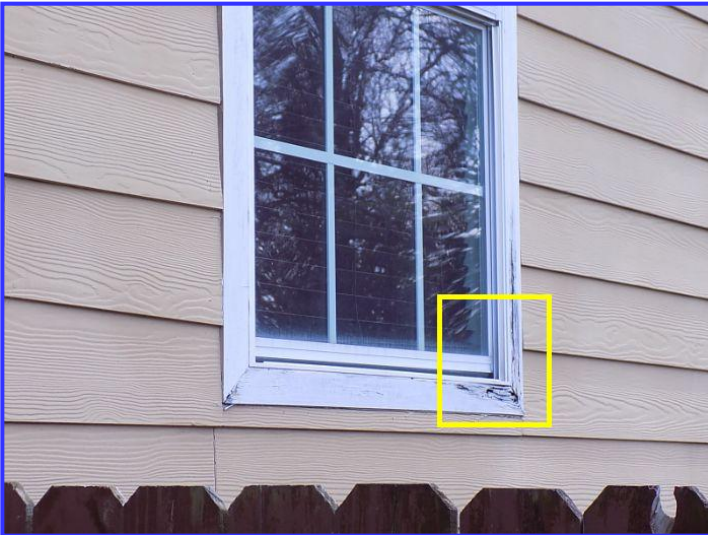
5.3. Multiple areas of damaged/soft window framing noted around the home. There may be additional damage that is not fully visible or noted. Recommend a qualified contractor review to improve, repair or replace all damages & any materials subsequently damaged due to these conditions. Not all damages may be noted in this report. See photos for examples

Damaged window framing at right

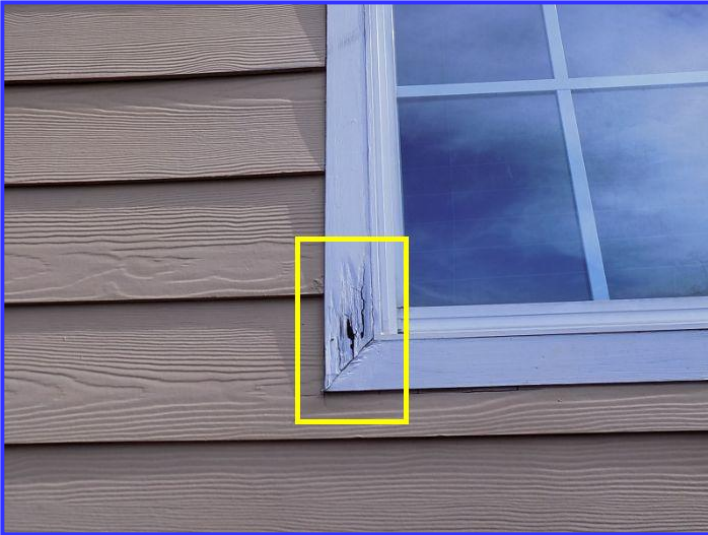
Damaged window framing at right side

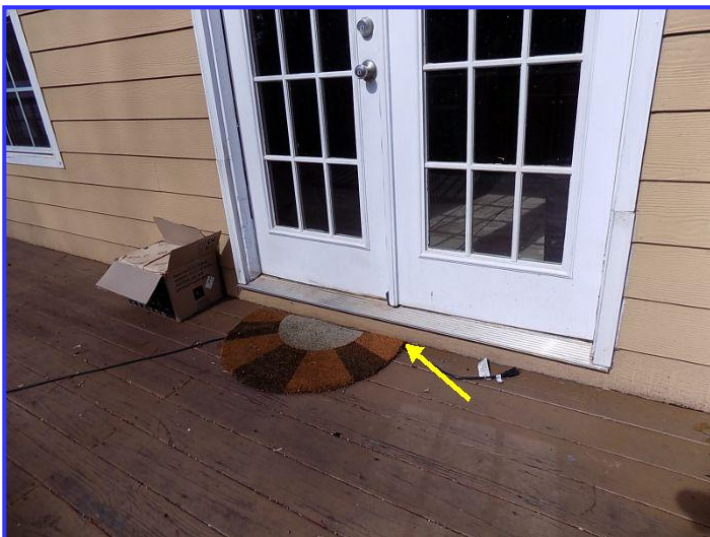
Suggested to install blocking under the threshold at exterior doors.

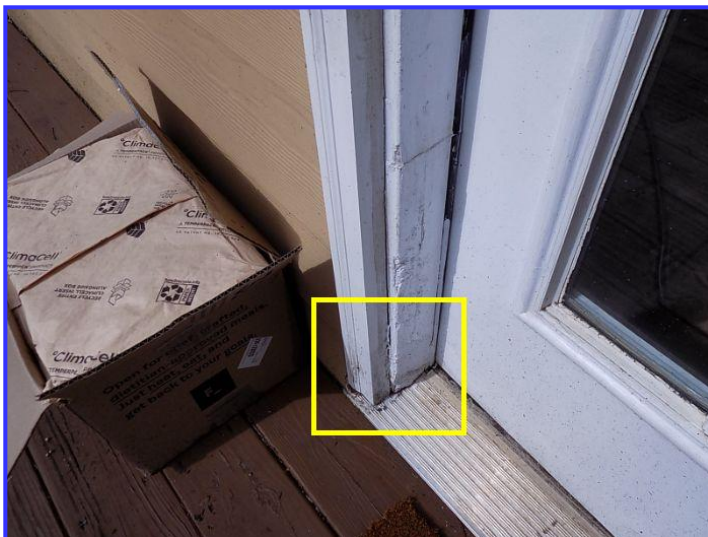
6.5. Door frame/trim damage on exterior door. There may be additional damage that is not fully visible or noted (i.e Subfloor or Threshold). Recommend a qualified contractor review to improve, repair or replace all damages & any materials subsequently damaged due to these conditions. See photos for examples

Damaged wood trim at the rear door

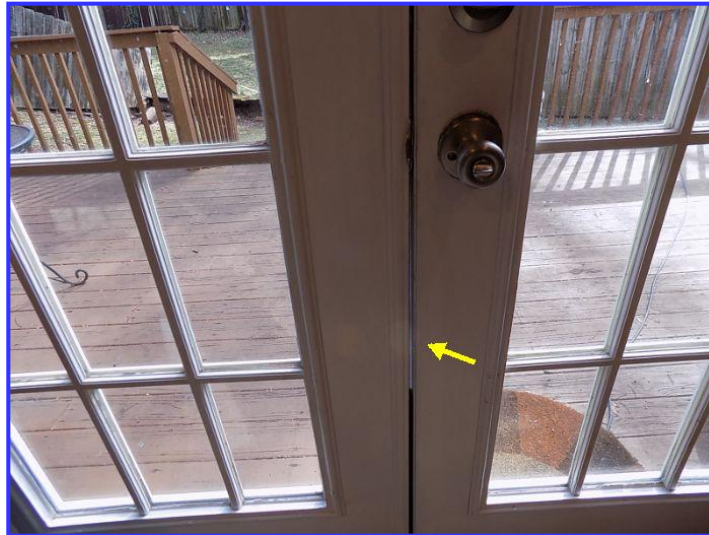
6.4. Damaged weatherstripping noted at one or more exterior doors around the home. Any damaged weatherstripping should be replaced to ensure proper seal and insulation. See photograph(s) for specific locations.

Gap at weatherstripping at rear door

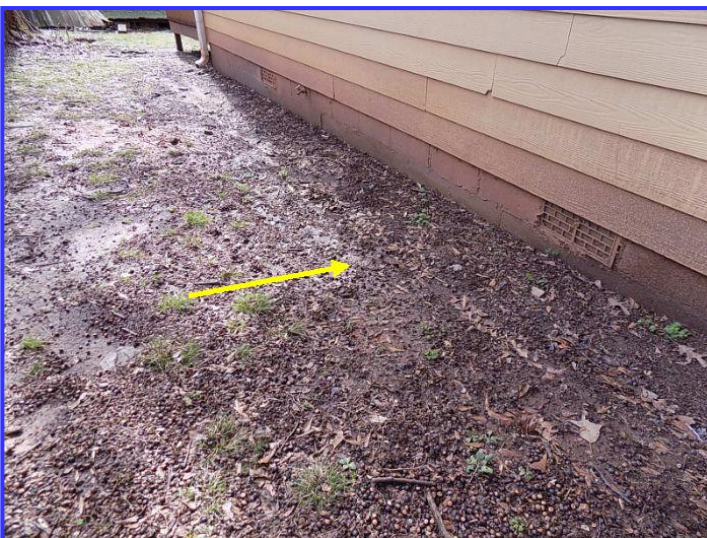
7.1. The soil outside of the house appears to be incorrectly sloped and should be repaired. It is recommended that a landscape contractor make a further evaluation and correct to prevent water from collecting against the foundation walls to prevent possible water entry.

Poor slope at the left side

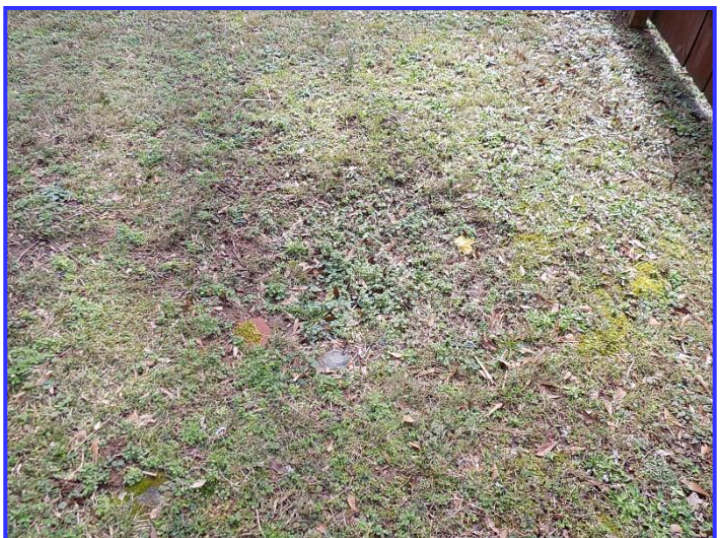
Hole in rear yard

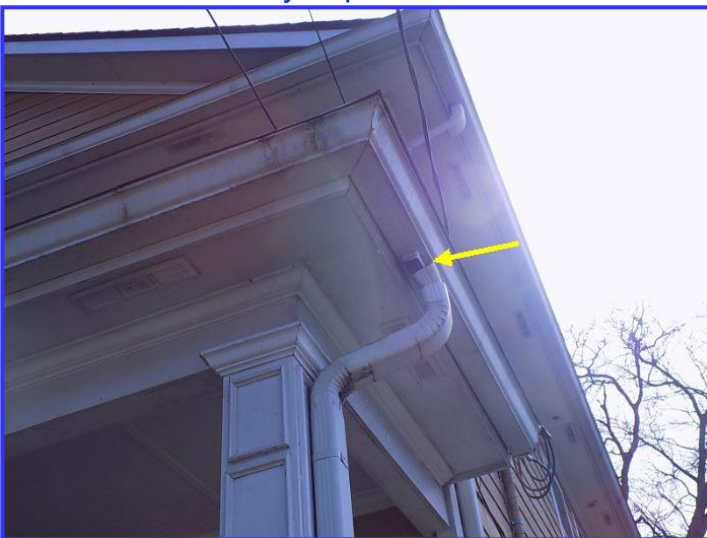
8.3. Disconnected downspout noted at right. Recommend re securing as needed by a qualified contractor.

Disconnected gutter at front right

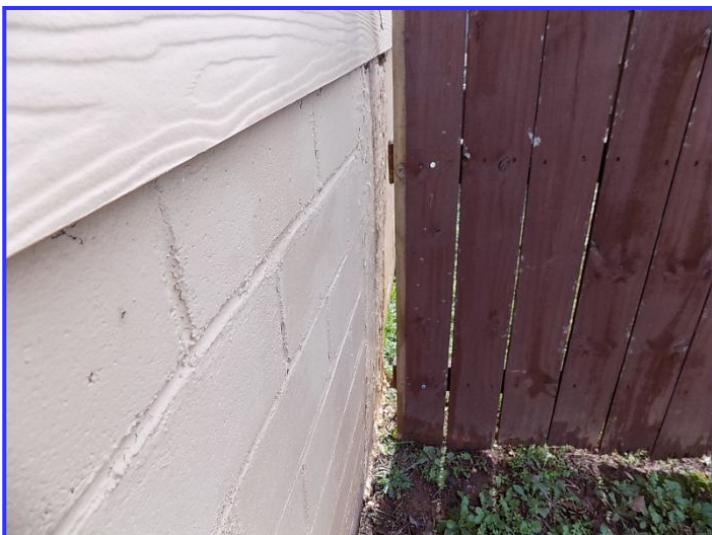
10.2. Uneven area of foundation at right side. Cracking noted on other side in crawlspace. Recommend sealing crack in crawlspace and monitor/repair as needed by a qualified foundation contractor.

Bulge at foundation section at right side

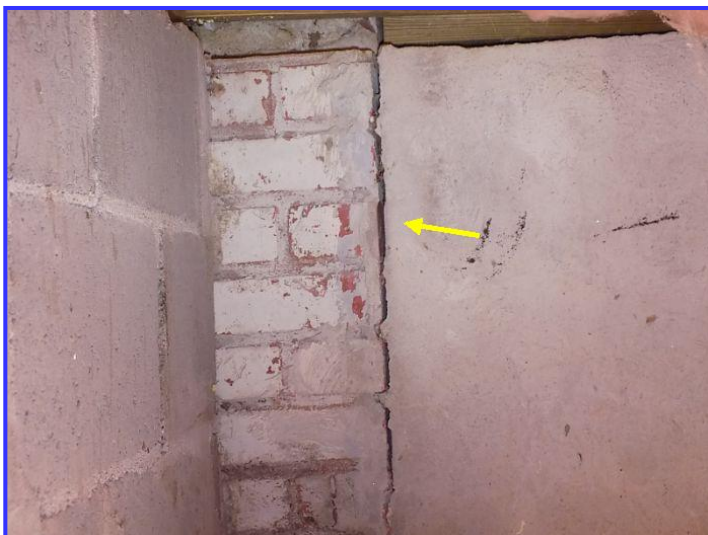
Crack at right wall at brick pier

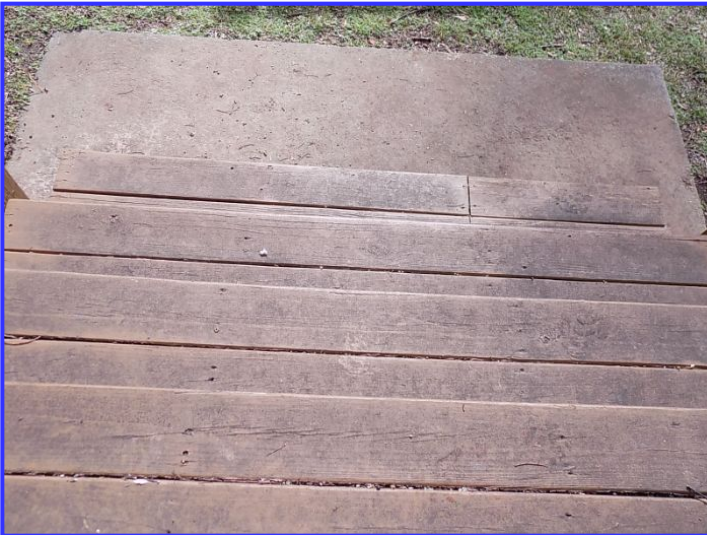
11.1. Loose stair tread noted at exterior steps. Suggest to secure as needed for safety. See photograph(s) for specific locations.

Loose stair treads at rear stairs

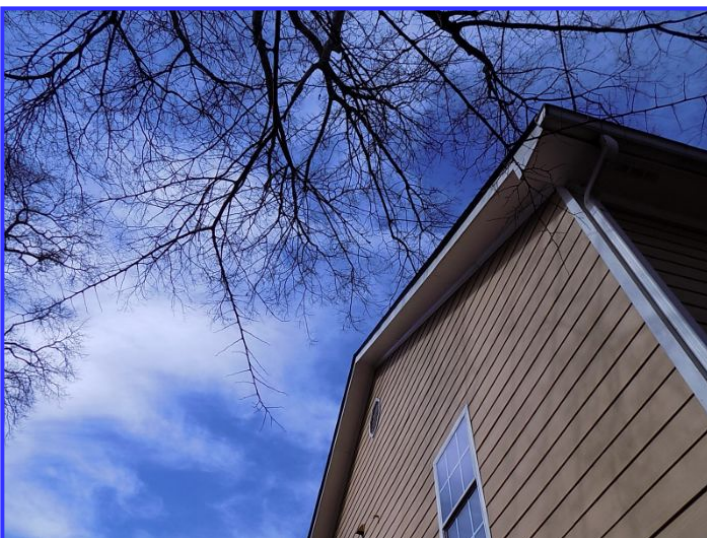
Keep tree limbs cut away from roof line around the home

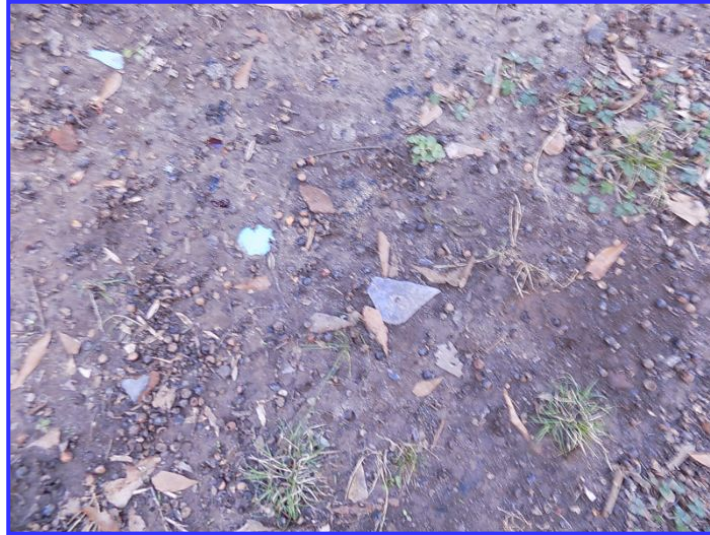
12.3. Broken glass noted at side yard. Recommend removal for safety.

Broken glass at left side yard

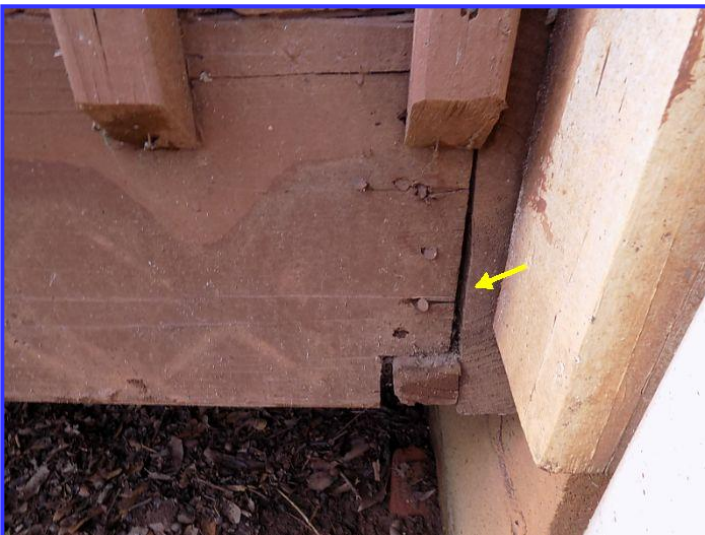
1.2. There were multiple issues noted with the deck on the home. It is suggested to have the entire deck reviewed and all repairs made by a licensed decking contractor. See photographs for example issues and locations.

Separation at band at rear deck

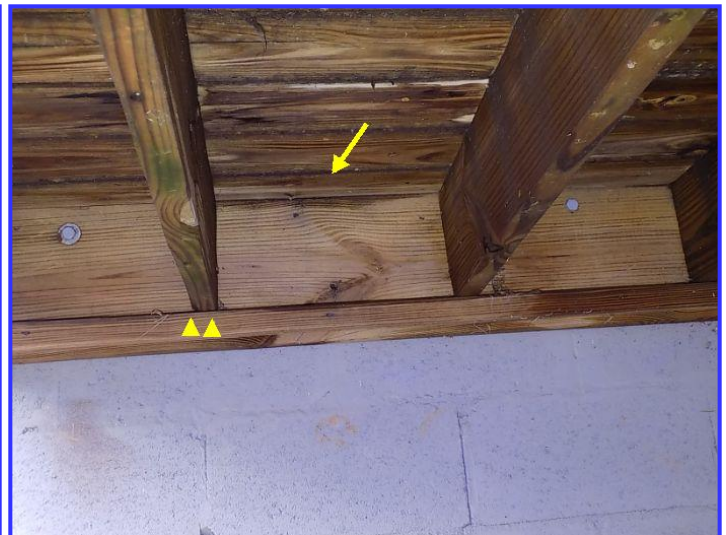
No flashing between deck and home, 3 nails needed

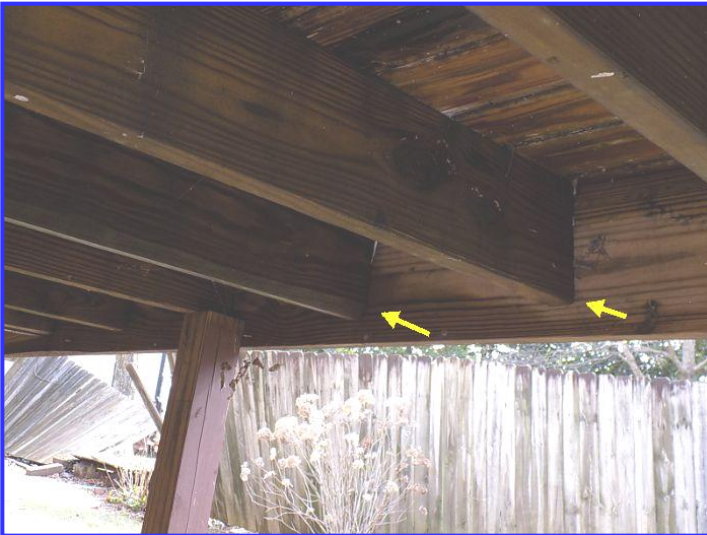
Recommend joist hangers at rear deck

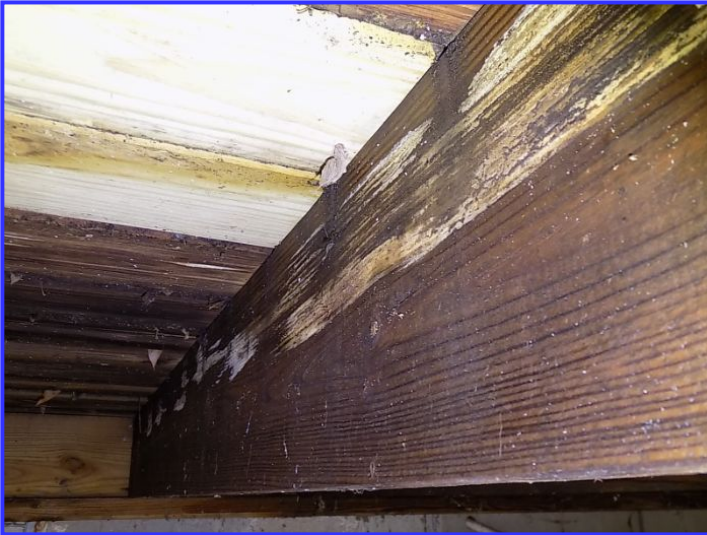
Wood rot at multiple deck joists

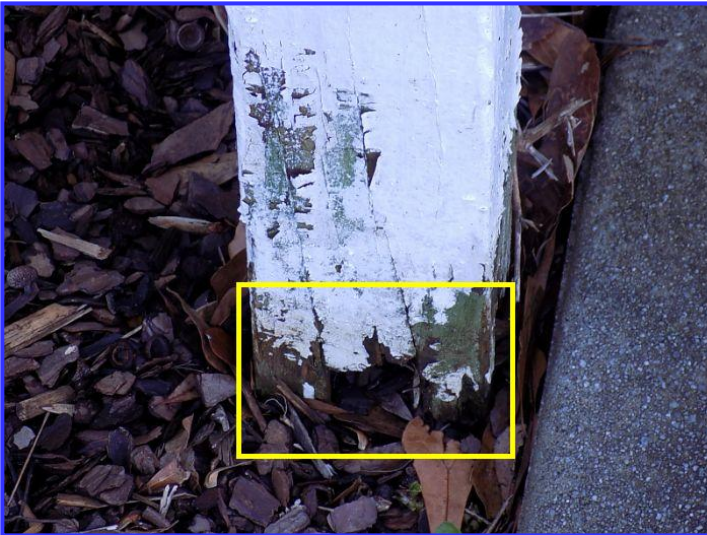
2.1. Wood rot at front porch support and post. Recommend review and repair by a qualified contractor as needed.

Wood rot at support at front porch

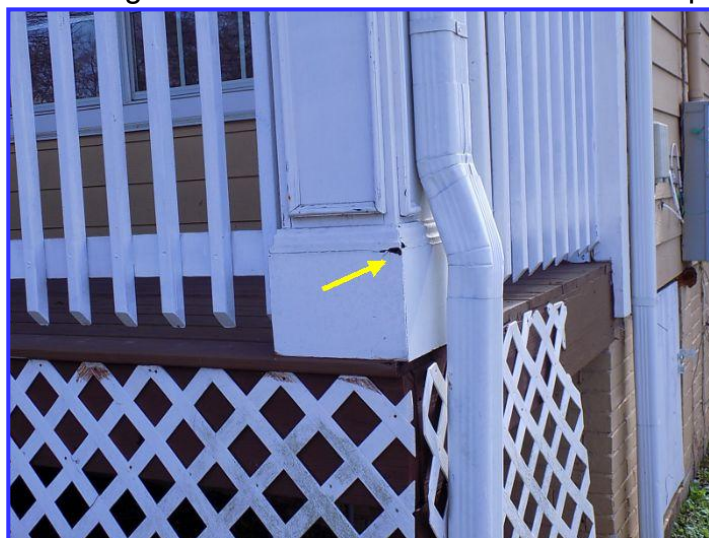
Damaged support post at front porch

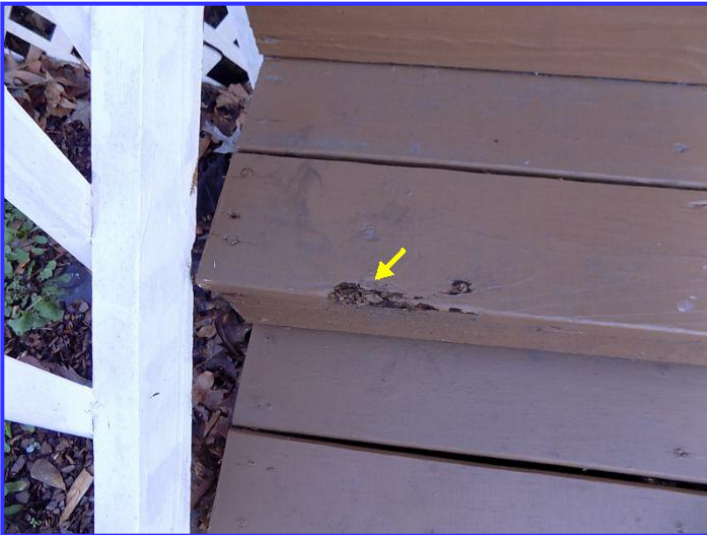
Damaged tread at front porch stairs

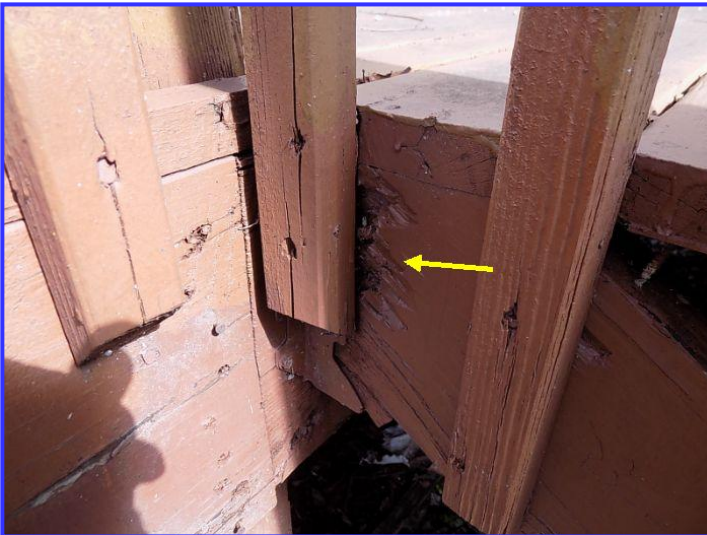
3.1. Stair stringer rot and damaged treads at rear deck. Recommend review and repair by a qualified deck contractor.

Stringer rot at rear deck

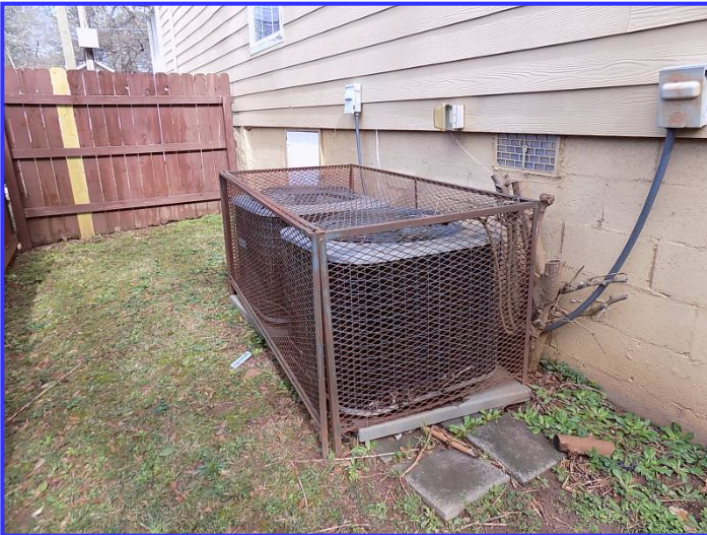
1.3. Unable to view AC data tag due to cage around AC. Corresponding unit inside is dated 2012. Recommend conferring with seller/disclosure about age and service as needed.

AC Unit(s) at right

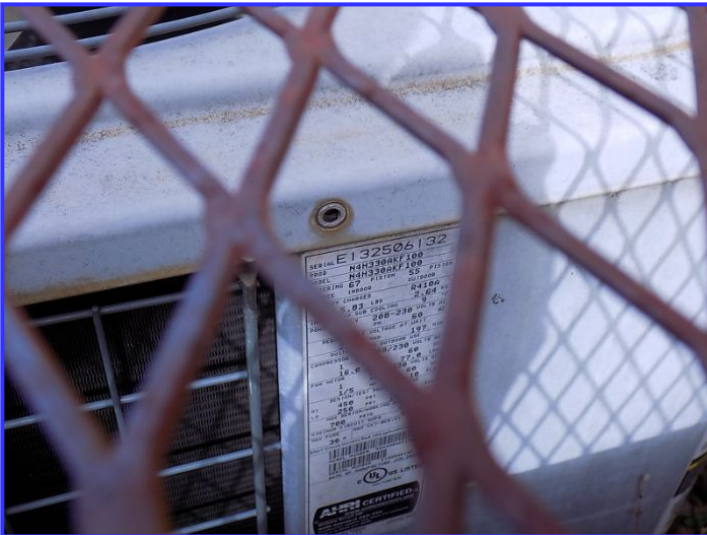
1.2. The AC could not be tested at the time of inspection, due to outside temperatures. However, the unit is at or surpassed its expected life, it is suggested to have the entire HVAC system reviewed and repaired by a licensed HVAC technician as needed. A complete service is recommended to ensure proper function and to prolong the remaining life. We make no guarantees as to the remaining life expectancy of the HVAC system.

2013 Comfort maker at rear

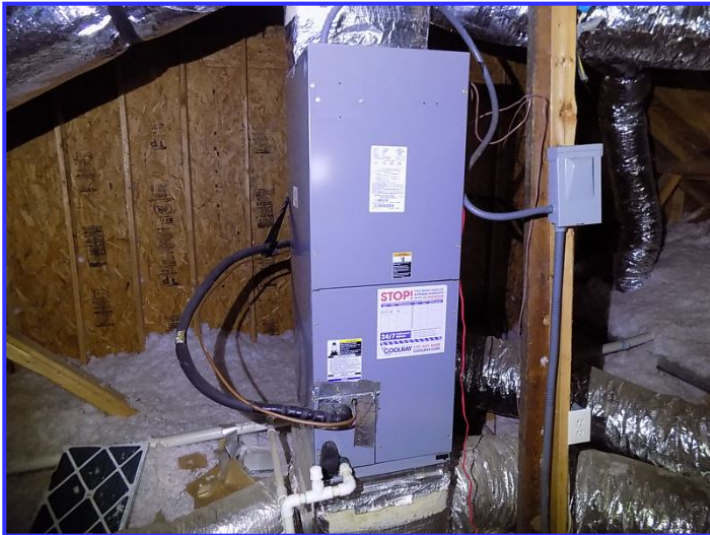
- 3.1. Appears functional but should be serviced due to age

Furnace in Attic

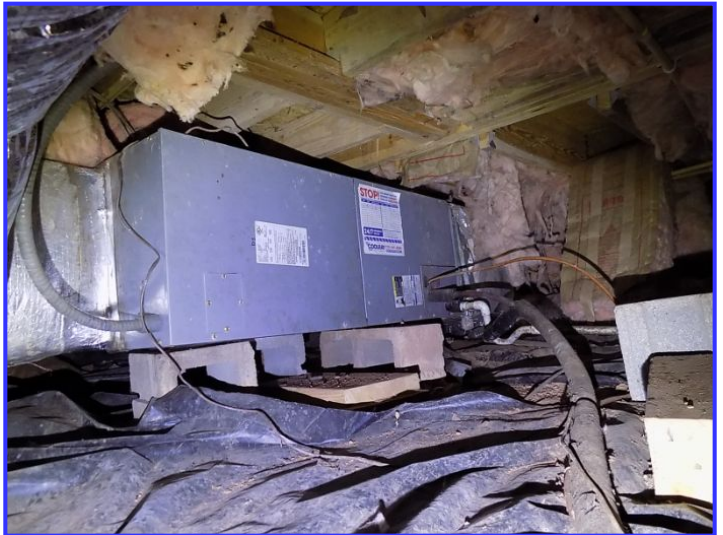
Furnace in crawlspace

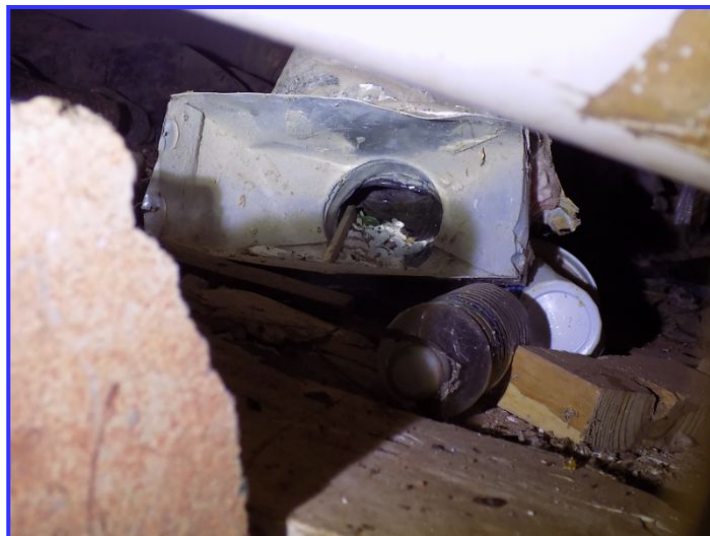
8.2. Loose duct in crawlspace. Limited view due to low clearance. This duct could be abandoned but limited view. Recommend monitoring airflow at this side of house (left side) and repair as needed.

Disconnected duct at left wall

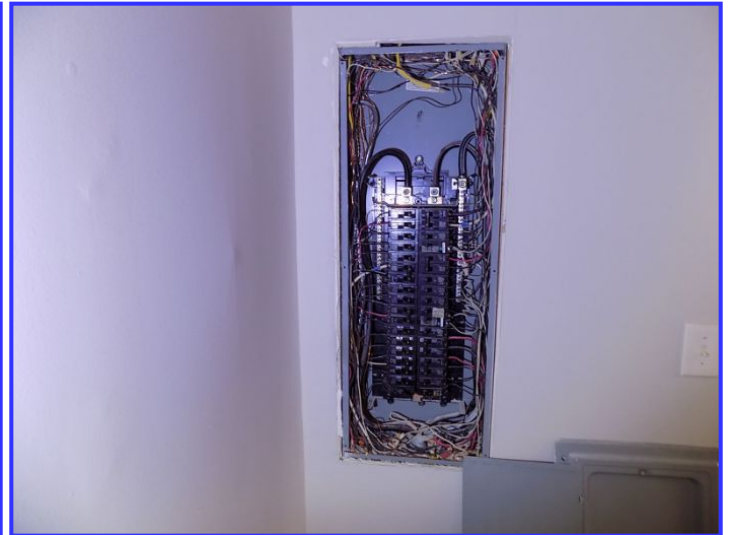
Interior wiring at main panel

3.2. Different brand names on panel and breakers. Improper breaker-panel matching can cause arcing and overheating in the panel as well a potentially void the panels warranty. We recommend a licensed electrician install new breakers in panel.

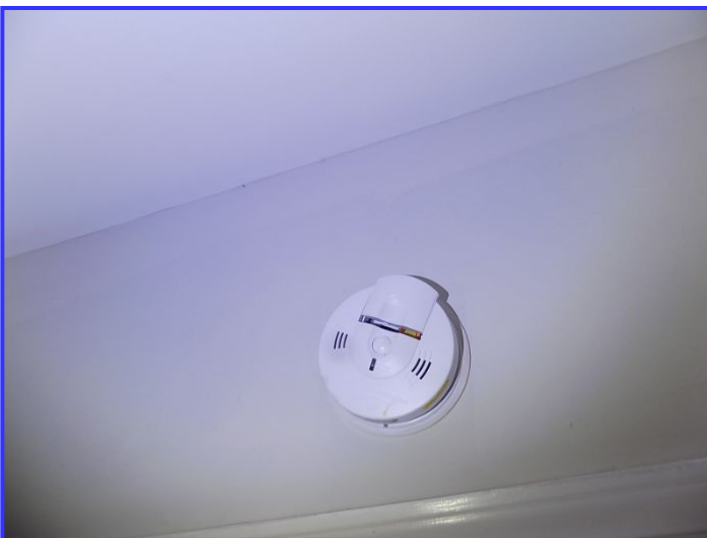
5.3. One or more smoke detectors were noted with missing batteries. Batteries should be installed for safety and proper function. See photographs for locations and details. All smoke detectors should be properly functioning.

Missing battery at smoke detector in kitchen

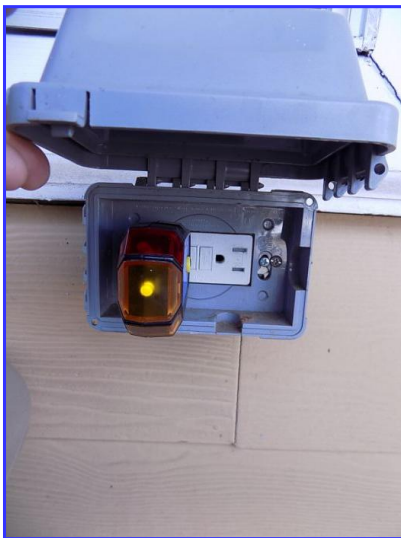
6.1. The **GFCI** outlet at the front did not trip and outlet at right would not re set when tested and should be replaced. Have a licensed electrician correct. Exterior outlets may fail over time and should be repaired as needed.

GFCI will not trip when tested at front

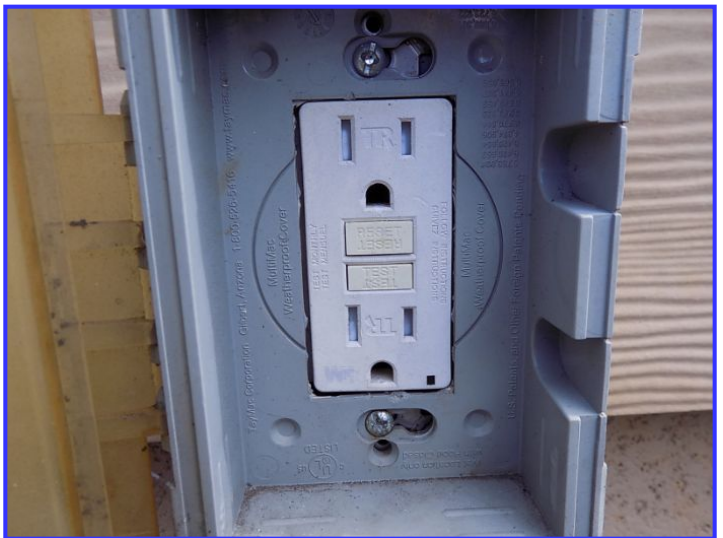
GFCI will not trip when re set at right

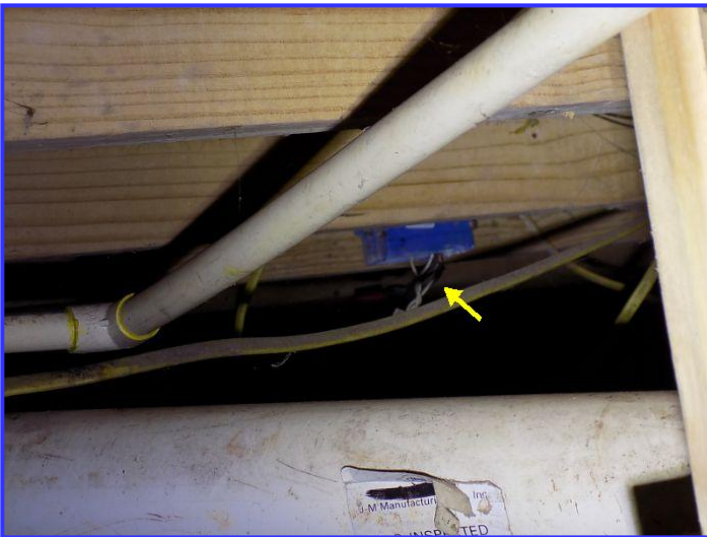
6.2. Open junction boxes were observed in the crawl space. Whenever an electric wire is cut and reconnected, the splice should be encased in a covered junction box to prevent shocks and separation of the splice.

Open junction box in crawlspace

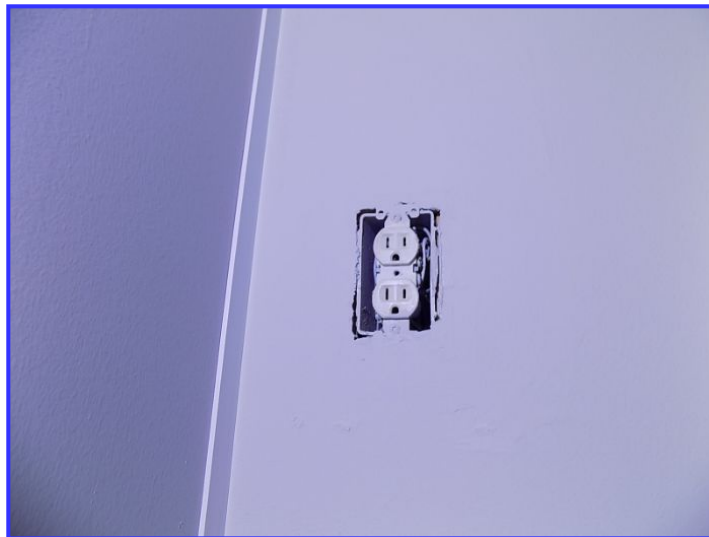
8.1. Missing cover plates observed at one or more interior receptacles throughout the home. Suggest installing cover plates for safety.

Missing cover plate at unit 3

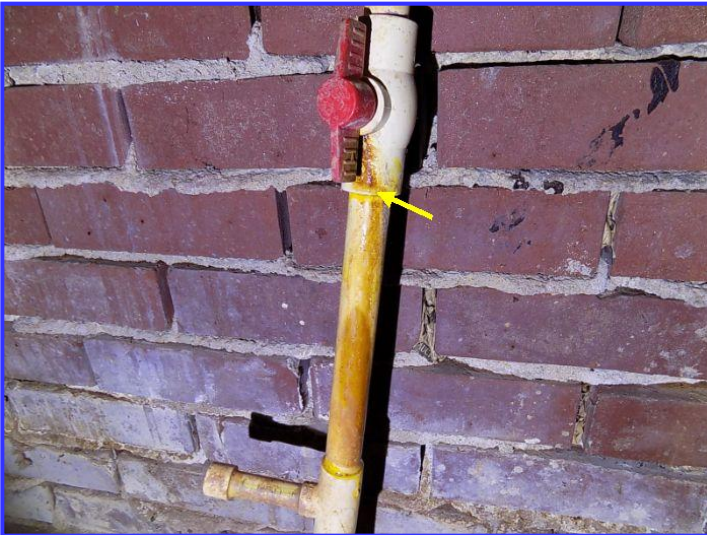
1.3. Leak at main water valve. Recommend review and repair by a qualified plumber as needed.

Leak noted at main water shutoff

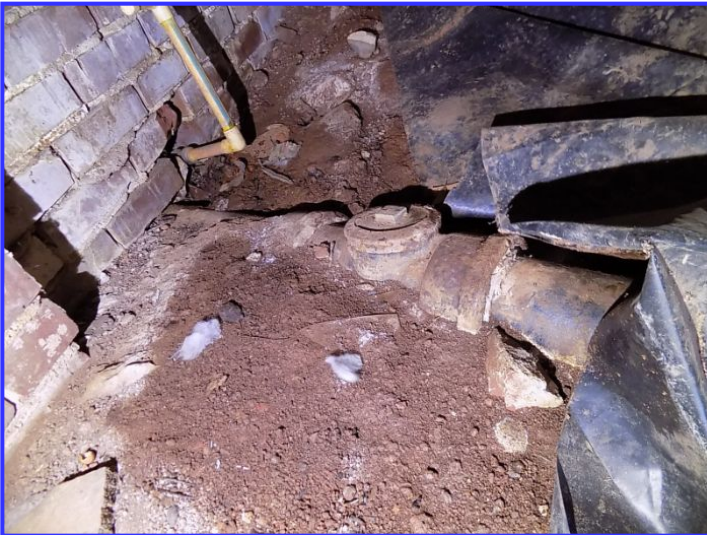
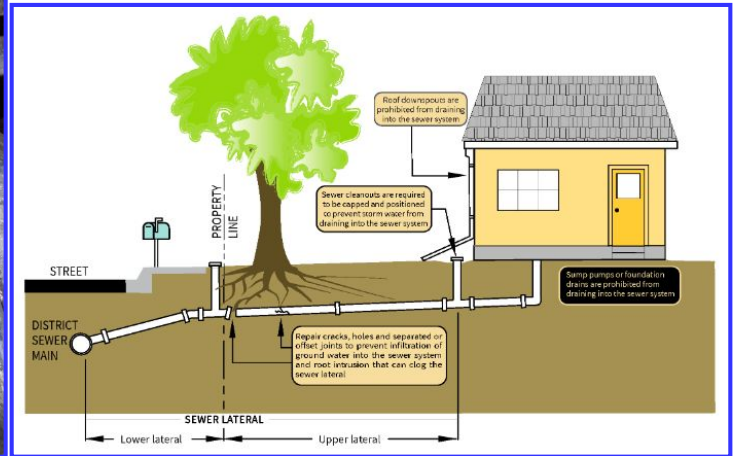
2.2. All or some of the waste water pipes in the home are cast iron or black steel. These were common in homes this age. The pipe will tend to rust along the bottom of the pipes if not properly sloped and have a life expectancy of 50-75 years. The pipes rust from the interior of the pipe and are only visually inspected from the exterior at the time of the inspection.

Cast iron/Black steel waste lines noted

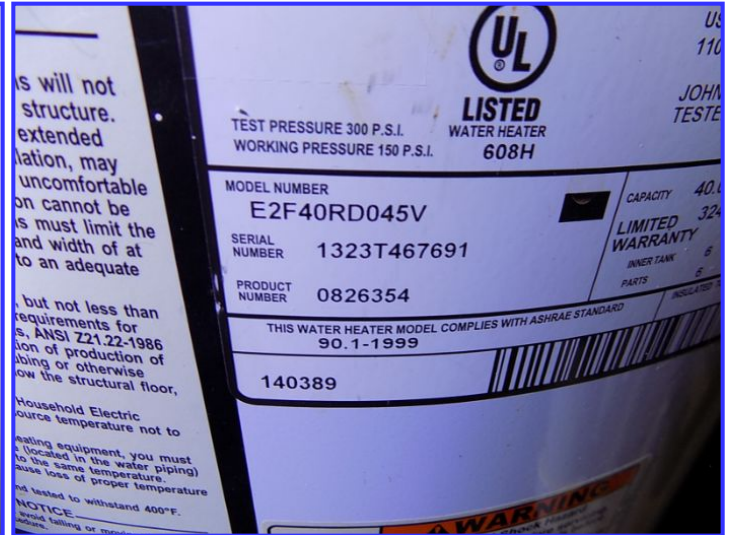
3.2. The water heater has surpassed or is near the end of the expected service life, and will likely need to be replaced in the future. However, it is functioning at the time of the inspection. We offer warranty as to the expected remaining service life of the unit. Suggested to have water heater reviewed and serviced as needed to prolong the remaining life of the unit.

2013 Whirlpool electric unit

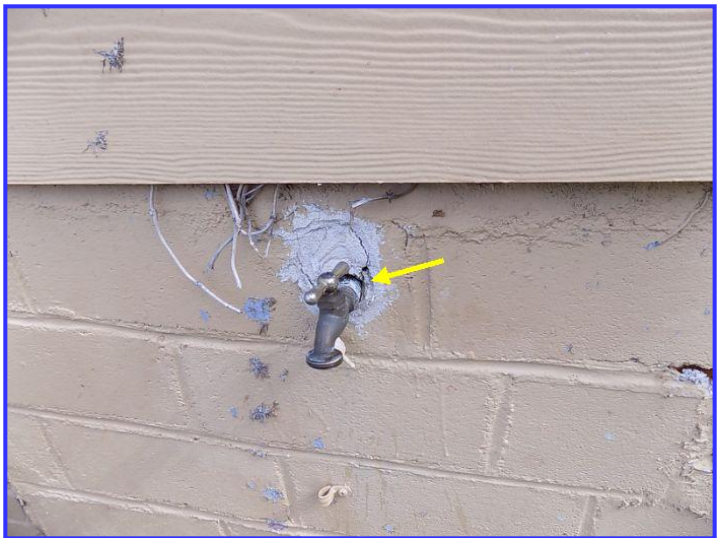
6.1. Recommend sealing at hose bibs around home as standard maintenance to prevent water intrusion as needed.

Seal around exterior hose bibs

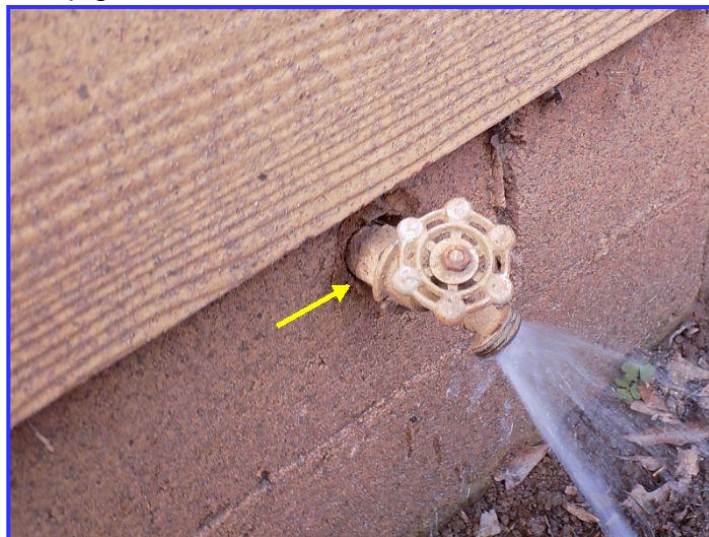
Seal around exterior hose bibs

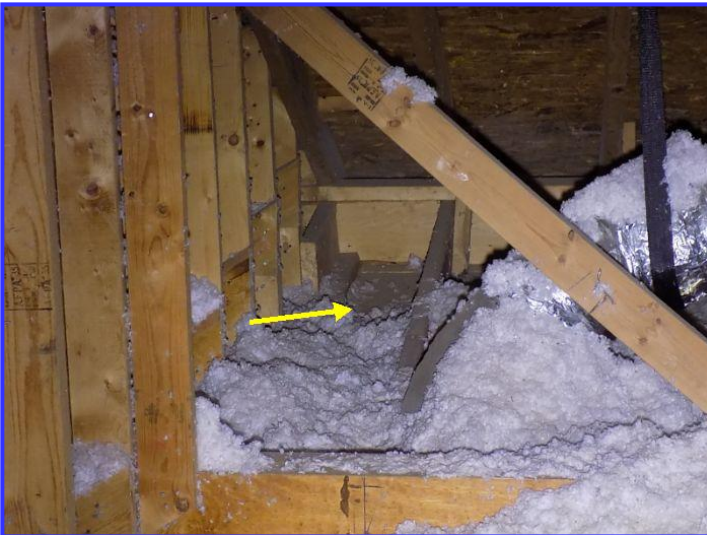
4.1. The blown insulation is thin in several areas. Recommend adding additional insulation to current minimum R-30 rating.

Thin or missing area of insulation in attic

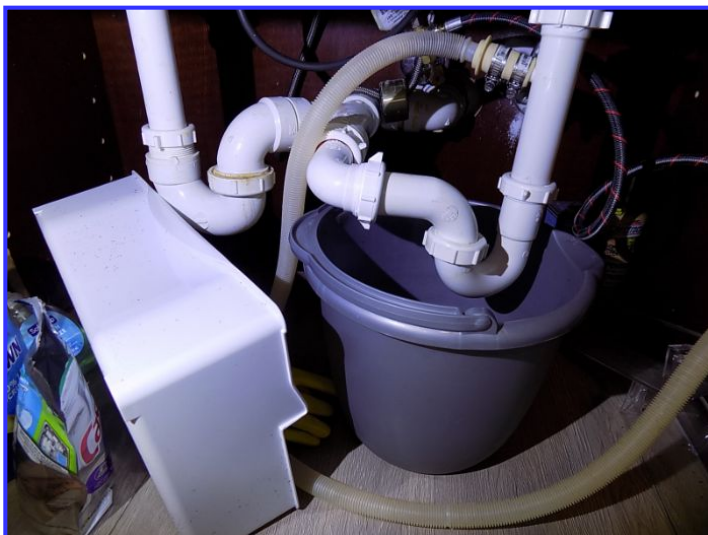
3.2. Bucket under trap in kitchen could indicate problems with leaking. No leaks noted at time of inspection. Recommend monitoring and repairing as needed by a qualified plumber.

Bucket under kitchen sink, no leaks noted

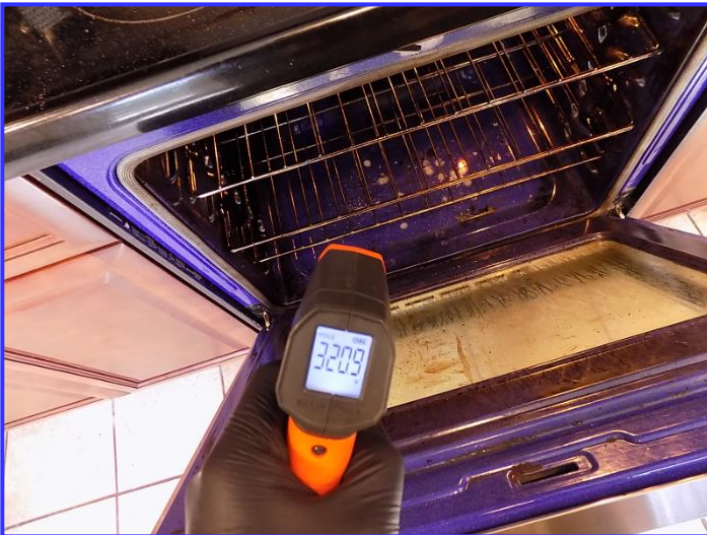
Operational oven

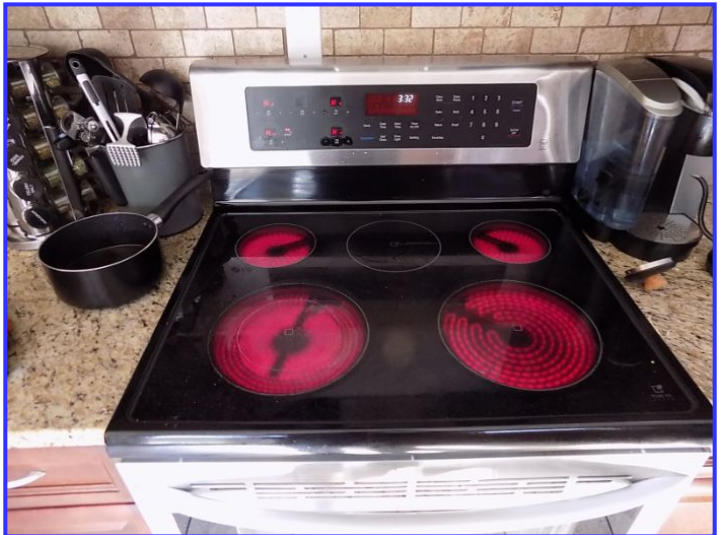
4.2. There is no anti tip bracket installed at the stove as required. This is a safety hazard for children who could stand on the oven door and tip the stove over. Have installed as needed.

No anti tip bracket installed at stove

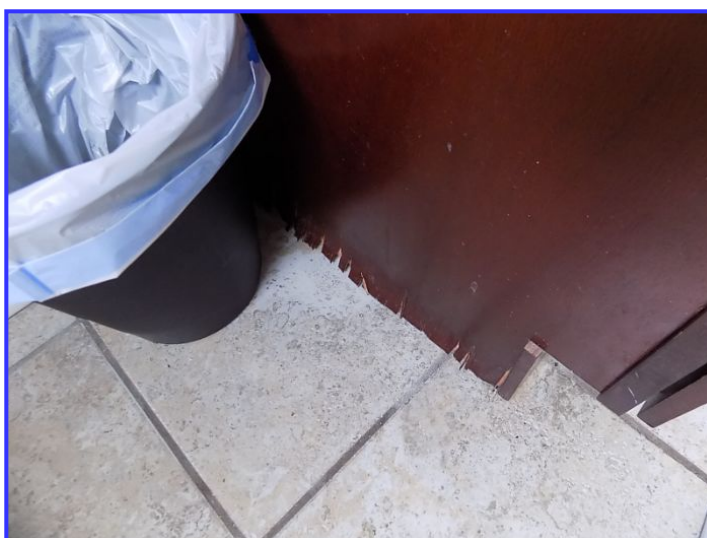
3.1. Damaged vanity noted. Recommend review and repair by a qualified contractor as needed.

Damaged vanity at upstairs hall bath

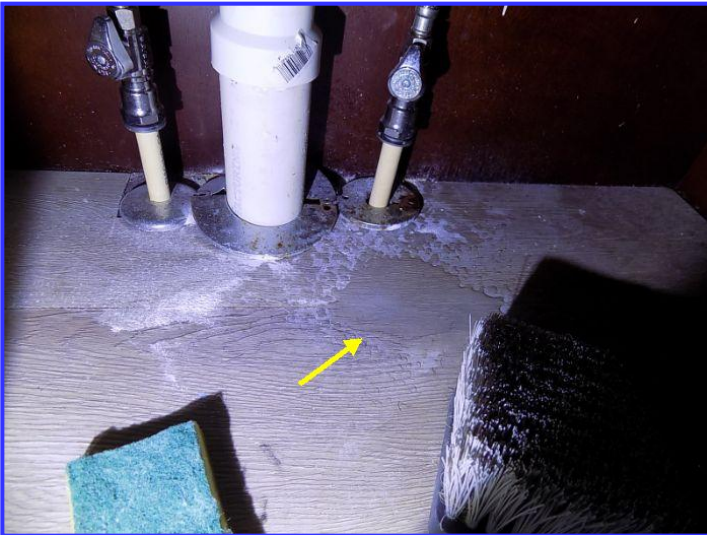
4.4. Leaking noted beneath one or more bathroom sink(s). See photographs for locations and details. Recommend review and repair by a qualified plumber as needed.

Leak at drain under sink in the upstairs hall bath

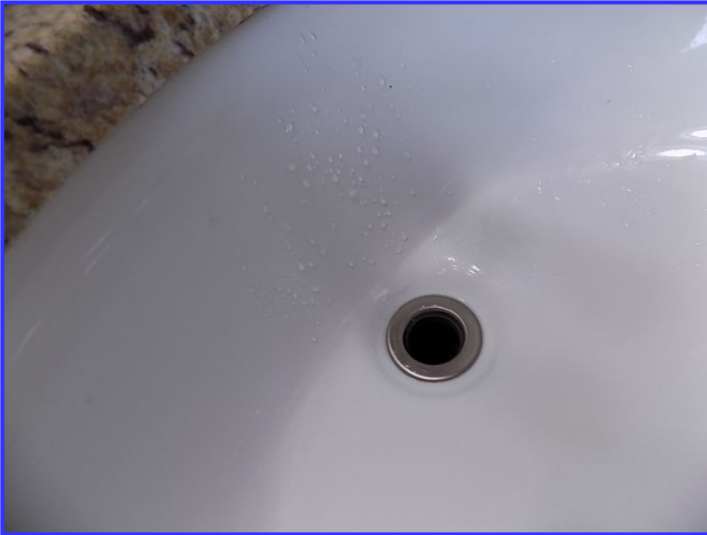
4.3. The drain stopper(s) was not functional/missing when tested. Have repaired or replaced as needed. See photographs for locations and details.

Non functioning drain stopper noted at the upstairs hall bath

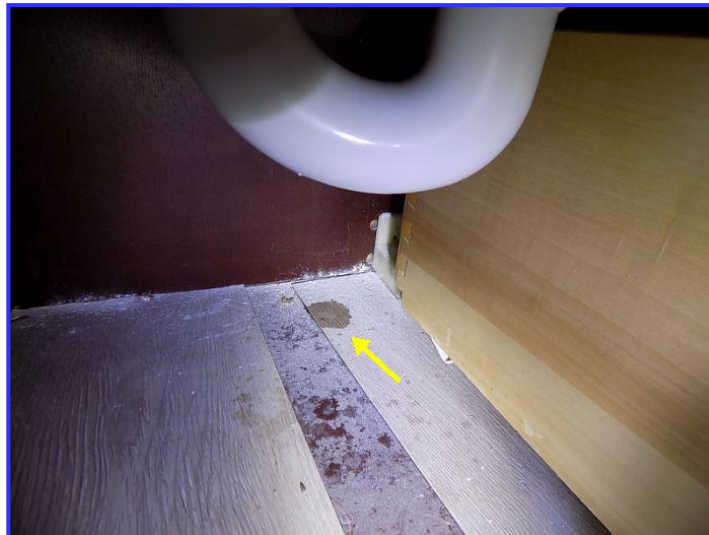
Leak at drain under sink in the main level guest bath
