All Atlanta Inspection Services

Inspection Report

2483 Memorial Dr SE, Atlanta , GA 30317
Inspection prepared for: Joey Gumataotao
Date of Inspection: 2/9/2025 Time: 2 pm
Age of Home: 88 years old Size: 2886 SF
Weather: Clear 58 degrees

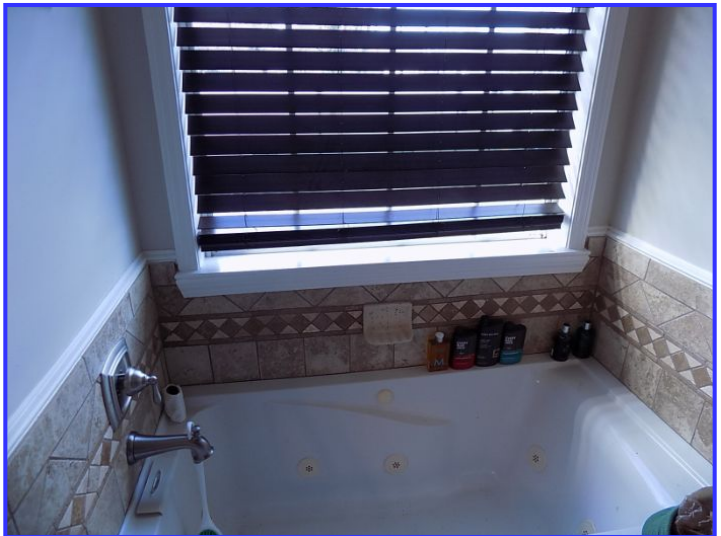
No safety glass over master bath tub

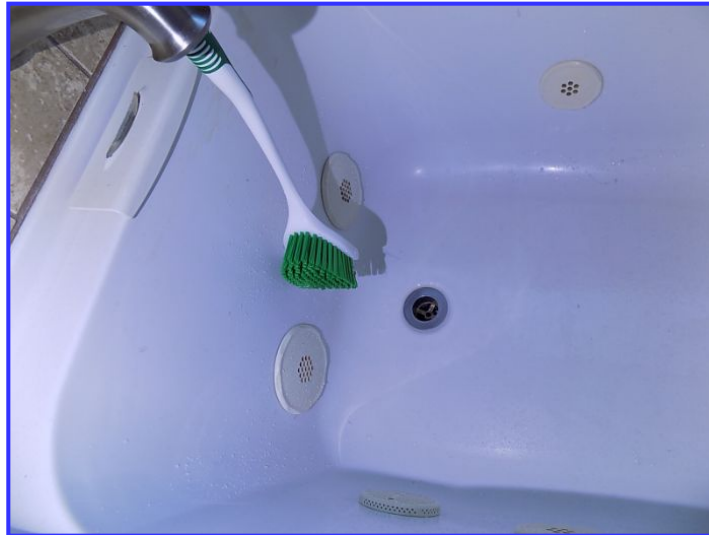
6.3. The drain stopper is missing/does not seal fully and the tub cannot be filled for testing. Have repaired as needed.

Missing plug at master bath, unable to test jets

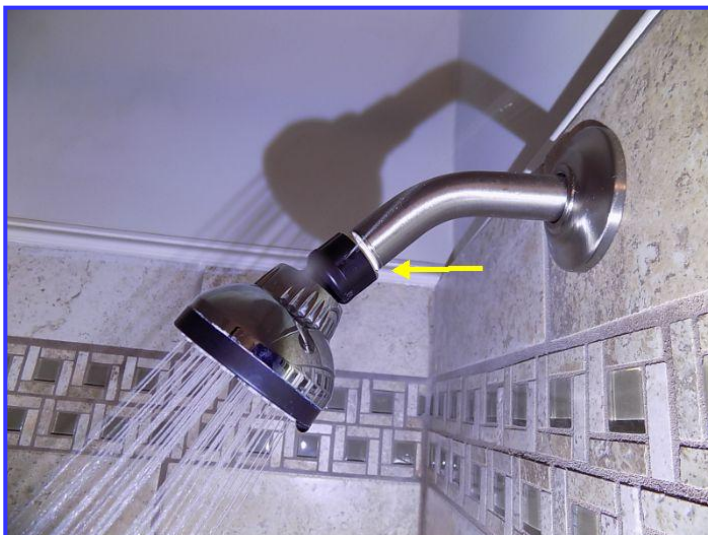
Leak at main level guest bath shower

9.1. Repair the leak at the bathroom shower heads as needed.

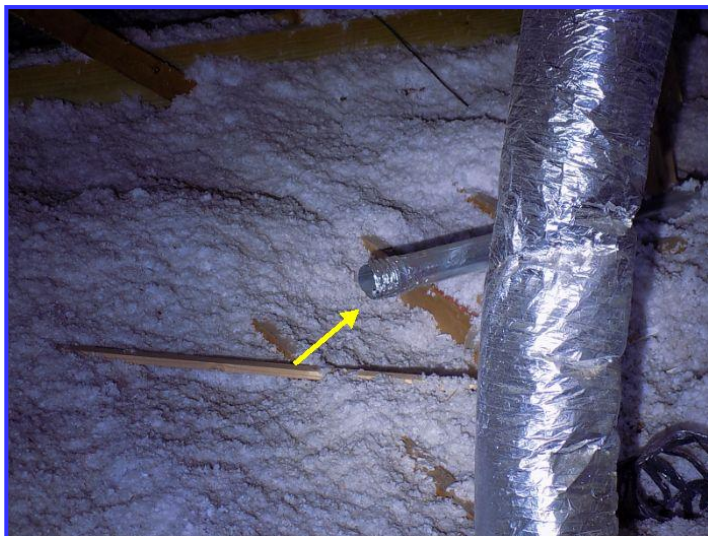
10.3. The duct from the bath vent needs to be extended to discharge to the exterior of the home and not into the attic area, this can cause a buildup of moisture and mold in the attic. All house vents should be directed to the exterior, A qualified contractor should repair as needed.

Bathroom fans noted discharging in the attic space

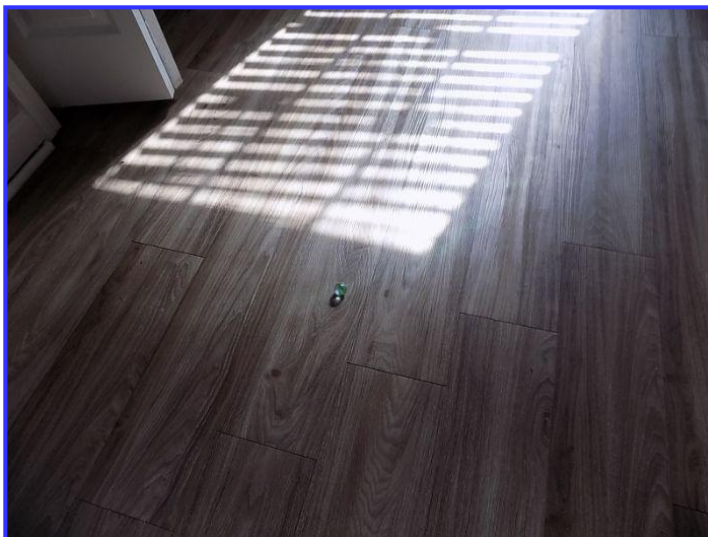
1.2. Unevenness is noted in the sub flooring around the main floor. This appears to be consistent the age and wood framed construction of the home, although not all framing members are visible at the time of inspection. This should be repaired and leveled if the finished flooring is replaced. If further review is desired, it is suggested to consult with a licensed contractor for review.

Uneven flooring at upstairs foyer

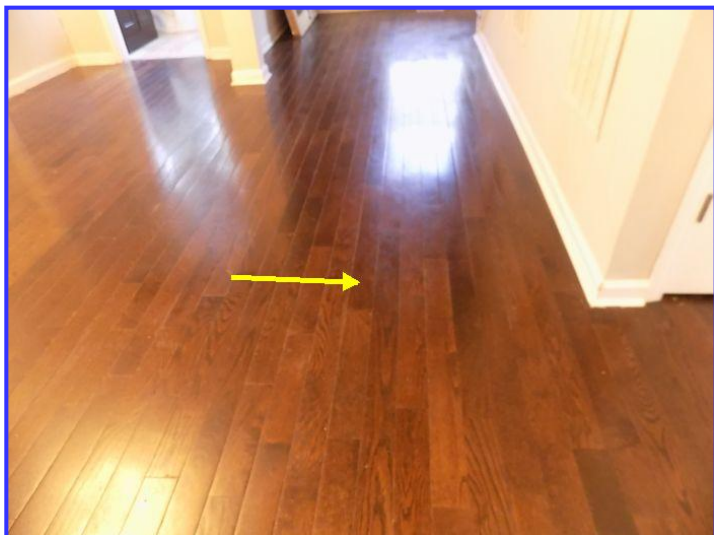
Low spot in floor at main foyer

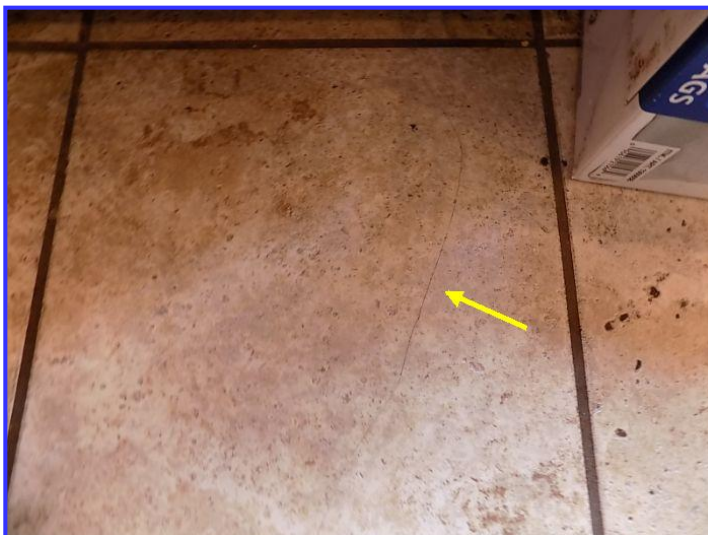
1.1. Cracked tiles noted at one or more locations inside the home. This could be from mechanical damage or improper installation. Suggested to have any cracked or damaged tiles repaired/replaced by a licensed flooring contractor as needed. See photographs for examples and locations.

Cracked tiles at kitchen

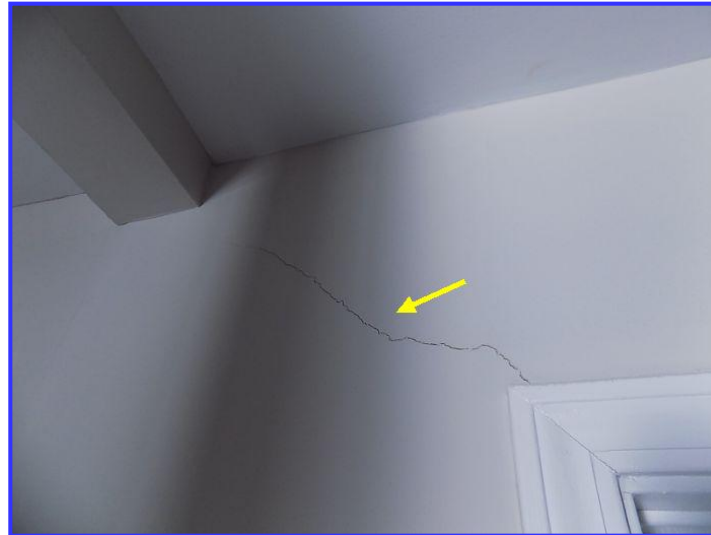
2.2. One or more settlement cracks were noted in the home. Have the cracks spackled and repaired and monitor this area for any continued movement. See photographs for locations.

Settlement crack at upstairs foyer

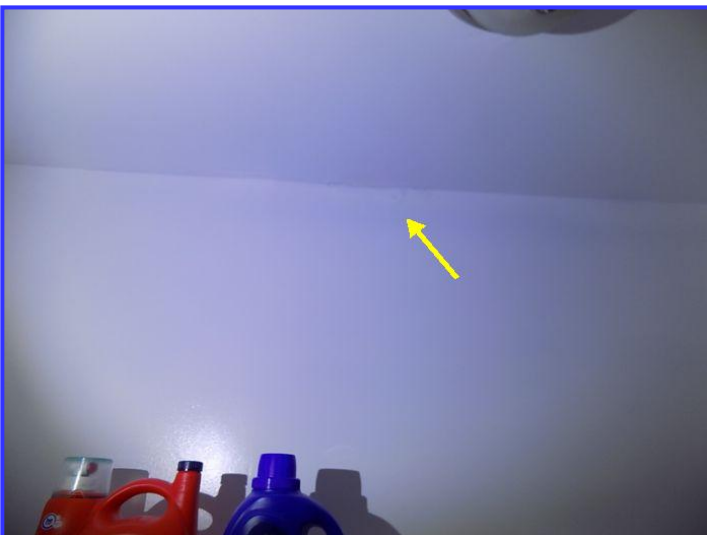
3.2. Evidence of patching observed. There were no visible leaks noted at the time of inspection. At the time of inspection, there was no way to determine the cause of the original damage. Suggest referring to the sellers regarding any prior repairs and monitoring and repairing as needed.

Patching at laundry room

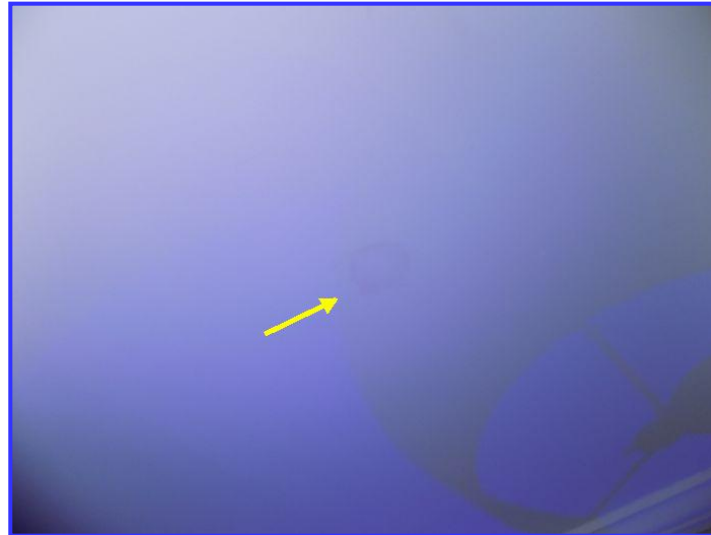
3.3. One or more water stains noted around home. See photographs for locations and details. Unable to determine the source of the water. Have the plumbing or roofing reviewed and repaired if needed. There is the possibility of hidden damage that should be investigated. Any subsequently damaged materials should be repaired as well.

Water stain at unit 2 ceiling

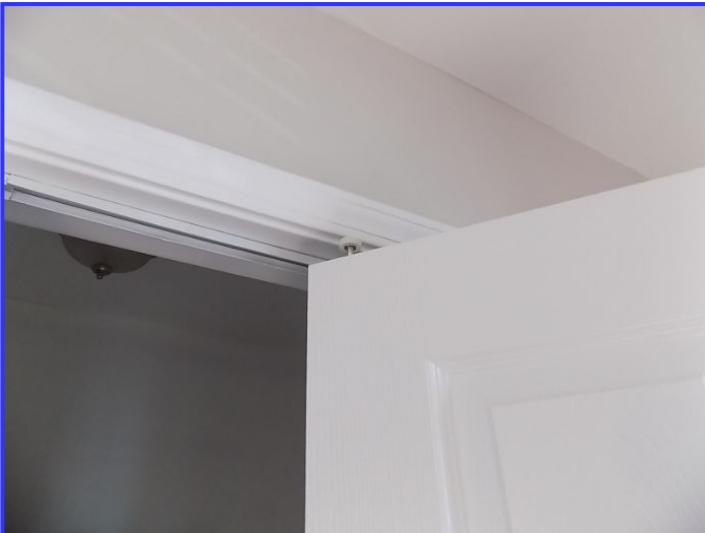
4.1. One or more misaligned doors noted inside the home. It is not uncommon for interior doors to not latch properly or stick on the frame. Typically minor adjustments are all that are needed to correct the situation. See photographs for locations and details.

Misaligned door at laundry room

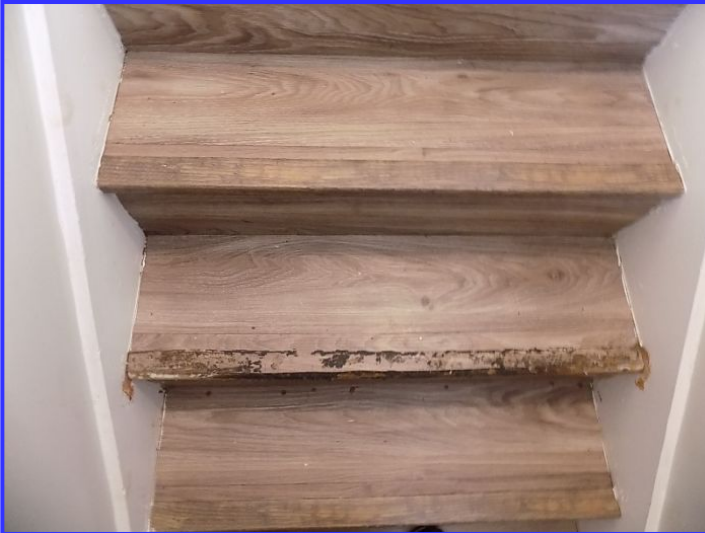
6.2. Damaged stair tread at main stairs. Recommend review and repair by a qualified contractor as needed.

Damage at stars

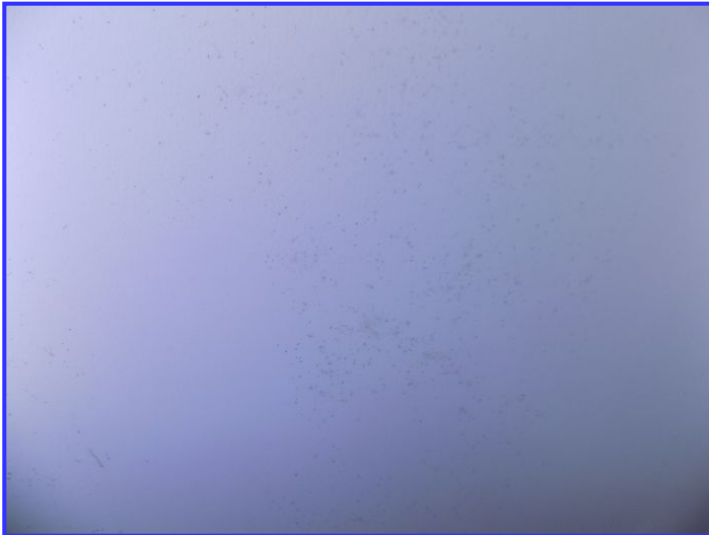
7.6. Possible mold/mildew on ceiling at upstairs hall bath. Recommend professional cleaning with a fungicide as needed.

Possible mold/mildew at upstairs hall bath ceiling

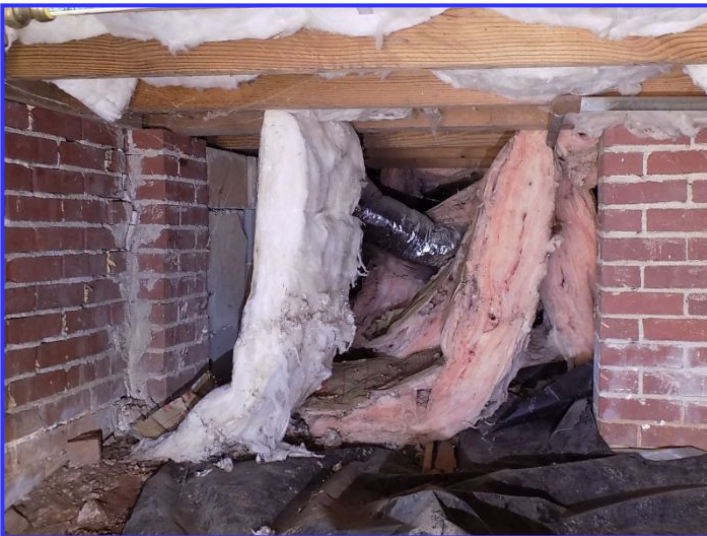
1.1. The crawl space is too low for safe access at areas due to fallen insulation due to rodents. The height is less than 18 inches and there are drains and plumbing running under the home. Inaccessible areas were viewed with strong light from the hatch. Inspection of the crawlspace is limited and areas that cannot be entered are excluded from the inspection report. There are many items in the crawlspace that are not visible and are excluded from the inspection. This includes water lines, drain lines, floor framing, foundation walls, sub flooring, and insulation. Have a proper access installed and the crawlspace fully inspected.

Limited view at front wall due to fallen insulation

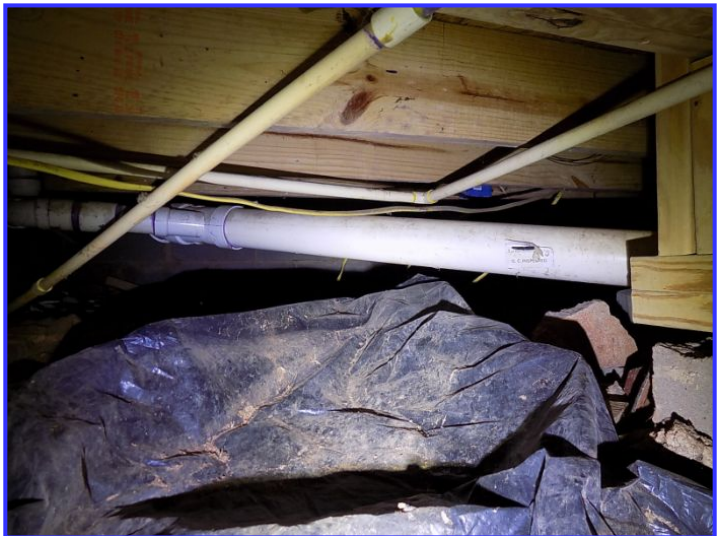
Limited view at left wall

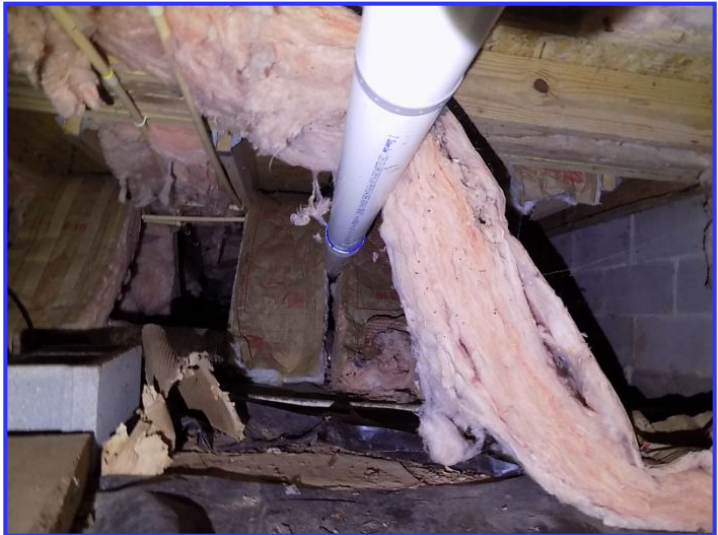
Limited view at rear wall due to fallen insulation

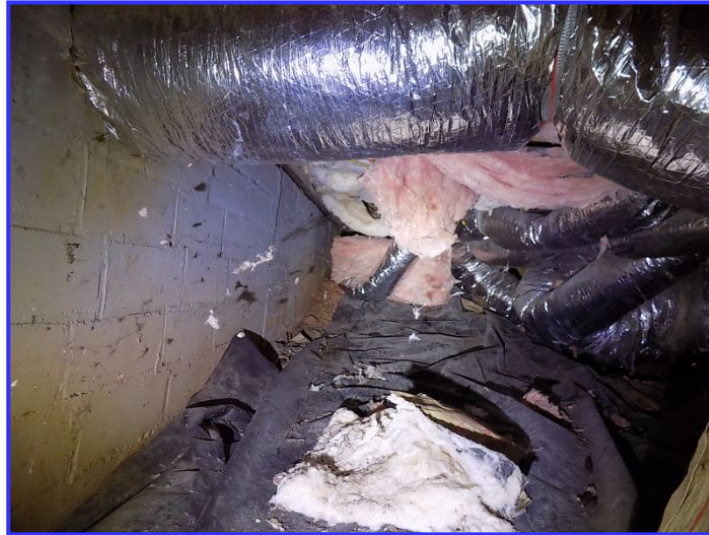
Limited view

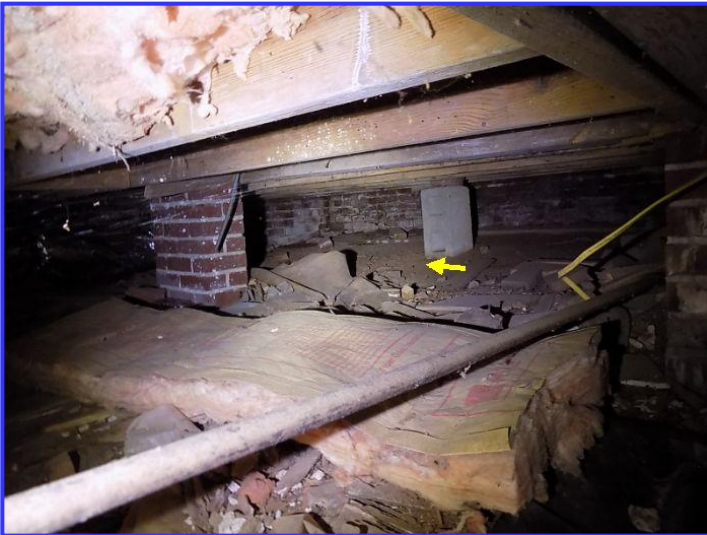
2.1. The vapor barrier is incomplete and many areas of the soil are exposed. Suggest installing a complete vapor barrier.

Gap at vapor barrier at front left wall

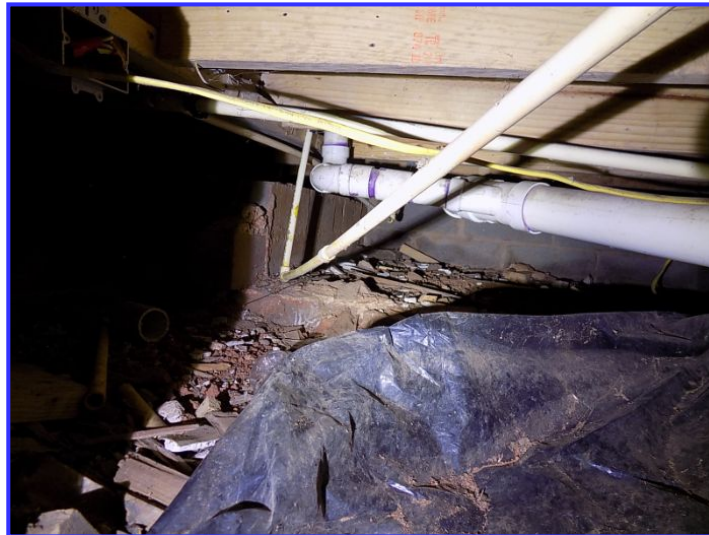
2.2. Remove the wood debris from the dirt floor in the crawl space. Any wood to ground contact is a possible avenue for termite entry.

Debris noted

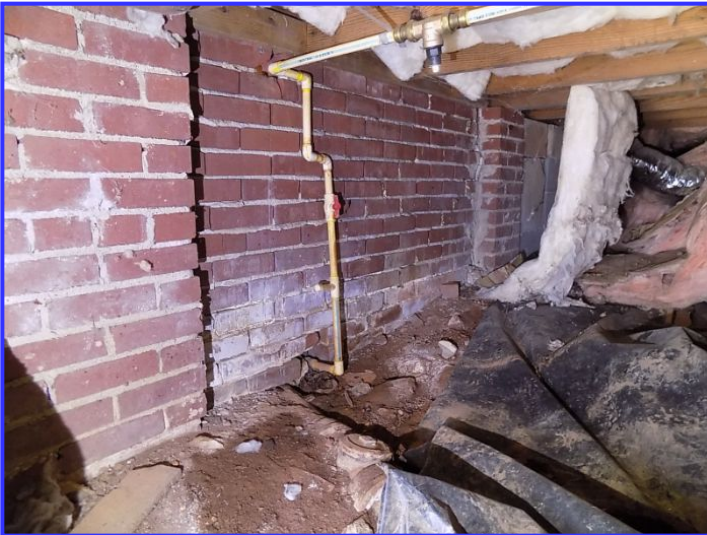
3.2. Efflorescence observed, this is a mineral deposit left behind from exterior water infiltration.

Efflorescence noted

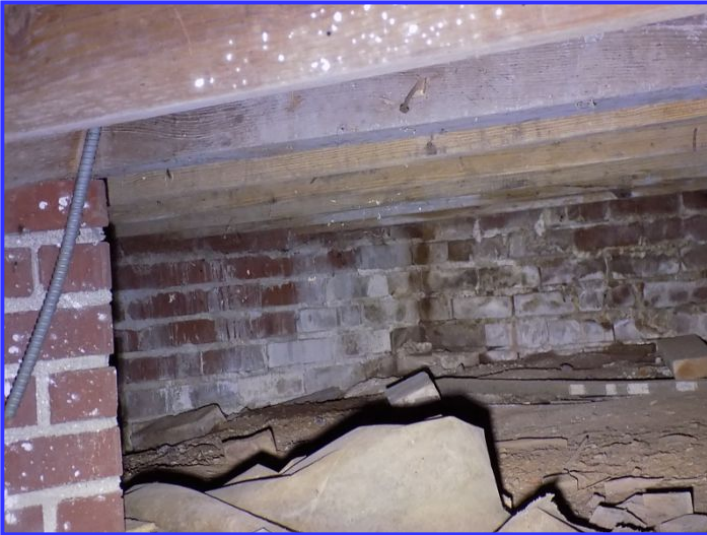
Efflorescence noted

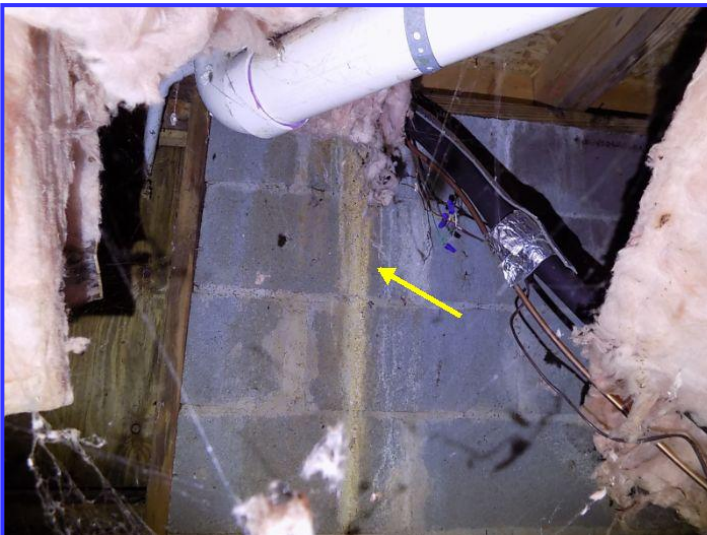
Efflorescence noted at rear wall

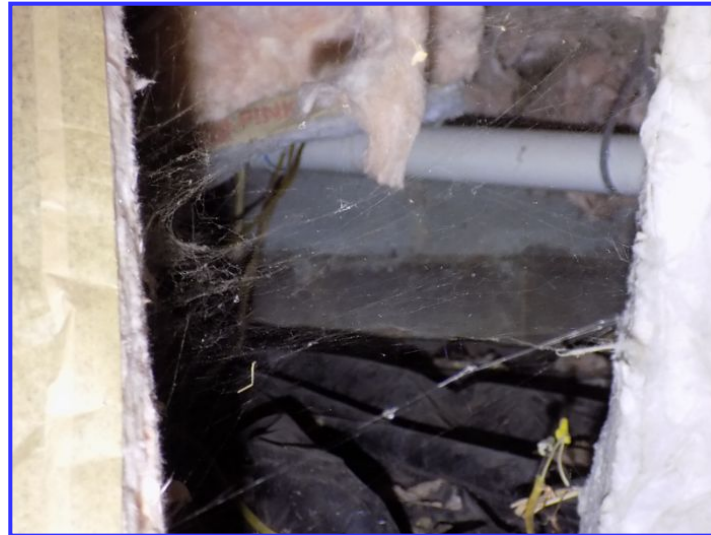
Efflorescence noted

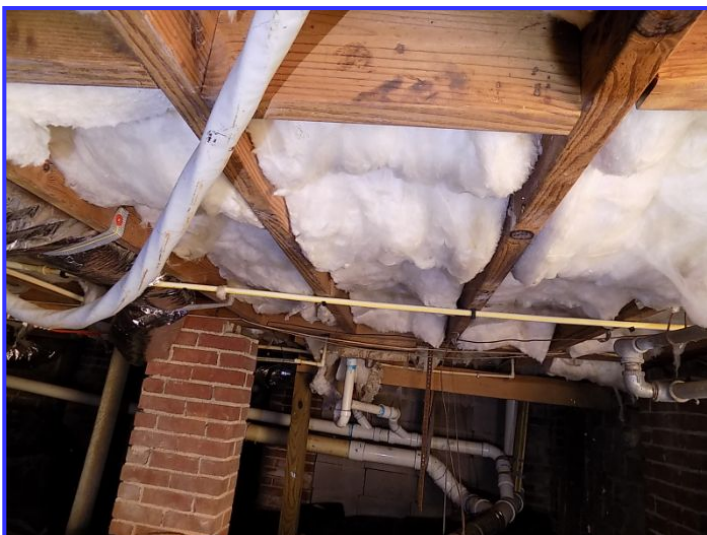
Limited view due to insulation

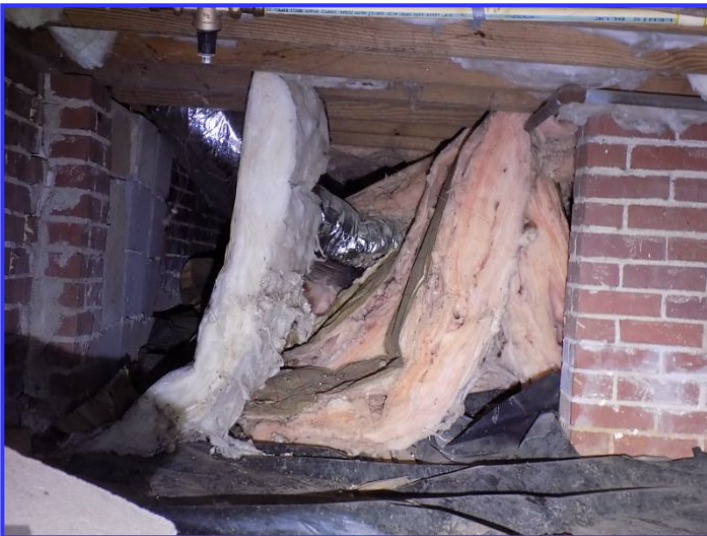
5.3. There is evidence of rodent activity in the insulation over the crawl space. Any damaged insulation should be replaced and the home examined and sealed by a pest control company to prevent further rodent entry.

Rodent bored holes in fallen insulation

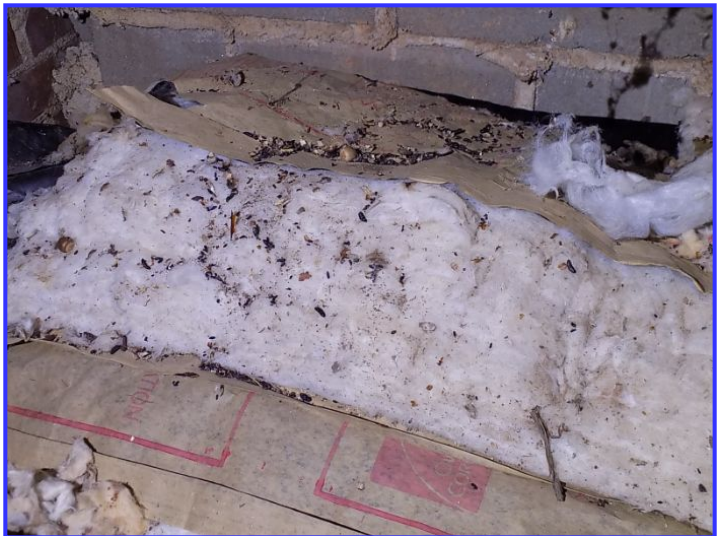
Rodent contaminated insulation in crawlspace

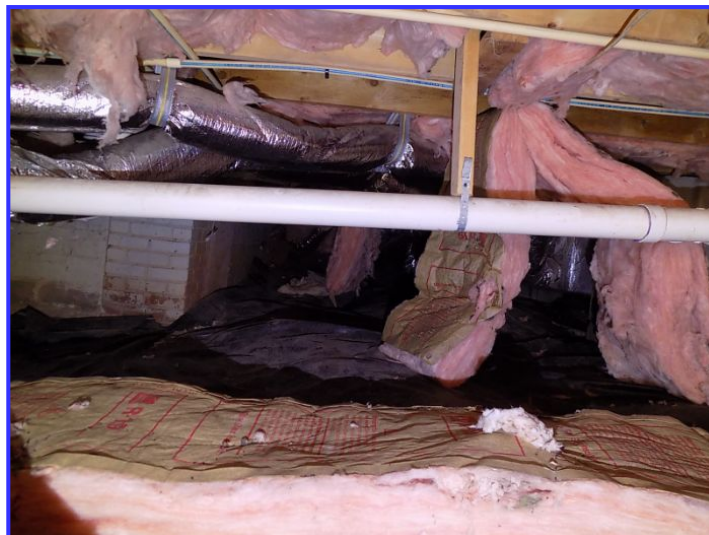
5.2. Loose and fallen insulation observed at the ceiling over the crawl space. Suggest securing as necessary.

Secure loose insulation at ceiling of crawl space

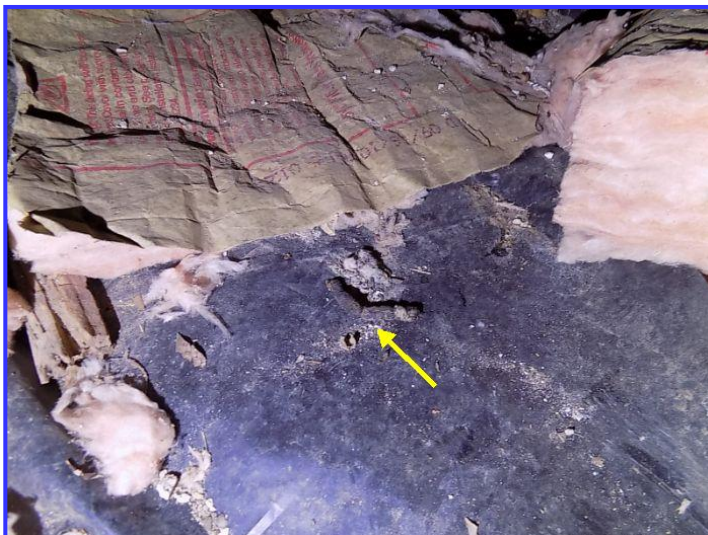
6.2. There is evidence of rodent activity under the home. Rodent droppings observed in the crawl space. Have the home examined by a qualified pest control company to seal any openings and prevent future rodent entry.

Rodent evidence

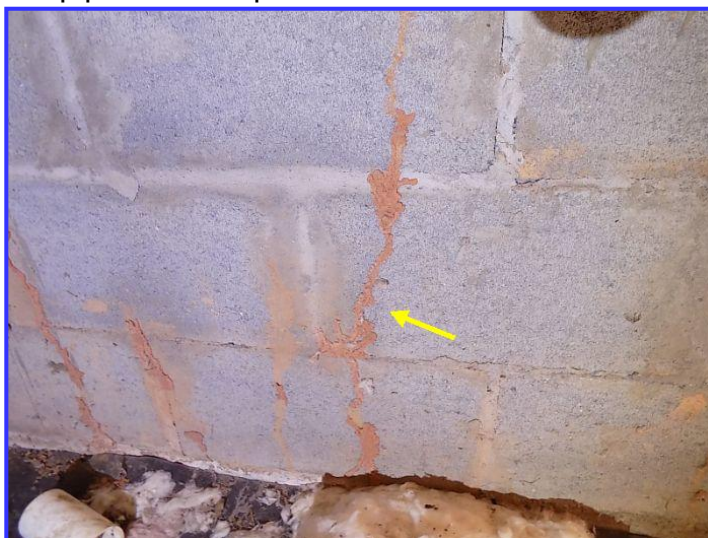
6.3. Evidence of termite activity is noted at the right wall in the crawl space. Have the area examined and treated by a pest control company. Any damaged wood framing should be repaired or replaced as needed.

Possible termite activity at right wall

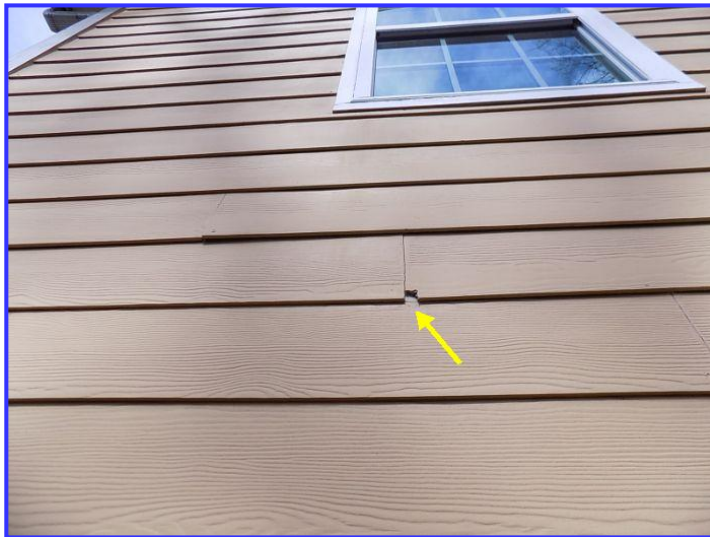
| Roof | | |
|---|---|--|
| Page 9 Item: 2 | Exterior Wall Condition | 2.4. Multiple areas of damaged lap siding were noted around the home. The siding should be reviewed and all damaged siding repaired by a licensed contractor as needed. See photographs for some examples and locations. |

Damaged area of siding at rear

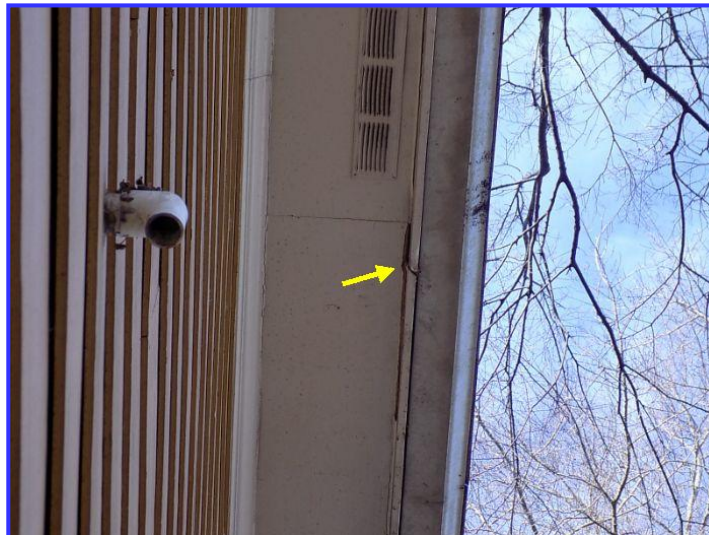
Damaged soffit noted at the left side

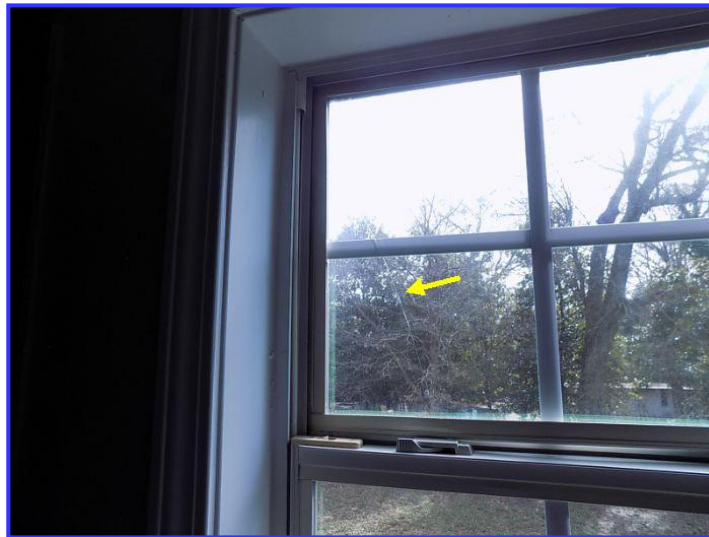
| <p>Page 13 Item: 5</p> | <p>Window/Frame Conditions</p> | <p>5.3. Multiple areas of damaged/soft window framing noted around the home. There may be additional damage that is not fully visible or noted. Recommend a qualified contractor review to improve, repair or replace all damages & any materials subsequently damaged due to these conditions. Not all damages may be noted in this report. See photos for examples</p> <p>5.4. Broken glass is noted in the window at one or more windows inside the home. The damaged glass should be replaced. See photographs for locations</p> |

Broken glass at upstairs hall bath

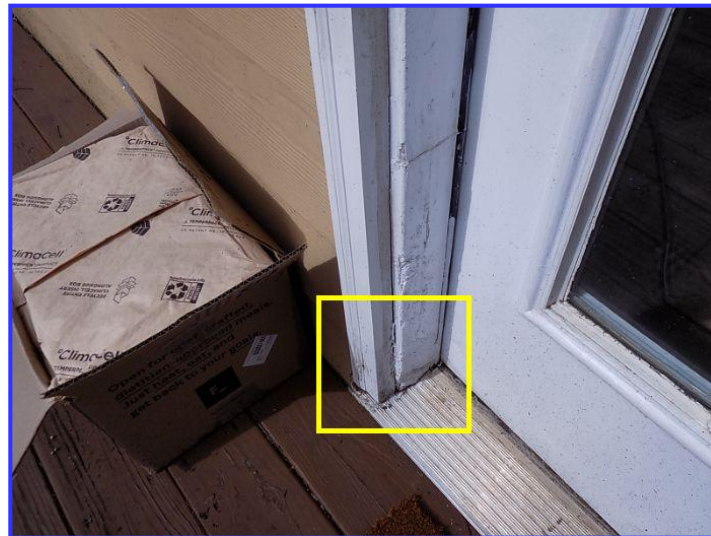
6.5. Door frame/trim damage on exterior door. There may be additional damage that is not fully visible or noted (i.e Subfloor or Threshold). Recommend a qualified contractor review to improve, repair or replace all damages & any materials subsequently damaged due to these conditions. See photos for examples

Damaged wood trim at the rear door

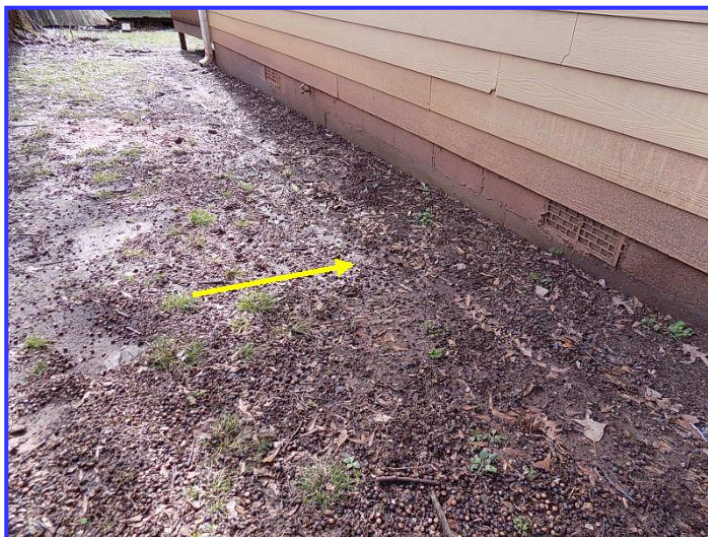
| Page 16 Item: 7 | Exterior Grading | 7.1. The soil outside of the house appears to be incorrectly sloped and should be repaired. It is recommended that a landscape contractor make a further evaluation and correct to prevent water from collecting against the foundation walls to prevent possible water entry. |

Poor slope at the left side

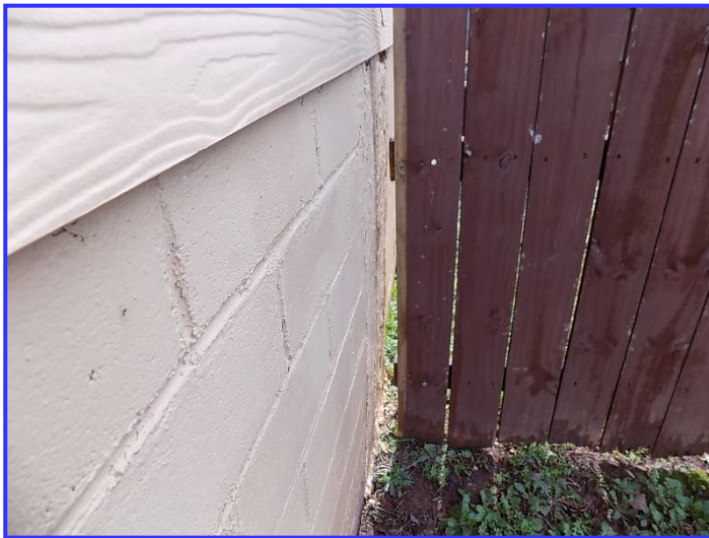
| Page 19 Item: 10 | Foundation Type | 10.2. Uneven area of foundation at right side. Cracking noted on other side in crawlspace. Recommend sealing crack in crawlspace and monitor/repair as needed by a qualified foundation contractor. |

Bulge at foundation section at right side

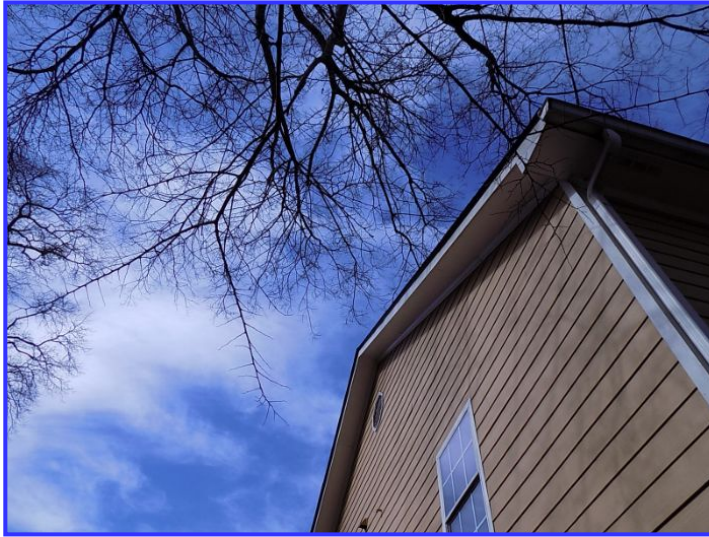
| <p>Page 20 Item: 12</p> | <p>General Exterior Comments</p> | <p>12.2. Suggest trimming tree limbs back away from the roof line. Tree limbs can allow rodents onto the roof or damage the shingles.</p> <p>12.3. Broken glass noted at side yard. Recommend removal for safety.</p> <p>12.4. Damaged fence at rear yard. Recommend repairs as needed.</p> |

Keep tree limbs cut away from roof line around the home

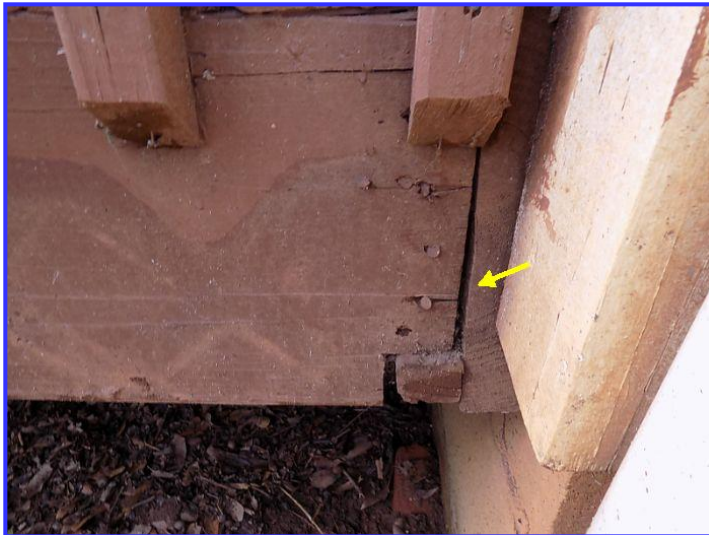
| Page 22 Item: 1 | Deck Conditions | <p>1.2. There were multiple issues noted with the deck on the home. It is suggested to have the entire deck reviewed and all repairs made by a licensed decking contractor. See photographs for example issues and locations.</p> <p>1.3. The deck is on overall poor condition. This could be due to lack of maintenance or poor original construction. Have a qualified deck contractor evaluate and repair for safety.</p> |

Separation at band at rear deck

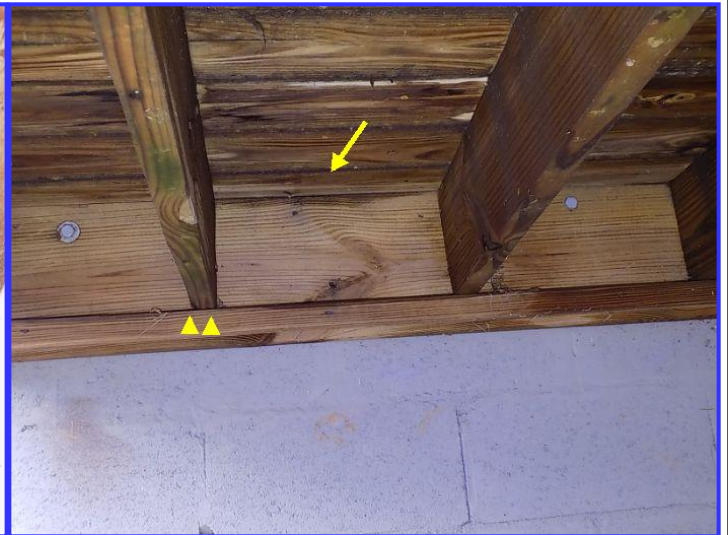
No flashing between deck and home, 3 nails needed

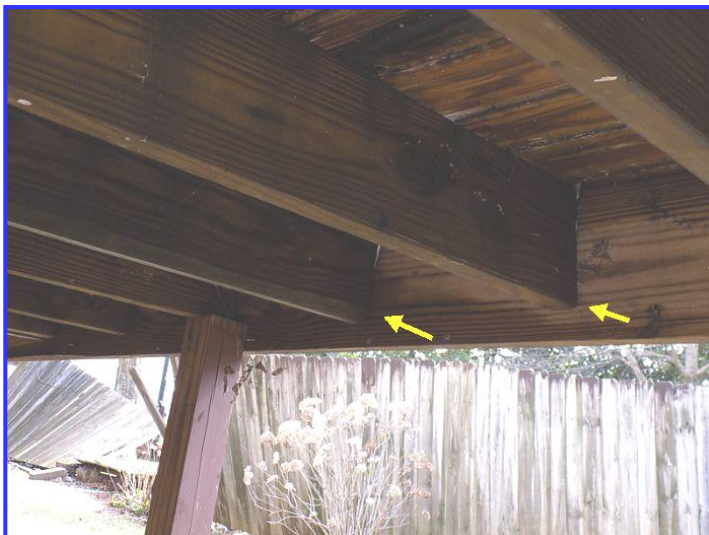
Recommend joist hangers at rear deck

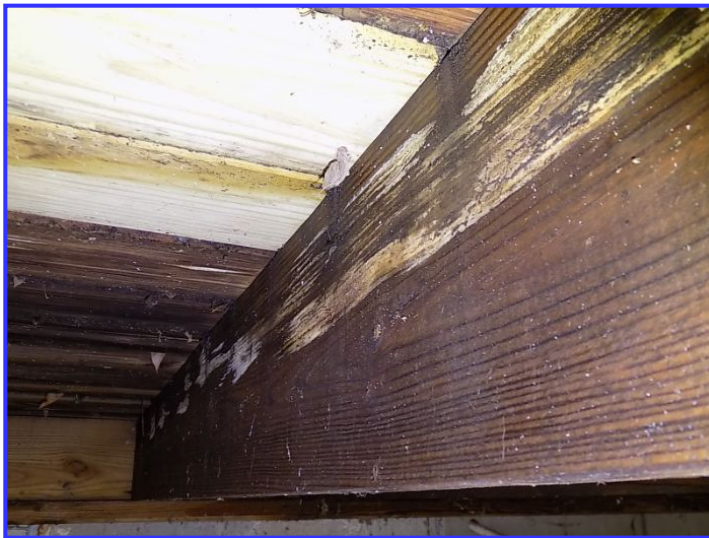
Wood rot at multiple deck joists

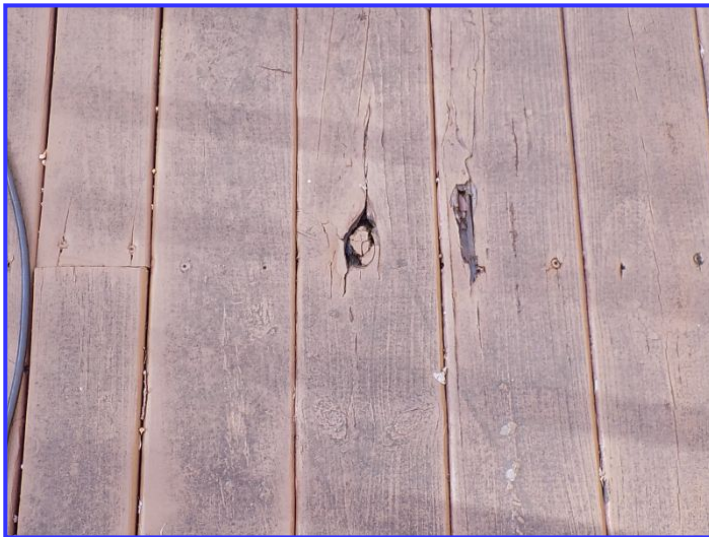
Wood rot at multiple deck boards

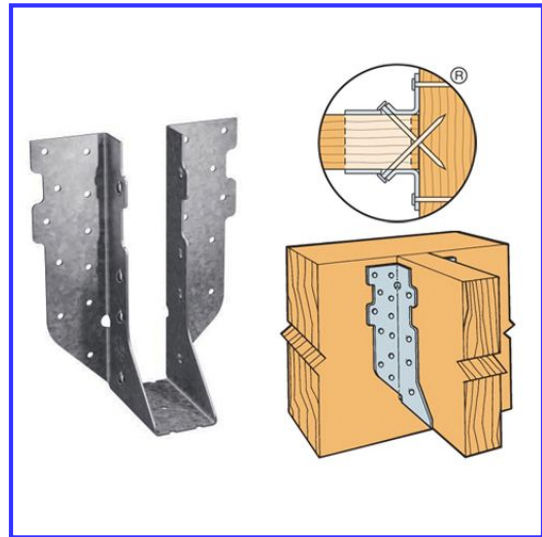
Joist hanger

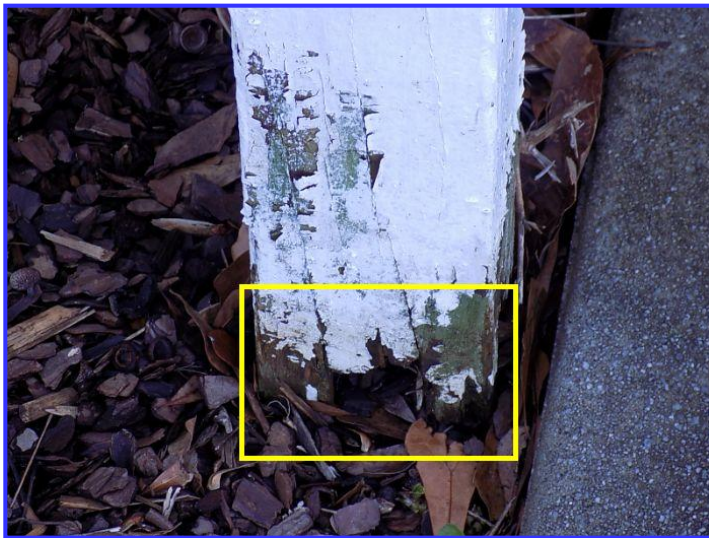
| Page 24 Item: 2 | Porch Conditions | 2.1. Wood rot at front porch support and post. Recommend review and repair by a qualified contractor as needed. |

Wood rot at support at front porch

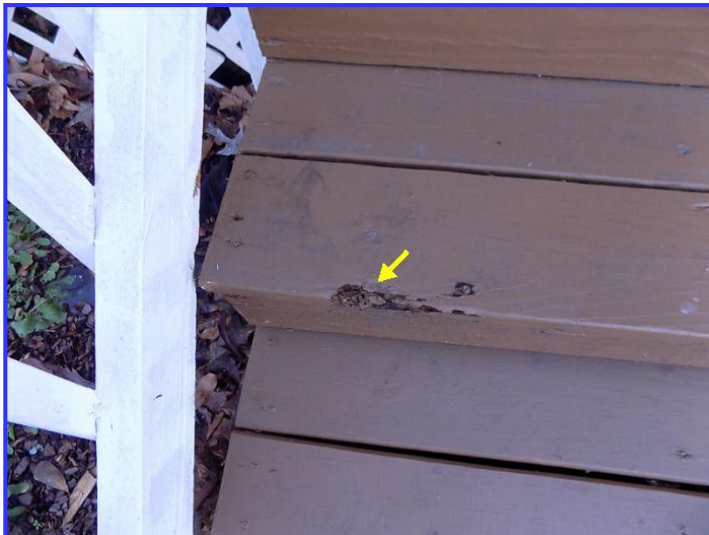
3.1. Stair stringer rot and damaged treads at rear deck. Recommend review and repair by a qualified deck contractor.
3.2. Damaged handrail at rear deck. Recommend repairs as needed by a qualified contractor.

Damaged tread at front porch stairs

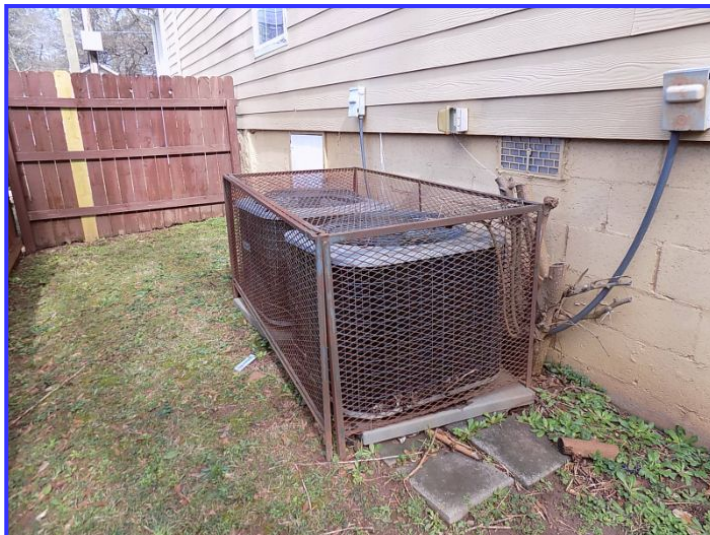
1.2. The AC could not be tested at the time of inspection, due to outside temperatures. However, the unit is at or surpassed its expected life, it is suggested to have the entire HVAC system reviewed and repaired by a licensed HVAC technician as needed. A complete service is recommended to ensure proper function and to prolong the remaining life. We make no guarantees as to the remaining life expectancy of the HVAC system.

AC Unit(s) at right

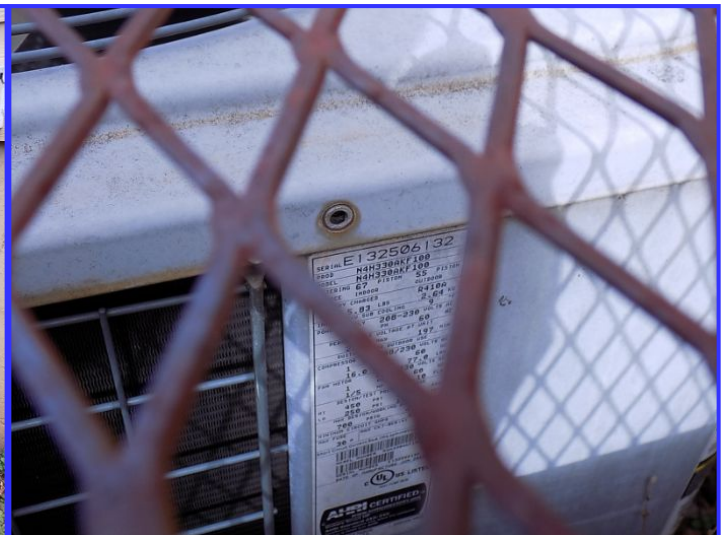
1.3. Unable to view AC data tag due to cage around AC. Corresponding unit inside is dated 2012. Recommend conferring with seller/disclosure about age and service as needed.

2013 Comfort maker at rear

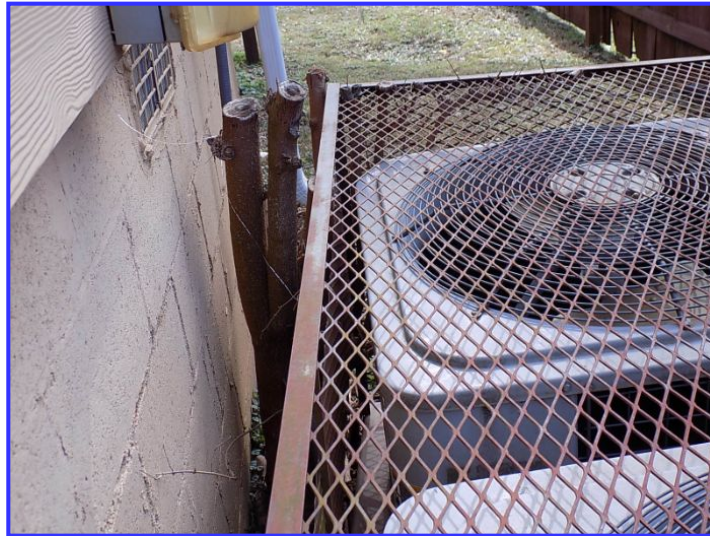
Unable to view tag for second AC due to cage

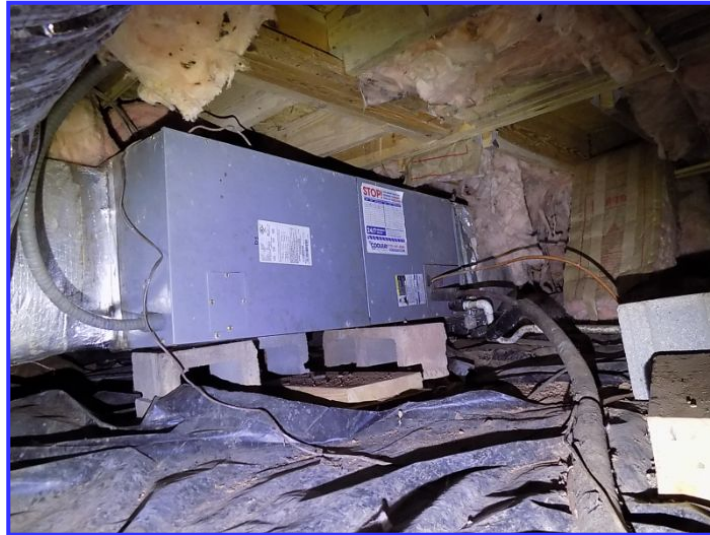
3.1. Appears functional but should be serviced due to age

Furnace in crawlspace

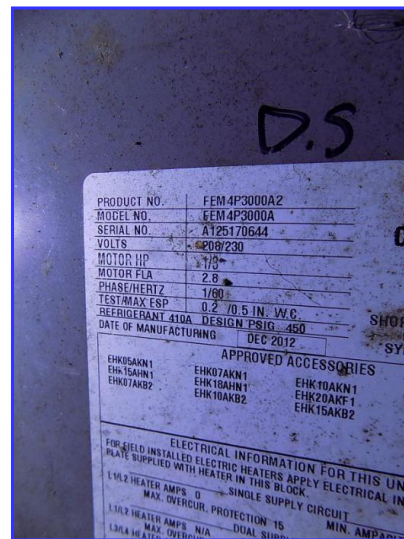
| <p>Page 29 Item: 5</p> | <p>Furnace System Conditions</p> | <p>5.1. The HVAC systems in the home should be fully examined and serviced due to their age. Annual service is recommended on all units over ten years old. Heat pump was tested using normal operating controls. Unit appeared to operate properly at time of inspection. As with all mechanical equipment, the unit may fail at anytime without warning. Inspectors cannot determine future failures. A heat pump is basically a compressor-cycle air conditioning system that can operate in reverse. As long as the unit is functioning properly in either the heating or cooling mode, it is an indication that the major components (compressor, fans, and coils) are operational. Adequate air flow is important to the efficiency of these units; the filter should be kept clean as with all air conditioners. Emergency heat is often provided by electric heat strips. These should be checked and serviced as needed by a HVAC tech. We recommend a detailed evaluation of the heating and cooling systems by a licensed HVAC contractor prior to closing. The systems should be checked to ensure they are sized properly for their installation, to ensure proper operation, and to check the efficiency of the units.</p> |

2012 Electric furnace in crawlspace

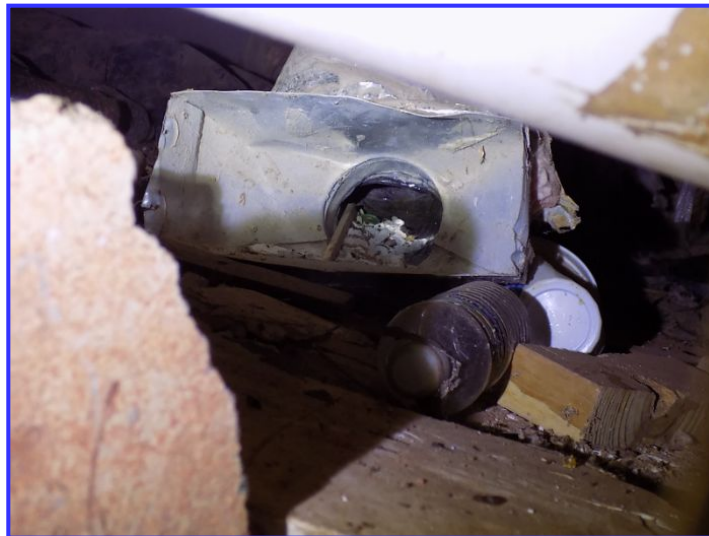
| <p>Page 31 Item: 8</p> | <p>Duct Condition</p> | <p>8.2. Loose duct in crawlspace. Limited view due to low clearance. This duct could be abandoned but limited view. Recommend monitoring airflow at this side of house (left side) and repair as needed.</p> |

Disconnected duct at left wall

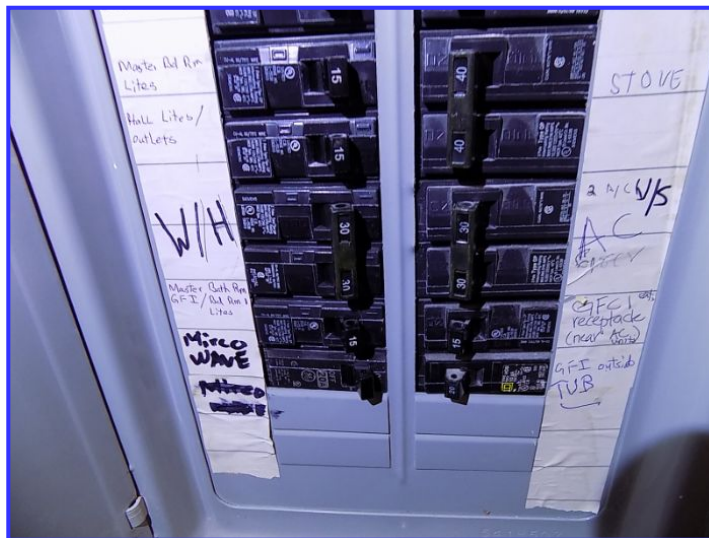
3.2. Different brand names on panel and breakers. Improper breaker-panel matching can cause arcing and overheating in the panel as well a potentially void the panels warranty. We recommend a licensed electrician install new breakers in panel.

Mismatched breakers

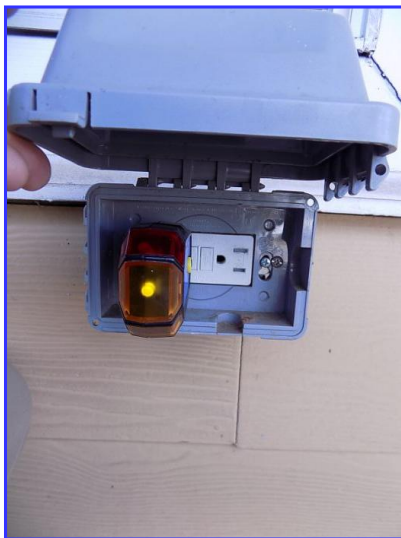
| <p>Page 35 Item: 6</p> | <p>Exterior Electrical</p> | <p>6.1. The GFCI outlet at the front did not trip and outlet at right would not re set when tested and should be replaced. Have a licensed electrician correct. Exterior outlets may fail over time and should be repaired as needed.</p> <p>6.2. Open junction boxes were observed in the crawl space. Whenever an electric wire is cut and reconnected, the splice should be encased in a covered junction box to prevent shocks and separation of the splice.</p> |

GFCI will not trip when tested at front
