All Atlanta Inspection Services

Inspection Report

2483 Memorial Dr SE, Atlanta , GA 30317
Inspection prepared for: Joey Gumataotao
Date of Inspection: 2/9/2025 Time: 2 pm
Age of Home: 88 years old Size: 2886 SF
Weather: Clear 58 degrees

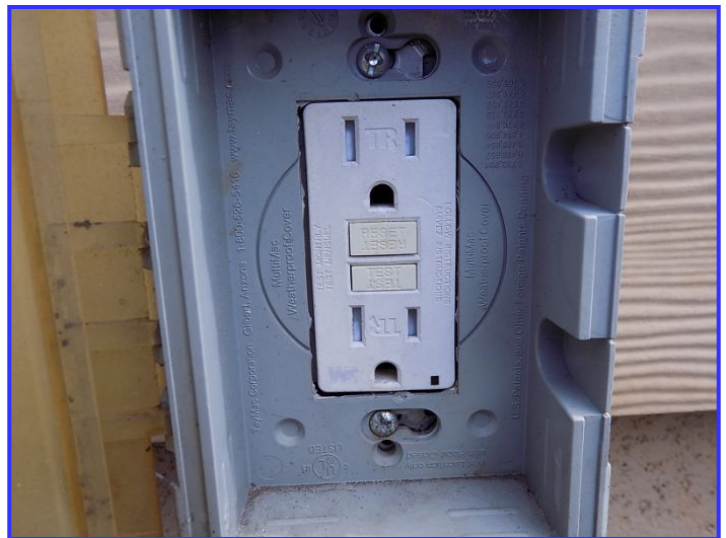
| <p>Page 35 Item: 6</p> | <p>Exterior Electrical</p> | <p>6.1. The GFCI outlet at the front did not trip and outlet at right would not re set when tested and should be replaced. Have a licensed electrician correct. Exterior outlets may fail over time and should be repaired as needed.</p> <p>6.2. Open junction boxes were observed in the crawl space. Whenever an electric wire is cut and reconnected, the splice should be encased in a covered junction box to prevent shocks and separation of the splice.</p> |

GFCI will not trip when re set at right

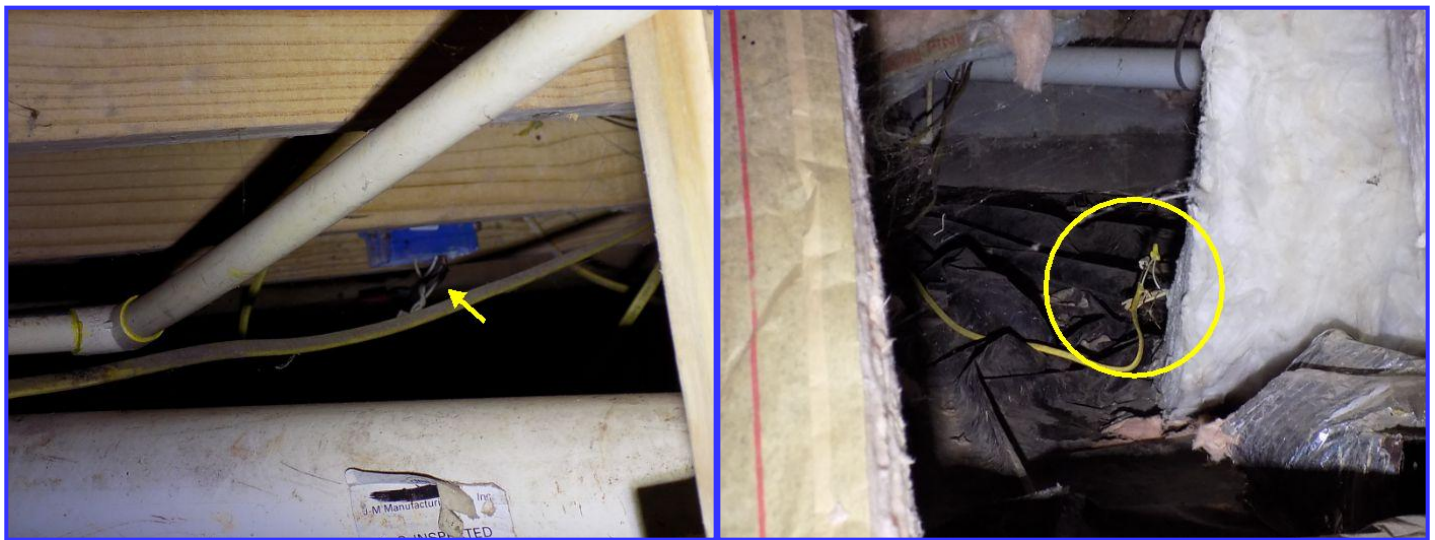
Open junction box in crawlspace

Open splices at rear crawlspace wall

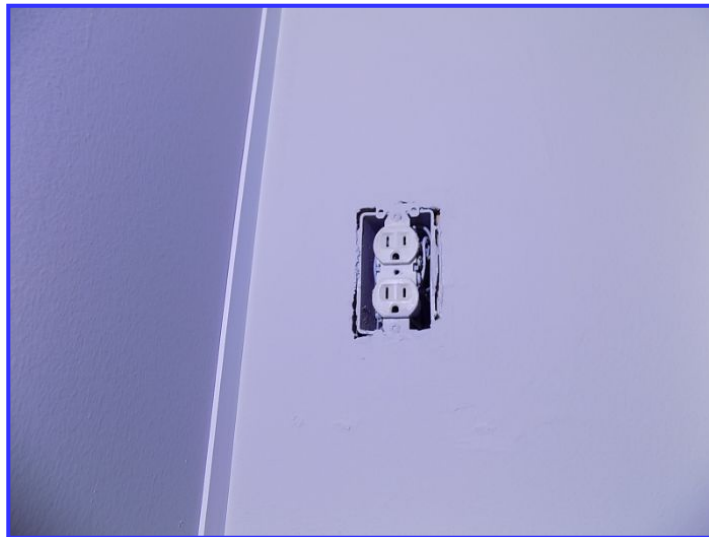
8.1. Missing cover plates observed at one or more interior receptacles throughout the home. Suggest installing cover plates for safety.

Missing cover plate at unit 3

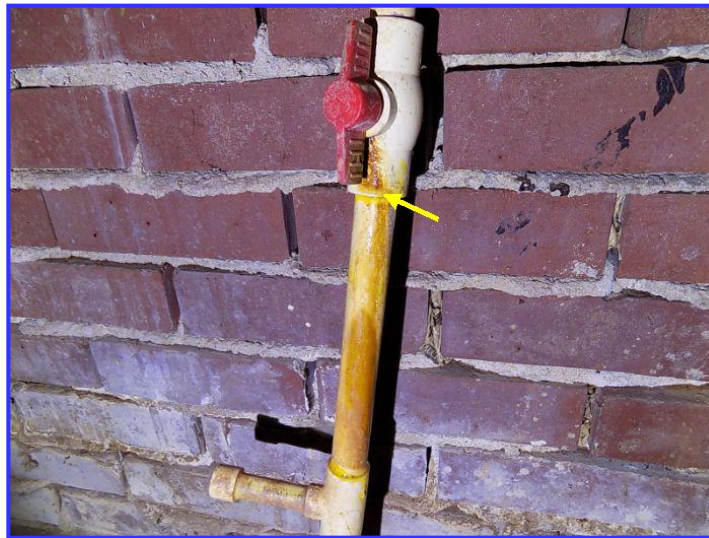
1.3. Leak at main water valve. Recommend review and repair by a qualified plumber as needed.

Leak noted at main water shutoff

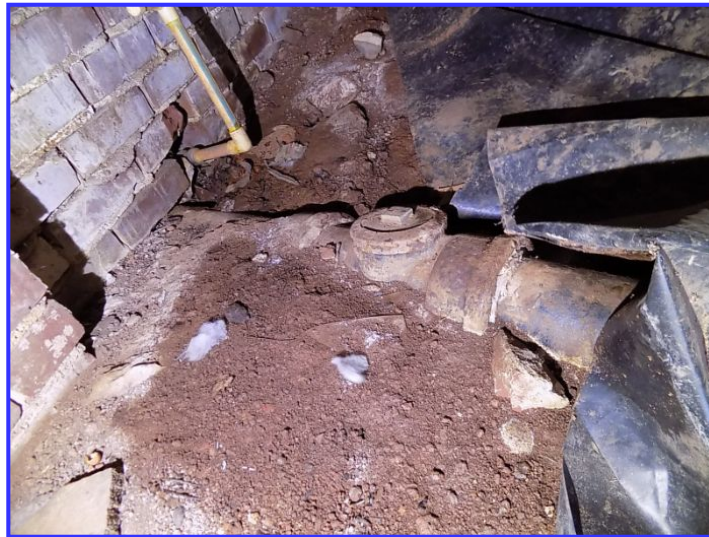
| <p>Page 38 Item: 2</p> | <p>Waste System Conditions</p> | <p>2.2. All or some of the waste water pipes in the home are cast iron or black steel. These were common in homes this age. The pipe will tend to rust along the bottom of the pipes if not properly sloped and have a life expectancy of 50-75 years. The pipes rust from the interior of the pipe and are only visually inspected from the exterior at the time of the inspection.</p> |

Cast iron/Black steel waste lines noted

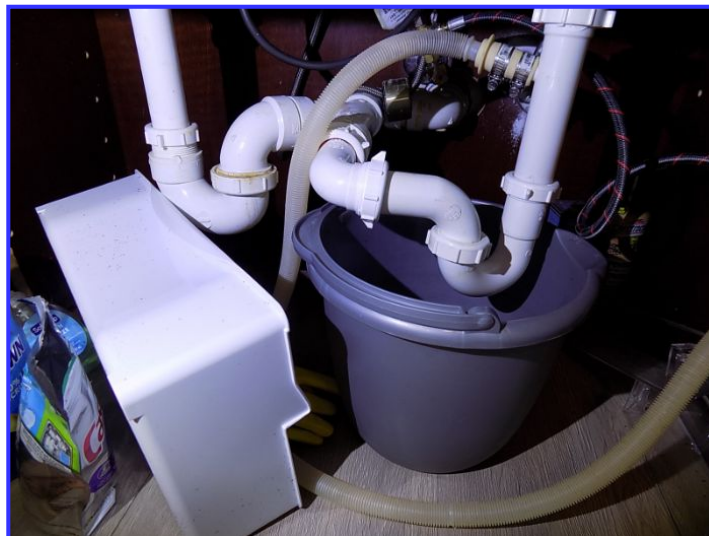
| Page 45 Item: 3 | Kitchen Traps/Drains/Supply | 3.2. Bucket under trap in kitchen could indicate problems with leaking. No leaks noted at time of inspection. Recommend monitoring and repairing as needed by a qualified plumber. |

Bucket under kitchen sink, no leaks noted

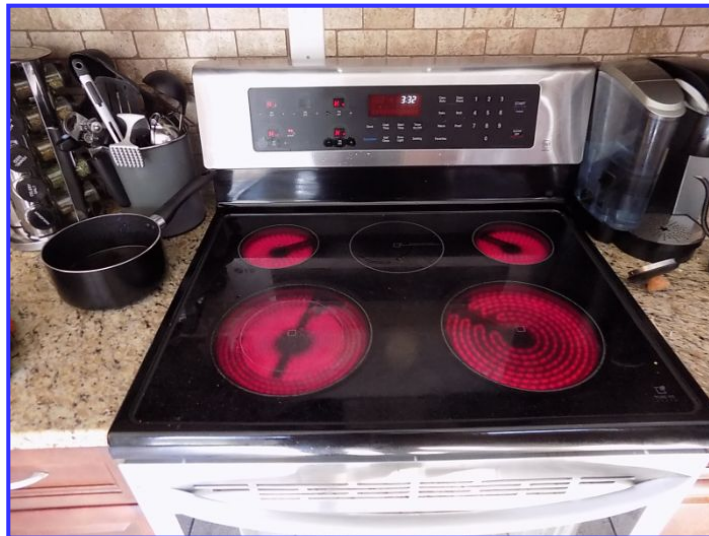
| Page 46 Item: 4 | Kitchen Appliances | 4.2. There is no anti tip bracket installed at the stove as required. This is a safety hazard for children who could stand on the oven door and tip the stove over. Have installed as needed. |

No anti tip bracket installed at stove

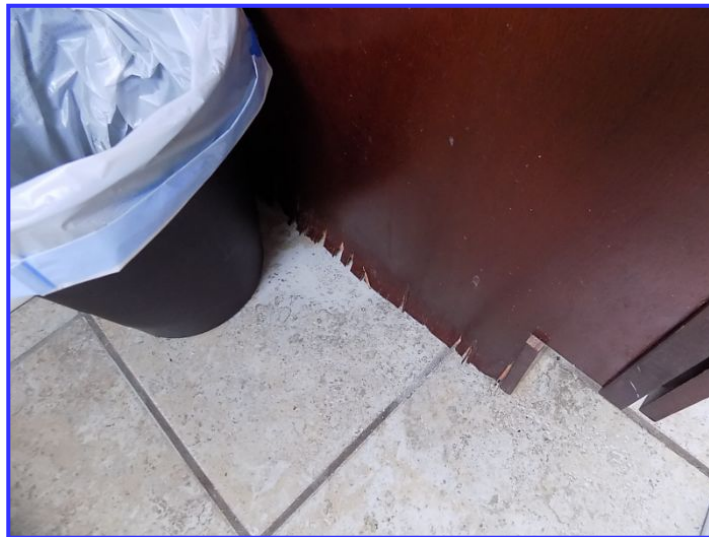
| Page 50 Item: 3 | Bathroom Counters/Cabinets | 3.1. Damaged vanity noted. Recommend review and repair by a qualified contractor as needed. |

Damaged vanity at upstairs hall bath

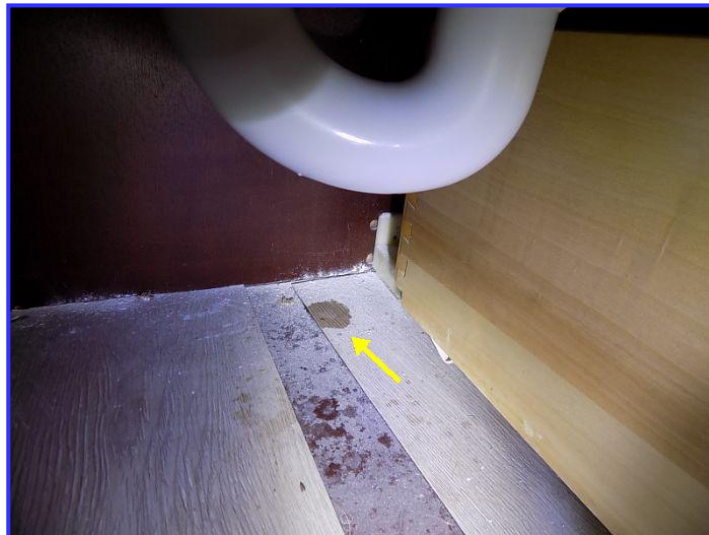
| Page 50 Item: 4 | Bathroom Traps/Drains/Supply | <p>4.4. Leaking noted beneath one or more bathroom sink(s). See photographs for locations and details. Recommend review and repair by a qualified plumber as needed.</p> <p>4.5. Improper "S" trap noted. This trap configuration may cause the trap to siphon dry, allowing sewer gas and odour to enter the dwelling. Suggest repair by a qualified professional.</p> |

Leak at drain under sink in the main level guest bath

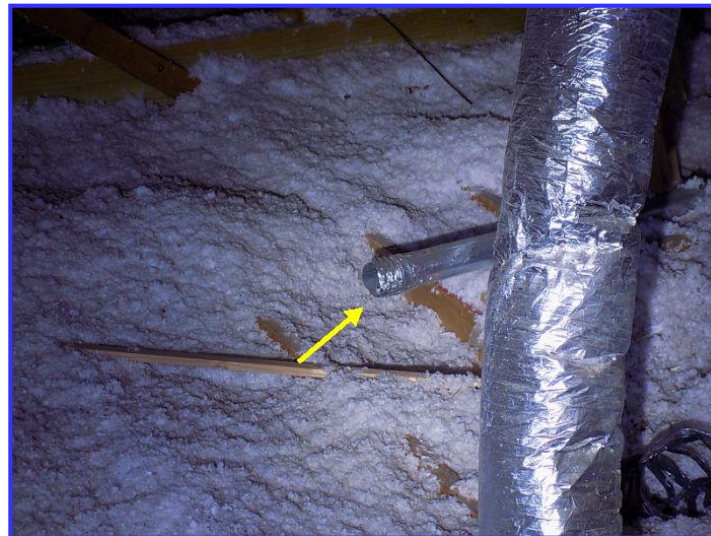
10.3. The duct from the bath vent needs to be extended to discharge to the exterior of the home and not into the attic area, this can cause a buildup of moisture and mold in the attic. All house vents should be directed to the exterior, A qualified contractor should repair as needed.

Bathroom fans noted discharging in the attic space

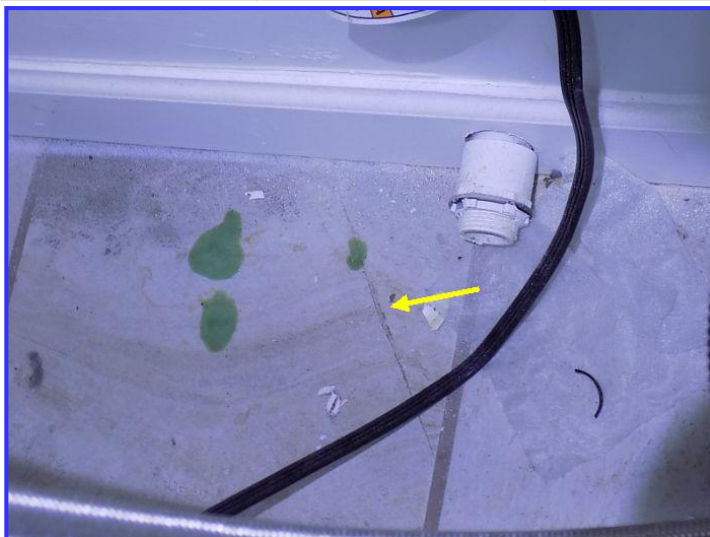
| <p>Page 55 Item: 1</p> | <p>Interior Flooring Condition</p> | <p>1.1. Cracked tiles noted at one or more locations inside the home. This could be from mechanical damage or improper installation. Suggested to have any cracked or damaged tiles repaired/replaced by a licensed flooring contractor as needed. See photographs for examples and locations.</p> <p>1.2. Unevenness is noted in the sub flooring around the main floor. This appears to be consistent the age and wood framed construction of the home, although not all framing members are visible at the time of inspection. This should be repaired and leveled if the finished flooring is replaced. If further review is desired, it is suggested to consult with a licensed contractor for review.</p> |

Cracked tiles at laundry room

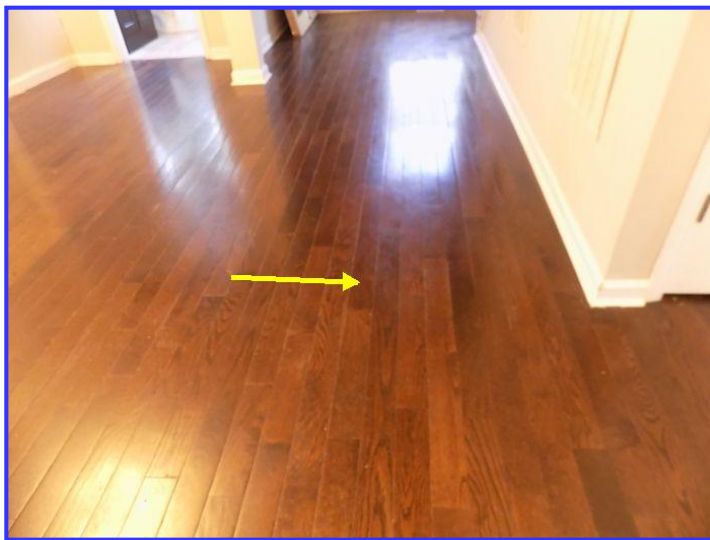
Low spot in floor at main foyer

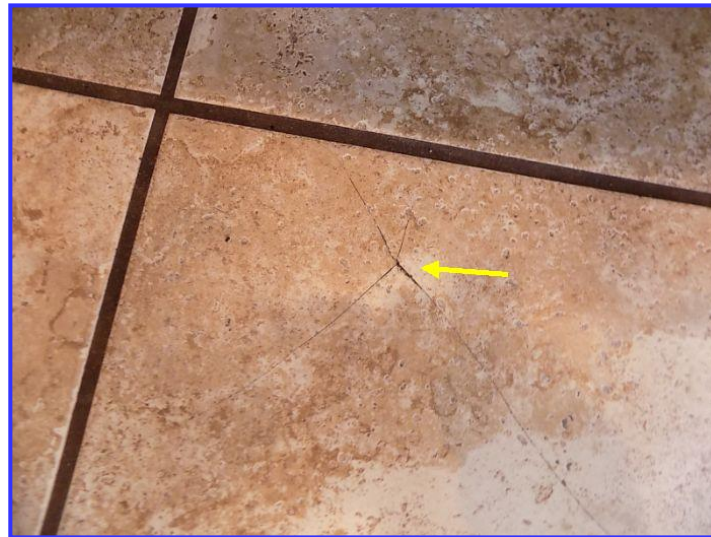
Cracked tiles at kitchen

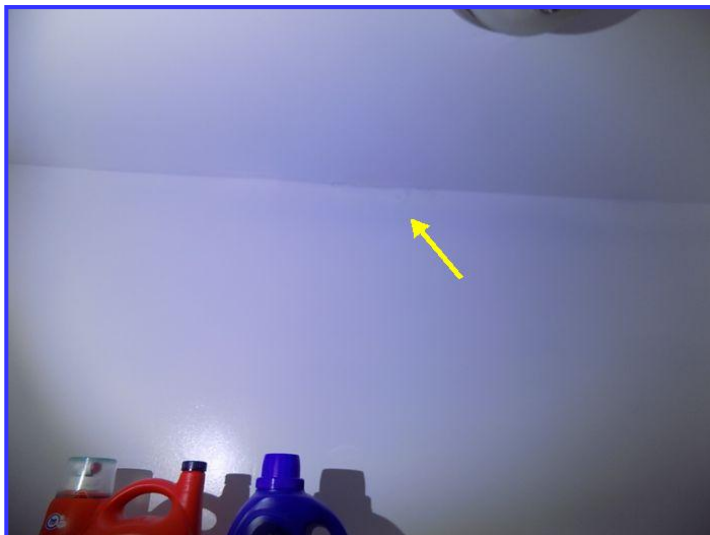
| <p>Page 57 Item: 3</p> | <p>Interior Ceiling Conditions</p> | <p>3.2. Evidence of patching observed. There were no visible leaks noted at the time of inspection. At the time of inspection, there was no way to determine the cause of the original damage. Suggest referring to the sellers regarding any prior repairs and monitoring and repairing as needed.</p> <p>3.3. One or more water stains noted around home. See photographs for locations and details. Unable to determine the source of the water. Have the plumbing or roofing reviewed and repaired if needed. There is the possibility of hidden damage that should be investigated. Any subsequently damaged materials should be repaired as well.</p> |

Patching at laundry room

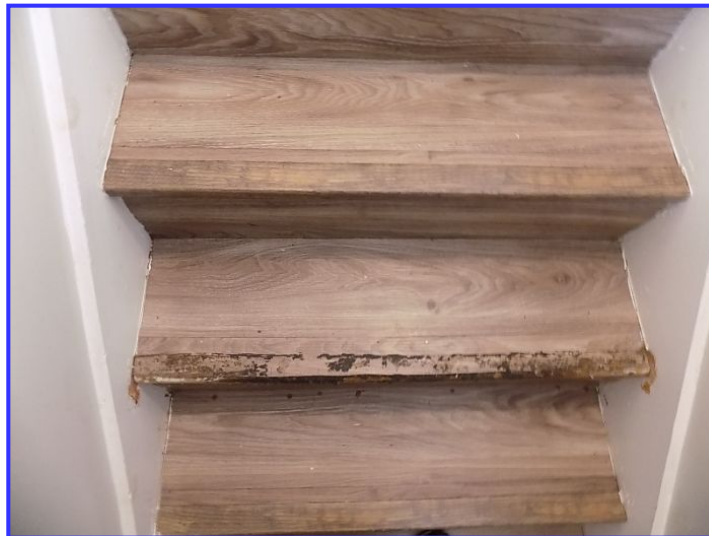
| <p>Page 59 Item: 6</p> | <p>Interior Stair/Rail Conditions</p> | <p>6.2. Damaged stair tread at main stairs. Recommend review and repair by a qualified contractor as needed.</p> |

Damage at stars

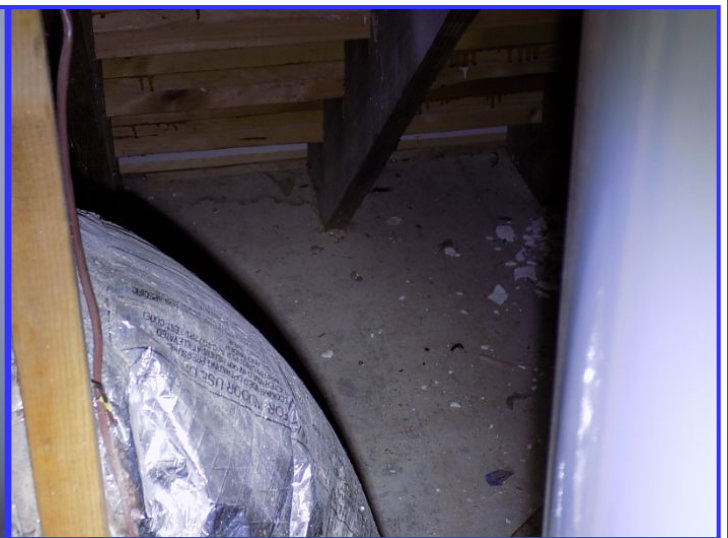
| <p>Page 59 Item: 7</p> | <p>Other Interior Area Comments</p> | <p>7.5. Evidence of rodents/animals is noted in the home. See some details in this report. There may be additional evidence not noted due to rodent infestation usually impacts multiple areas in the home. A more thorough inspection from a qualified Pest Control Company is recommended to seal any openings to prevent animal entry and subsequent damage noted and repaired.</p> <p>7.6. Possible mold/mildew on ceiling at upstairs hall bath. Recommend professional cleaning with a fungicide as needed.</p> |

Rodent droppings under stairs at main level

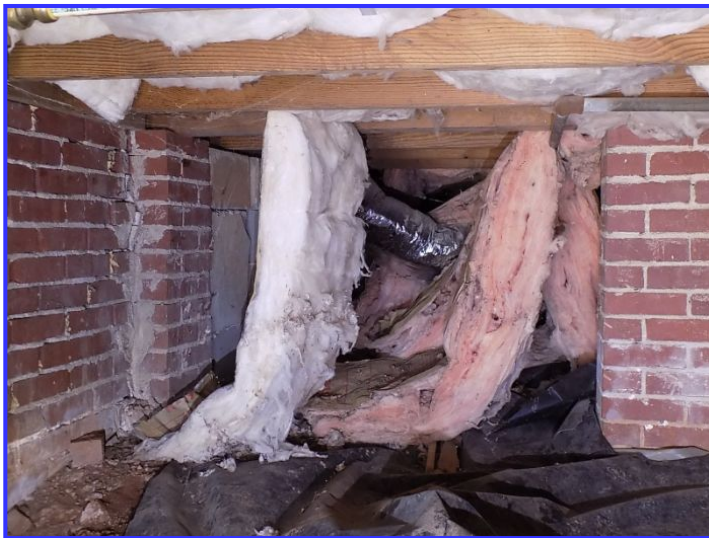
1.1. The crawl space is too low for safe access at areas due to fallen insulation due to rodents. The height is less than 18 inches and there are drains and plumbing running under the home. Inaccessible areas were viewed with strong light from the hatch. Inspection of the crawlspace is limited and areas that cannot be entered are excluded from the inspection report. There are many items in the crawlspace that are not visible and are excluded from the inspection. This includes water lines, drain lines, floor framing, foundation walls, sub flooring, and insulation. Have a proper access installed and the crawlspace fully inspected.

Limited view at front wall due to fallen insulation

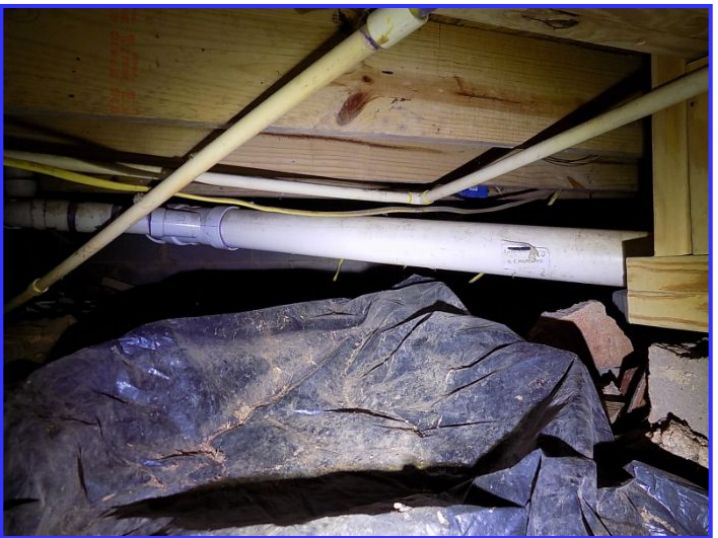
Limited view at left wall

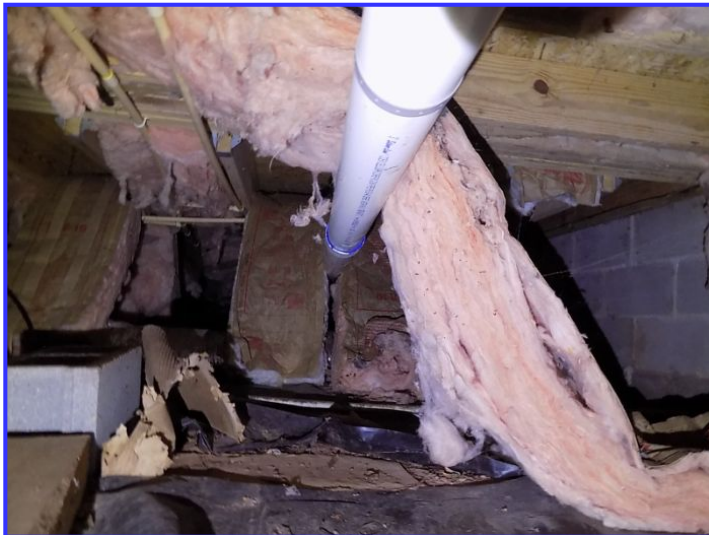
Limited view at rear wall due to fallen insulation

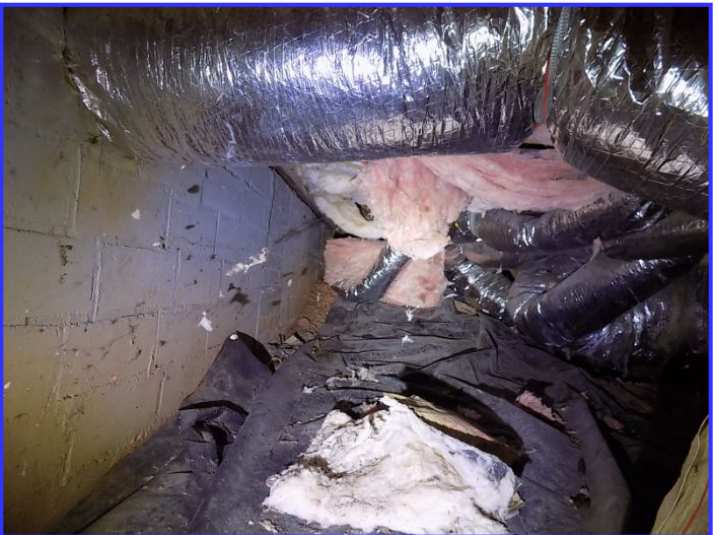
Limited view

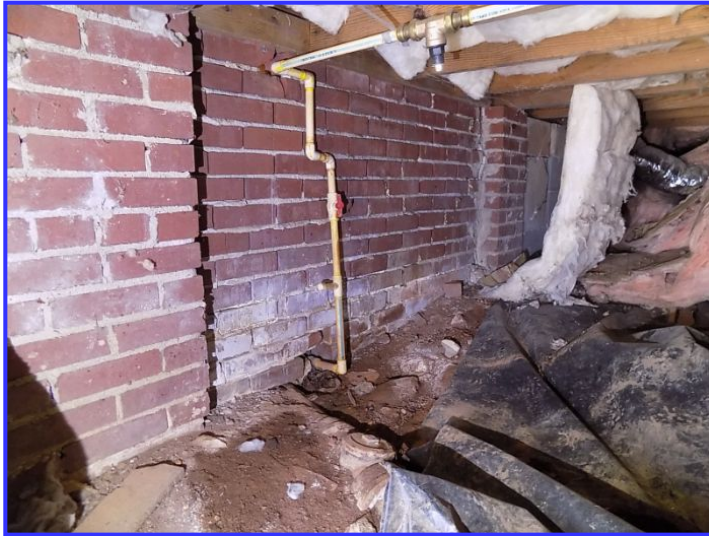
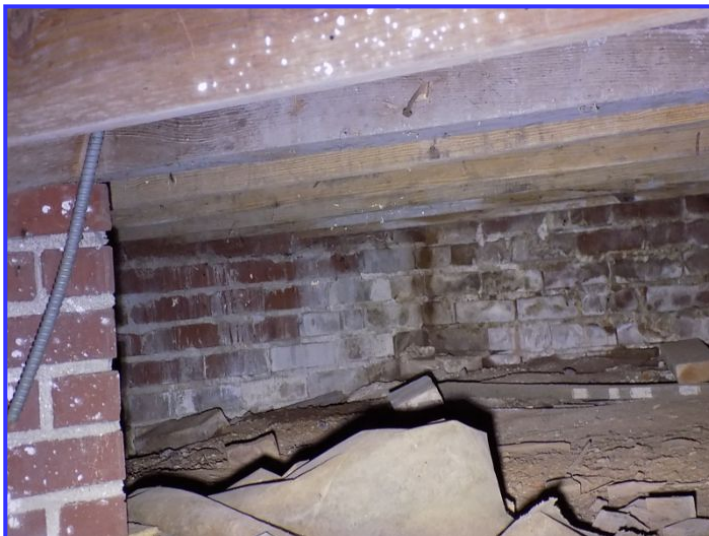
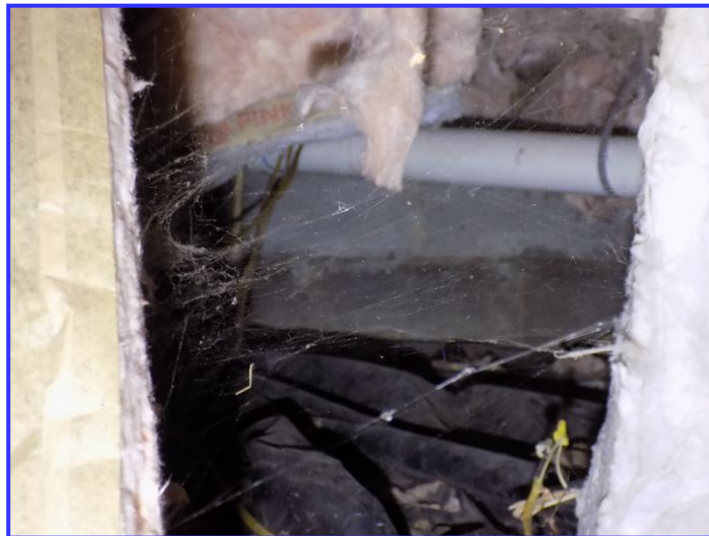
3.2. Efflorescence observed, this is a mineral deposit left behind from exterior water infiltration.

Efflorescence noted

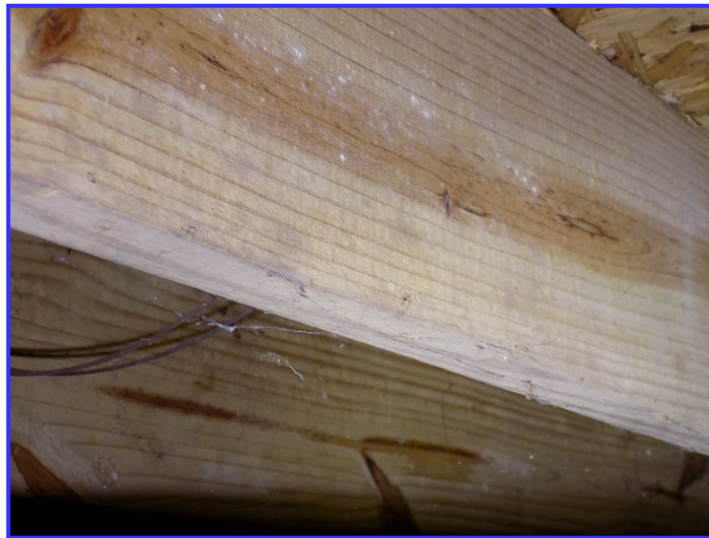
| Page 65 Item: 4 | Crawl Space Framing Conditions | 4.1. Organic growth on framing in crawl. These conditions may indicate mold or fungus growth. Once moisture issues are resolved, professional cleaning with a fungicide is recommended. |

Organic growth on framing

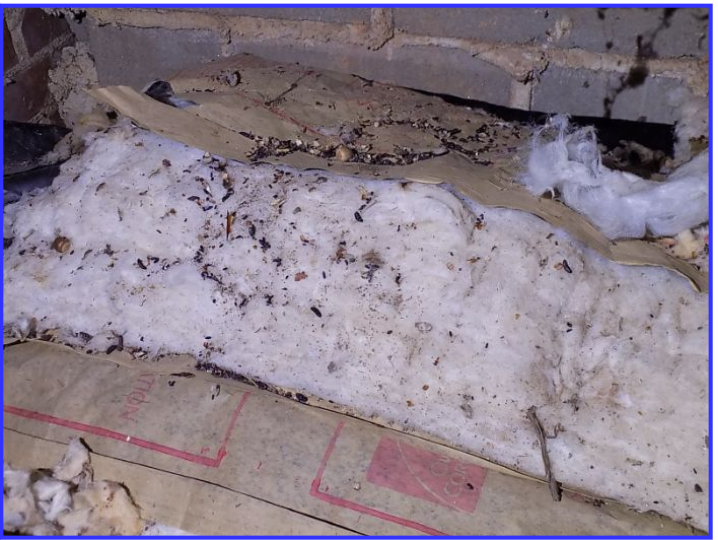
| Page 66 Item: 5 | Under Floor Vent/Insulation Conditions | <p>5.2. Loose and fallen insulation observed at the ceiling over the crawl space. Suggest securing as necessary.</p> <p>5.3. There is evidence of rodent activity in the insulation over the crawl space. Any damaged insulation should be replaced and the home examined and sealed by a pest control company to prevent further rodent entry.</p> |

Rodent contaminated insulation in crawlspace

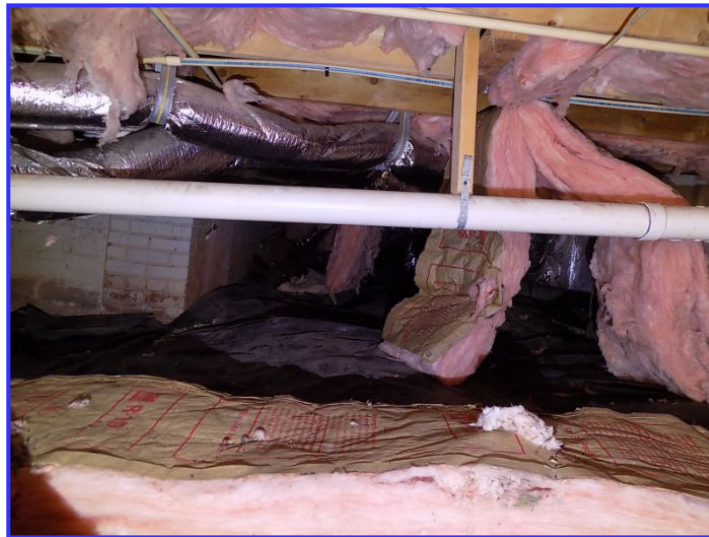
Secure loose insulation at ceiling of crawl space

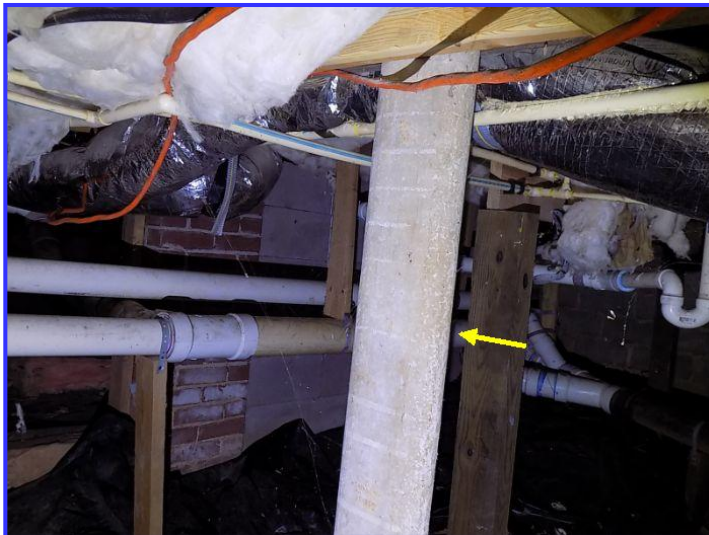
| Page 67 Item: 6 | Crawlspace Comments | <p>6.1. Elevated moisture levels and lack of conditioned air make crawl spaces likely areas for organic growth. Because certain people are more sensitive to growth and certain molds are toxic, it is always recommended that a mold testing be done if the buyer is concerned. In most cases cleaning with a fungicide and repairs to lower the moisture level are needed.</p> <p>6.2. There is evidence of rodent activity under the home. Rodent droppings observed in the crawl space. Have the home examined by a qualified pest control company to seal any openings and prevent future rodent entry.</p> <p>6.3. Evidence of termite activity is noted at the right wall in the crawl space. Have the area examined and treated by a pest control company. Any damaged wood framing should be repaired or replaced as needed.</p> <p>6.4. Possible asbestos "transite" pipe in crawlspace. Recommend review by an asbestos mitigation specialist for repair/removal as needed.</p> |

Possible asbestos transite pipe in crawlspace

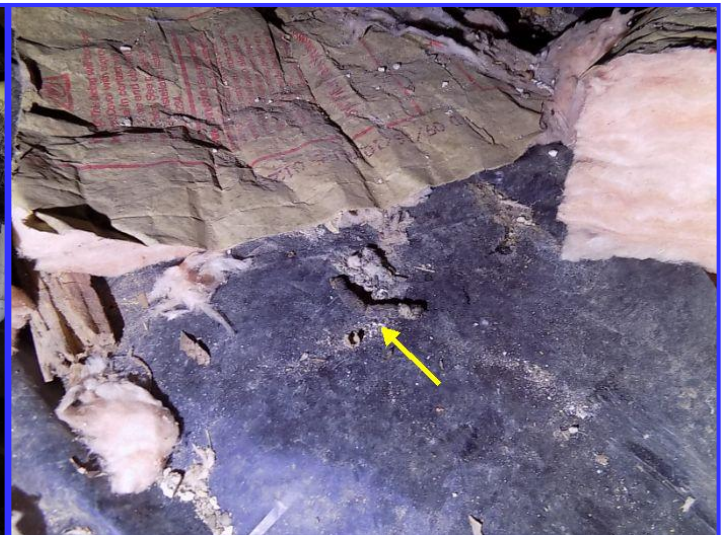
Rodent evidence

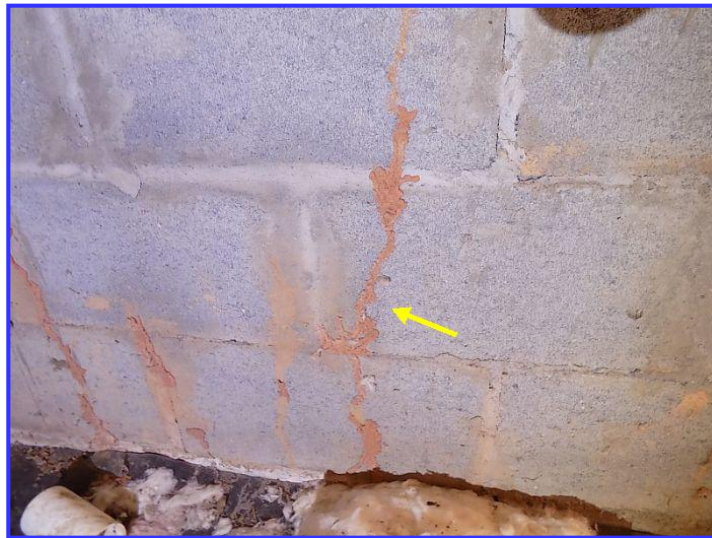
Possible termite activity at right wall
